INCIDENT ACTION PLAN

Location
Bayou Corne
Sink Hole

RE: In-Place Inclinometer, Tiltmeter, and Water-Level Monitoring System, Napoleonville Dome Weekly Report: May 04, 2013, Through May 10, 2013

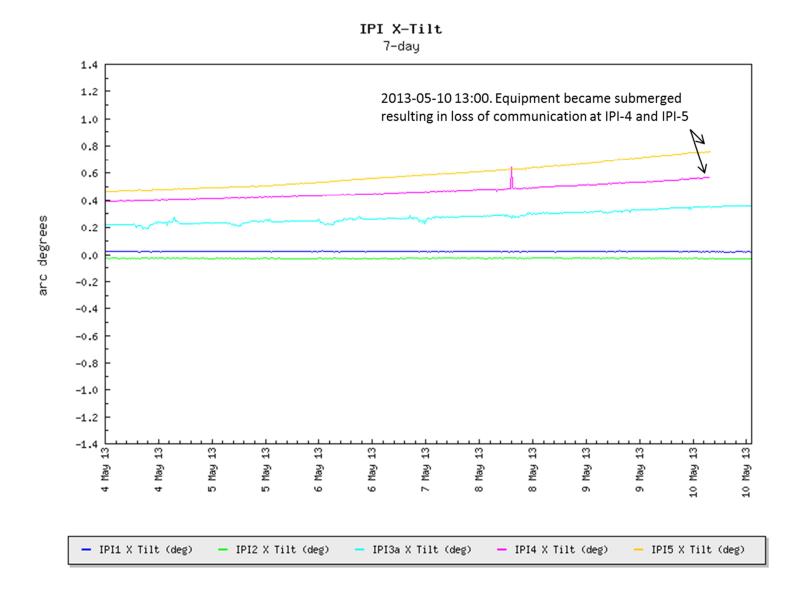
Figure 2. Inclinometer X-Direction Temporal Trends.

This week, tilt readings from inclinometers IPI-3a, IPI-4, and IPI-5 showed continued, accelerated tilt of 0.18 degree toward the south, 0.21 degree toward the east-northeast, and 0.31 degree toward the northeast, respectively. No substantial tilt was observed at IPI-1, IPI-2, the tiltmeters located on the shop, Pad 3, or the brine storage tanks. IPI-4 and IPI-5 became submerged and communication with the instruments was lost at 13:00 on May 10 because of a breach in the western berm after a heavy rainstorm. Instruments were above water level on January 15, 2013 (the previous, highest water level observed since project inception); however, current water levels are approximately 0.25 feet higher. The fact that housings and antennas are completely submerged indicates that subsidence of potentially several feet has taken place at the IPI-4 and IPI-5 instruments. The equipment cannot safely be retrieved until water levels decrease.

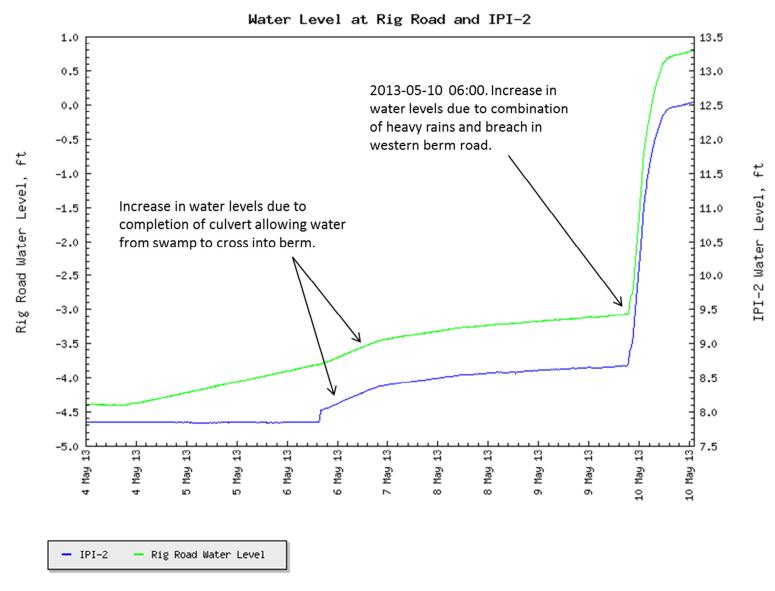
Figure 5. Water-Level Temporal Trends Showing Rig Access Road and IPI-2 Data.

Figure 5 shows water-level temporal trends at the IPI-2 and Rig Access Road transducers. Water levels inside the berm slowly increased throughout the week after a culvert was

completed and opened on the northern end of the western berm road. Water levels apparently rose over the IPI-2 transducer (which was reported last week as subaerially exposed) and allowed allowing water-level measurements at that transducer. An early-morning intense rainstorm on May 10 caused a breach in the western berm road and allowed water to flow across the berm and essentially equalize water levels inside the berm with those outside. Water level at the Rig Access Road transducer rose approximately 3.85 feet since the breach occurred and raised a total of 5.2 feet throughout the week. The increase in water levels submerged the Pad 3 transducer, which had also been subaerially exposed, and allowed the water level to be measured at that site, as shown in Figure 6. Figure 7 shows a detailed, zoomed-in view of water levels on May 10 at the Rig Road and IPI-2 transducer.
