US DOT PHMSA AID Situational Awareness for Employees: SAFE Bulletin¹ Internal Corrosion – Crude Oil

49 C.F.R. Part 195 Transportation of Hazardous Liquids by Pipeline

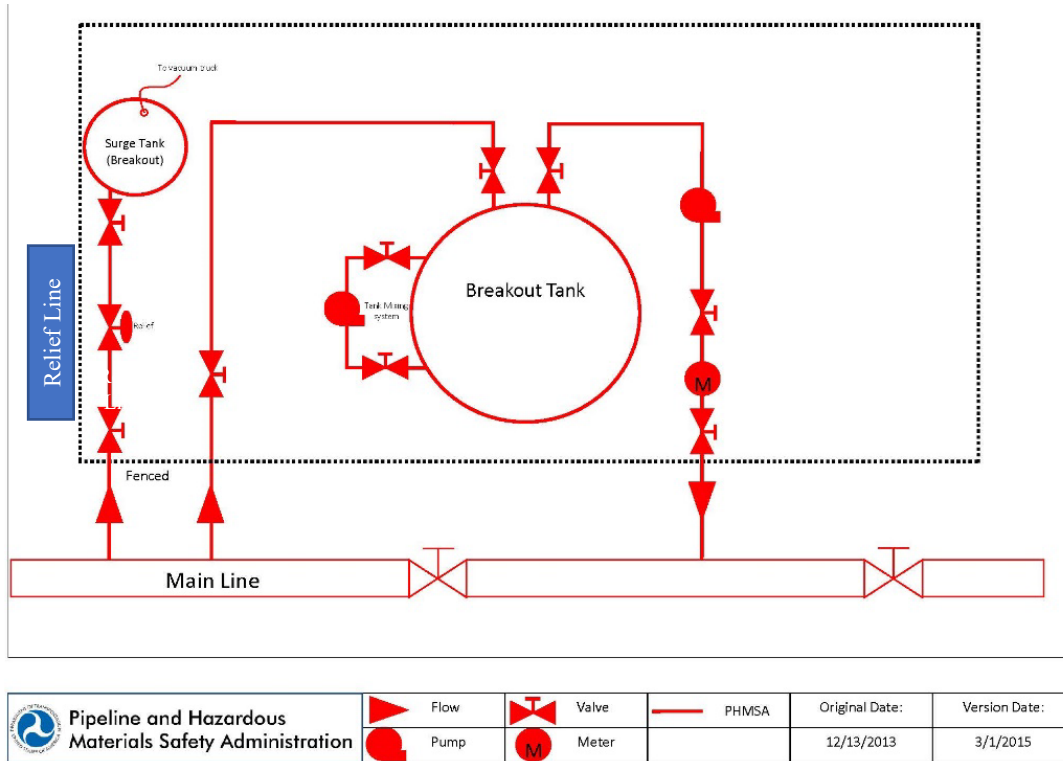
Due to their intermittent, low flow, or stagnant use, underground relief lines, strainers, drain lines, valves, meters/provers, by-pass lines, and dead legs may accumulate water in low points. Figures 1 and 2 illustrate examples of operational dead legs. Figure 1 shows a relief line to a surge tank from a main line. The product is stagnant except when the pressure in the main line exceeds the set point on the relief valve and relieves into the surge tank. As shown in Figure 2, drain lines

Figure 1: Relief Line from Main Line Pipeline to Surge Tank (Breakout)

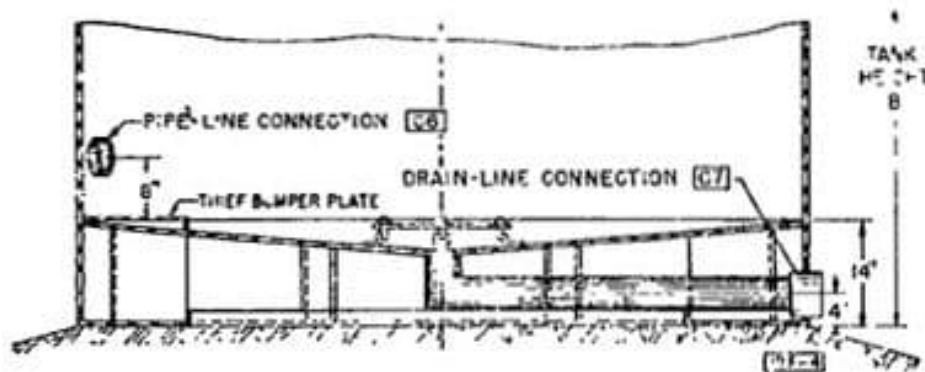
connecting to tanks are another example of a location that is highly susceptible to internal corrosion due to low elevation and intermittent flow.

Figure 2: Skirted Cone Bottom Drain-line⁴on Breakout Tank

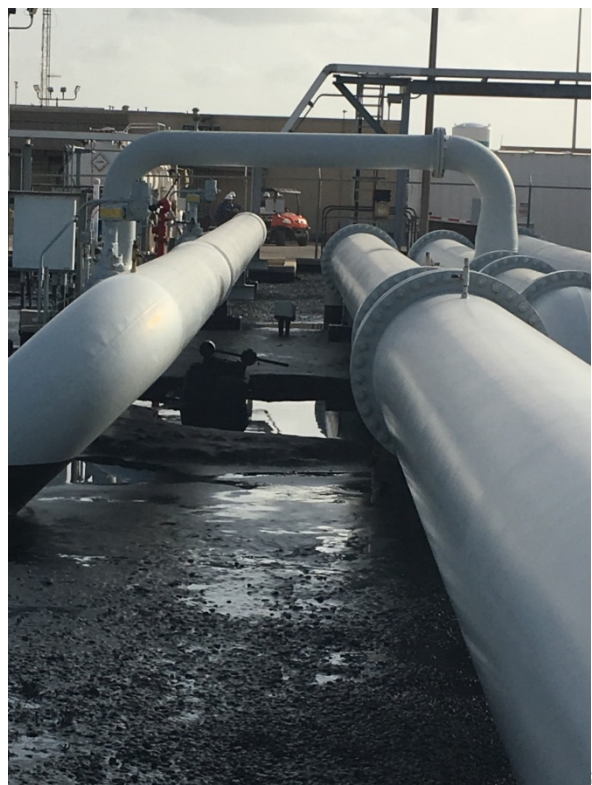
In August 2018, after about six hours of ship unloading at the marine terminal, a 36-in pipeline failed at 110 psig at the 6 o'clock position due to under deposit internal corrosion. The failed pipeline released 4,922 barrels of crude oil within the containment area of the terminal. Approximately 5 barrels reached the harbor and 4,888 barrels were recovered. There were no fatalities or injuries.

Figure 8. Crude Oil Pooling at Leak Location (Photo provided by Enterprise).

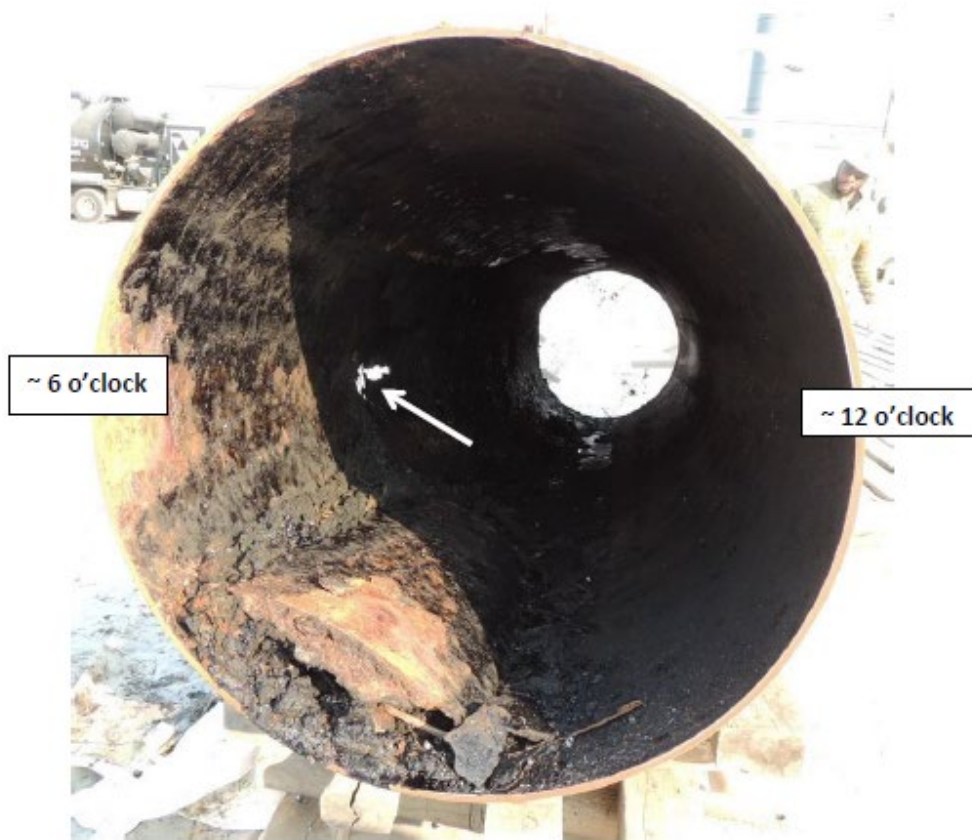
The investigation identified the following contributing factors: ineffective implementation of their internal corrosion and integrity management programs (IMP), failure of the leak detection system associated with a large pressure drop of 29%, the failure to implement findings from past accidents to prevent recurrence, and a crack in the containment wall.

Figure 9. The white arrow indicates the perforation site at 6 o'clock. The sediment at bottom of pipe shifted when the pipe was rotated to place the pipe for field observations (Figure 3 from Stress Engineering Services' Metallurgical Report).

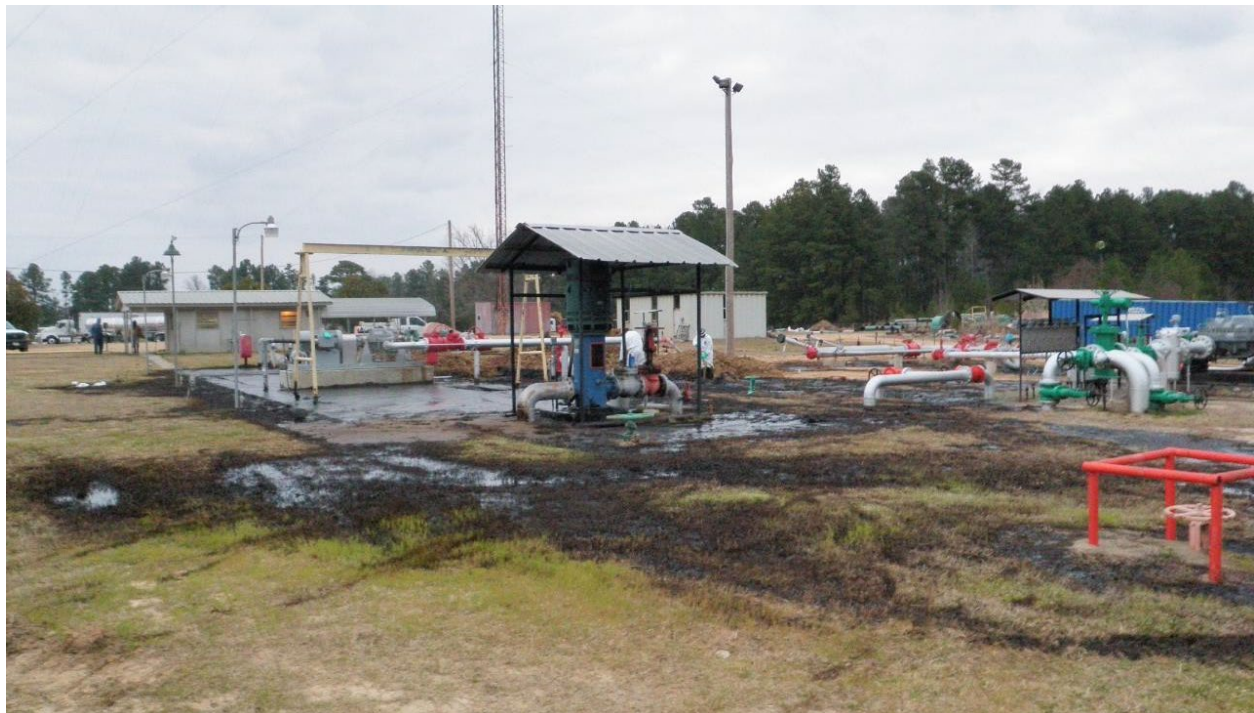
Figure 11. The release of oil was caused from a 12-inch underground pipe west of blue suction pump. Photo EPA.

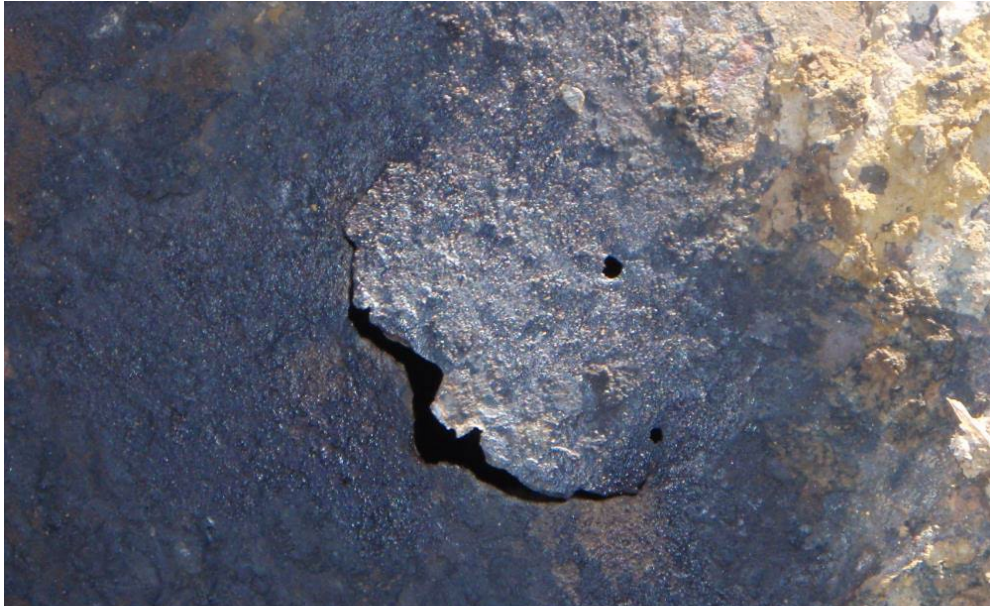
The strainer was part of the original 1940 construction. The strainer failure was caused by extreme, localized internal corrosion. The internal corrosion was caused by an acidic environment, most probably naphthenic acid (normal in crude oil). There was no evidence of MIC. [Failure Investigation Report](#)

Figure 12. Failed Strainer (external view).

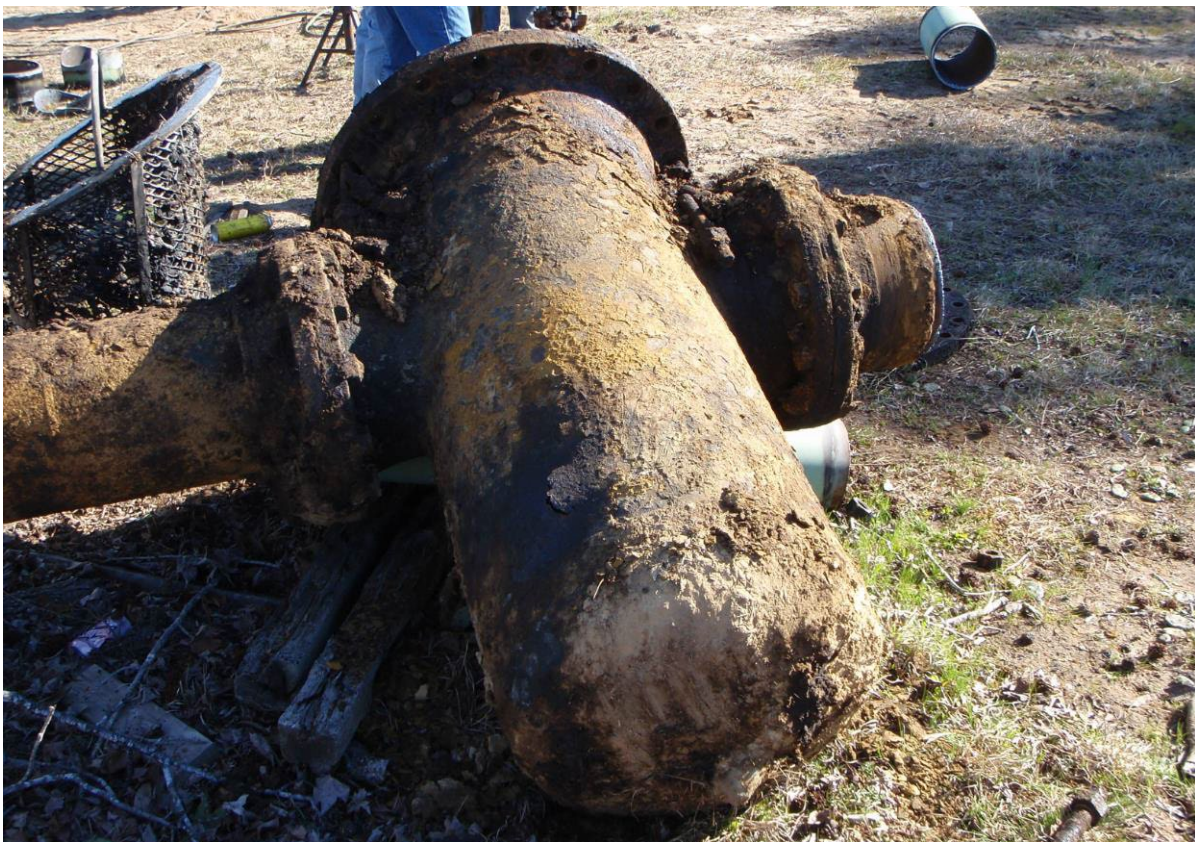
Figure 13. Failed Strainer.
