US DOT PHMSA AID Situational Awareness for Employees: SAFE Bulletin¹

Side-Entry Tank Mixer Product Releases from Crude Oil Breakout Tanks Due to Hinge Assembly Disengagement and Other Causes

49 C.F.R. Part 195 Transportation of Hazardous Liquids by Pipeline

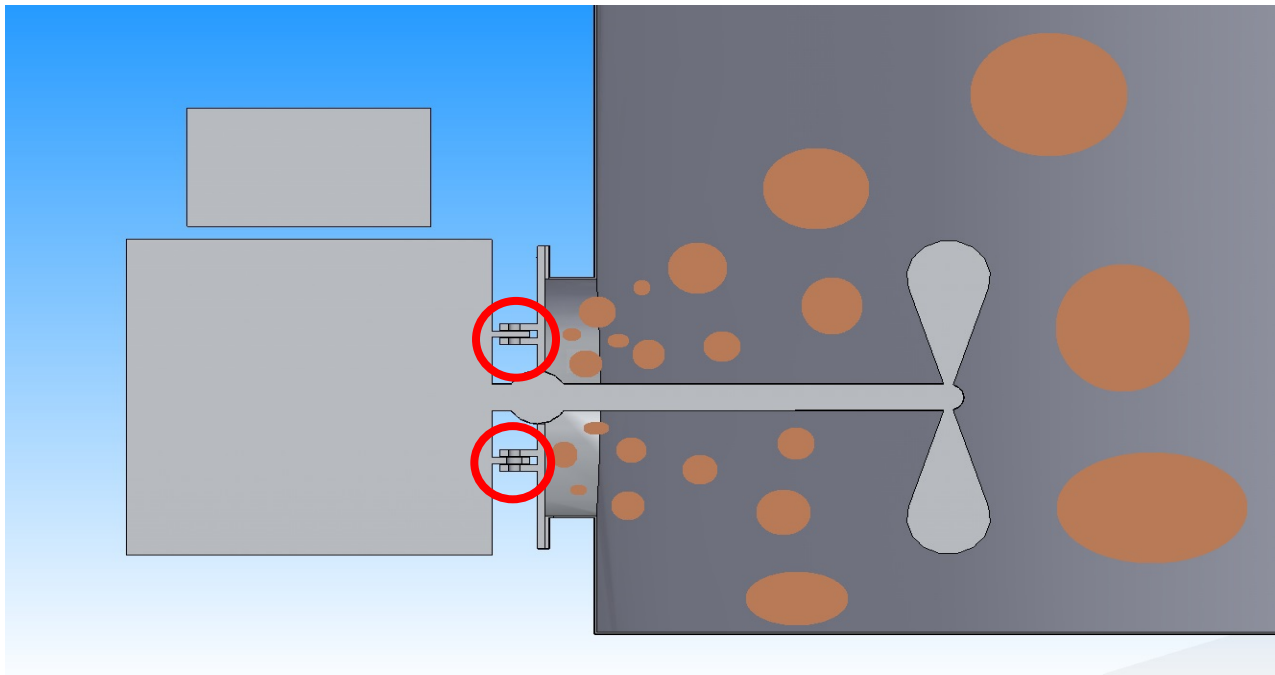
Figure 1: Upper and Lower Hinge Pin Assemblies Circled in Red

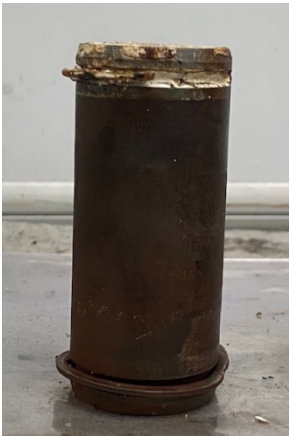
For identification purposes, Figures 2 and 3 show hinge pin used prior to 1990 with a snap ring and Figures 4 and 5 show hinge pin used from 1990-2008 with a retaining ring over the snap ring. During operation of the mixer, over many years of usage, the lower clip ring could disengage allowing the top or bottom hinge pin to work its way up and out. The hinge pin could come out of the bracket holding it to the mixer, upsetting the mixer, and allowing crude oil to spill from the tank through the mixer cover flange penetration. While operators pump the product out of the tank, it is not possible to stop the product from releasing until the level of the product is below the mixer.

Figure 2: Pre-1990 Hinge Pin – Solid Pin with Snap Ring

In 1990, Jensen notified customers via certified mail of potentially serious safety conditions that required their immediate attention. The 1990 notice advised customers to inspect the mixers for signs of movement in the top hinge pin, to move the hinge pin back to the normal position, and to not operate the mixer until the retrofit kit was installed (see Figure 6). The manufacturer further recommended inspections every six months to ensure serviceability of the retrofitted hinge assembly.

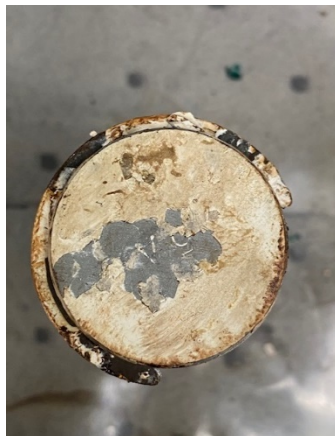
Figure 3: Pre-1990 Snap Ring without Retaining Ring

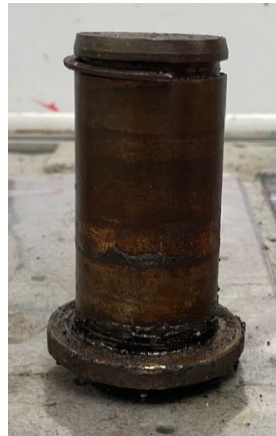
Figure 4: 1990-2010 Hinge Pin -Solid Pin with Retainer Ring

In 2011 Jensen informed their customers that there was an instance where the retainer ring at the lower end of the upper hinge pin disengaged allowing the pin to creep upward until it released the main hinge plate. Jensen advised customers to replace all prior hinge pins with a new two-piece hinge pin that incorporated solid end flanges (see Figure 7) for mixer models 680-VA, 650-VA, 620-VA, 605-VA, 480-VA, 450-VA and the 420-VA.

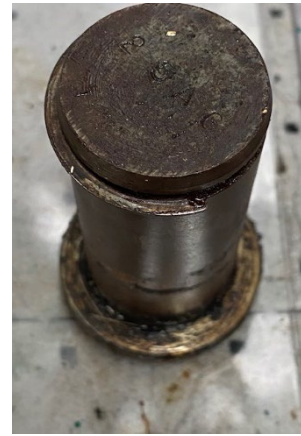
Figure 5: 1990-2010 Hinge Pin Design Solid Pin with Retainer Ring

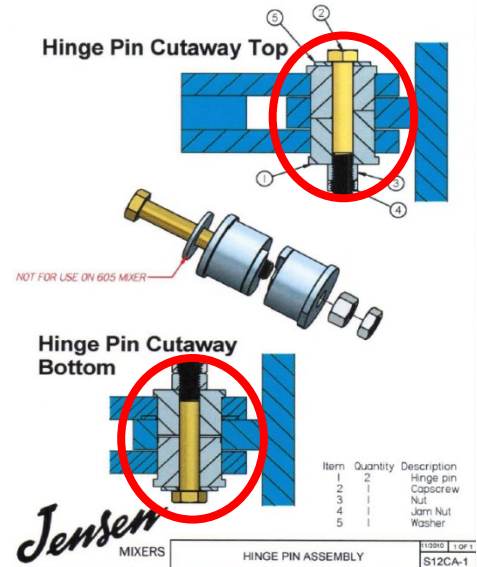
The manufacturer began using this new design, referred to as the “split pin” design, in 2008 on all newly manufactured mixers (see Figure 7). The split pin is manufactured from a solid piece of bar milled down the center area. When Jensen repairs or refurbishes any mixer at their facility, they bring the older mixer up to the current hinge assembly. Operators have not reported to PHMSA any events of Jensen’s current hinge assembly design used since 2008. For more information on this brand, please visit the company’s website at www.jensenmixers.com/.

Figure 7 – Current Jensen Hinge Pin Design

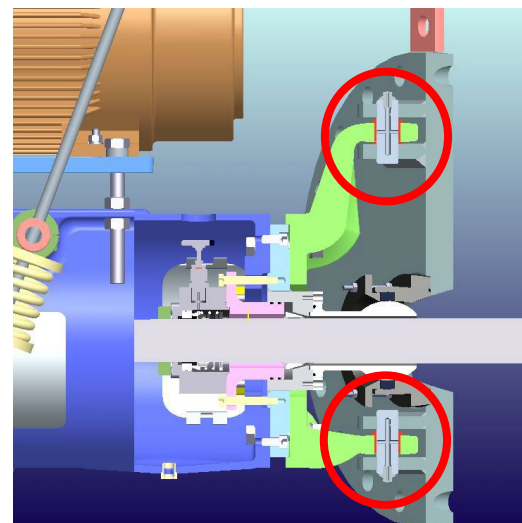
Figure 8 shows Philadelphia Mixing Solutions’ hinge or swivel pin design. The design includes a swivel pin with an interference fit (a fastening between two parts achieved by friction after the parts are pressed together under force) to prevent the pin from moving up or down, and a snap ring. The interference fit plus snap rings (top and bottom of the hinge pins) provide a redundant design, if one fails there is a second mechanism to provide backup. The hinge pins require periodic greasing to lubricate the bushing. Operators have not reported to PHMSA any events of Philadelphia Mixing Solutions hinge assembly. For more information on this brand, please visit the company’s website at www.philamixers.com.

Figure 8: Philadelphia Mixer Solutions’ Swivel Pin Arrangement

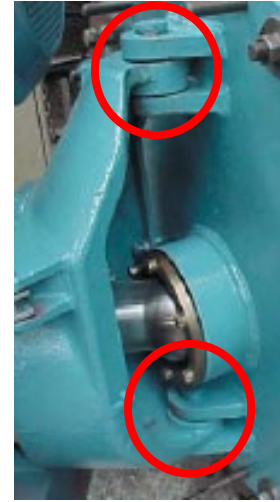
SPXFLOW did not provide information for or review this bulletin prior to publication.⁶ As depicted in Figure 9, the Plenty mixer module is supported by two swivel hinge bearings which ensure ease of manual angle changing and the swivel seal is affected by a heavy-duty static Soloseal™ acting on a stainless steel spherical ball. For more information on this brand, please visit the company’s website at <https://www.spxflow.com/>.

Figure 9: SPXFLOW Plenty Mixer Hinge Assembly

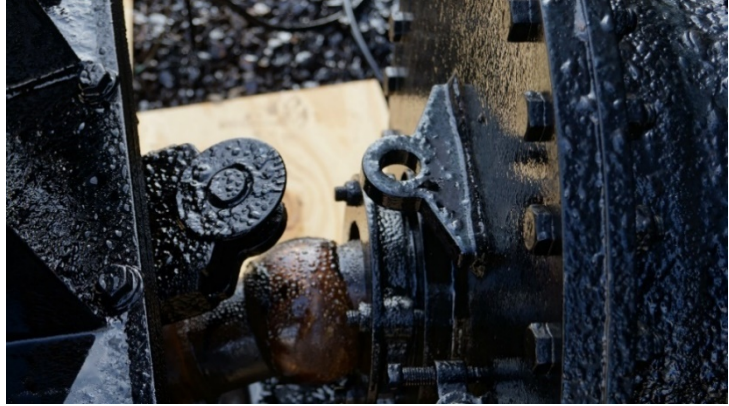
Summary: On January 11, 2020, operator personnel noticed a tank level drop. Field investigation discovered crude oil releasing from the tank mixer, which involved an older unit using an obsolete hinge pin design. While the product was pumped out of the tank to below the tank mixer level, 6,034-barrels were released into the tank dike. The investigation determined the snap ring on the top pin broke which allowed the pin to move up and disengage the hinge point. The mixer tilted causing damage to the propeller shaft seal. The damaged seal allowed crude oil to flow from the tank into the dike. A new mixer was installed. All tank mixers were inspected and retrofitted with the 2011 hinge assembly kits from the manufacturer. Figures 10-11 show the disengaged top hinge pin from the cover flange, the mixer, and the failed snap ring.

Figure 10: Disengaged Hinge Assembly

Root Cause: A tank mixer leak occurred due a snap ring which broke after many years of service, which resulted in the pin for the top mounting bracket becoming disengaged. The mixer was installed with the first 1990 retrofit design from the manufacturer but had not been upgraded to the second, 2011, retrofit. The tank had been recently acquired and the new operator did not have complete records for the tanks. The manufacturer has confirmed that notices and replacement parts were received by the prior tank operator.

Product Release Cause	Remediation
Vibration caused hinge pin to disengage.	Replace hinge assembly using the newest (2011) retrofit kit. Monitor for vibration readings. Remediate condition causing vibration.

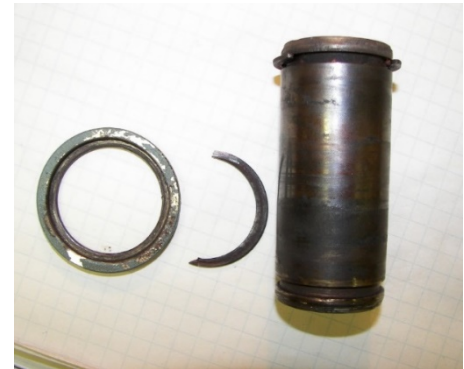
Figure 11: Broken Snap Ring.
