#### INCIDENT ACTION PLAN

Location	Control Level	Operational Period	
Bayou Corne Sink Hole	Company Supervisory	From 10/9/12	To 10/10/12

RE: In-Place Inclinometer and Tiltmeter Monitoring System, Napoleonville Dome Weekly Report: September 29 Through October 5, 2012

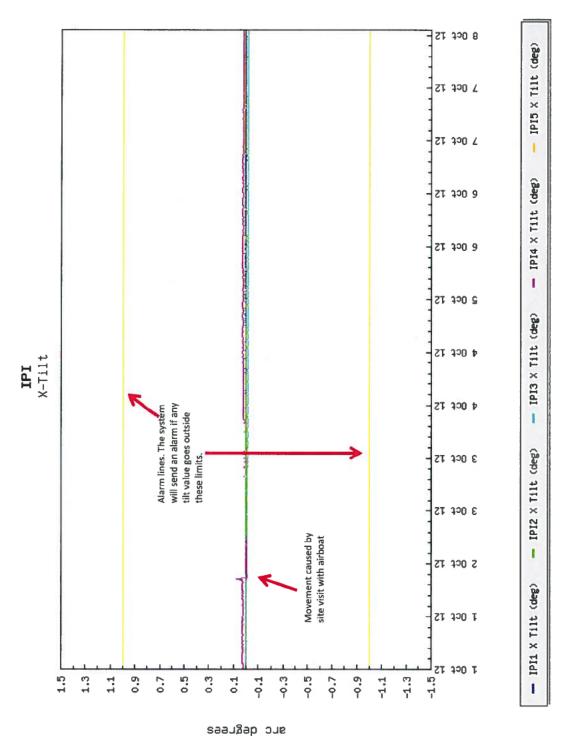
Figure 2. Inclinometer X-Direction Temporal Trends.

Cornerpost bracing that was installed by airboat crews was inspected on the morning of Tuesday, October 2. Data indicates that the airboat visits to site IPI-4 caused noise in the data. The post that holds the datalogger housing at IPI-3 was left tilted approximately 30 degrees; on Wednesday morning this was corrected by lashing it upright to another post at the site. This also caused noise in the data. With the additional shoring, however, data noise has been reduced. At 14:45 on Thursday, October 4, IPI-4 recorded approximately 0.01 degrees tilt toward the sinkhole. IPI-5 is recording tilt toward the sinkhole following a linear trend at a rate of approximately 0.0013 degrees/day. Strain left in the system from corner-post construction may cause the posts to tilt over time as they reach equilibrium. Other IPI and tiltmeter data have reflected stable conditions over the past week.

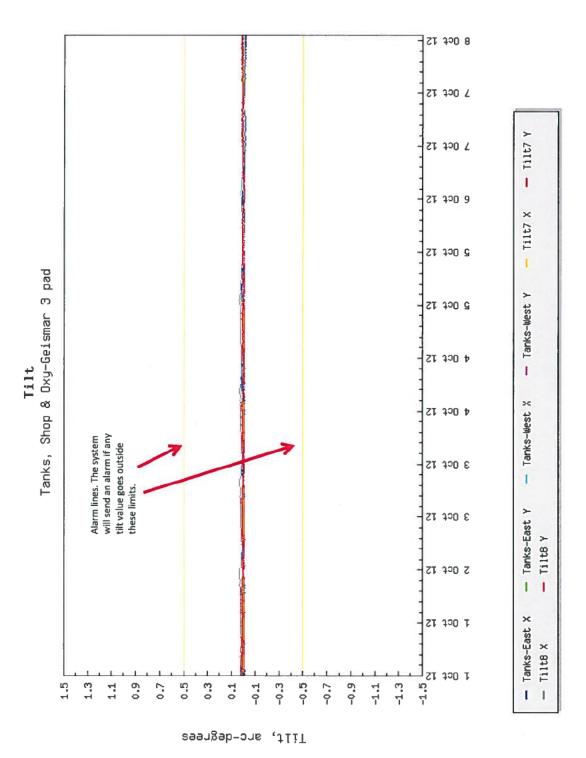
Figure 4. Tiltmeter Temporal Trends.

Communication problems have been greatly reduced, but have not been completely solved. Settings in the Atlas server caused issues with communication; but these have been corrected. Antenna were reconfigured to improve communication with site Tilt 8 (Oxy-Geismar 3 pad);

however, the site has currently been offline for 2 days because of unknown causes. Texas Brine Company, LLC will be notified as soon as the communication problem is corrected.

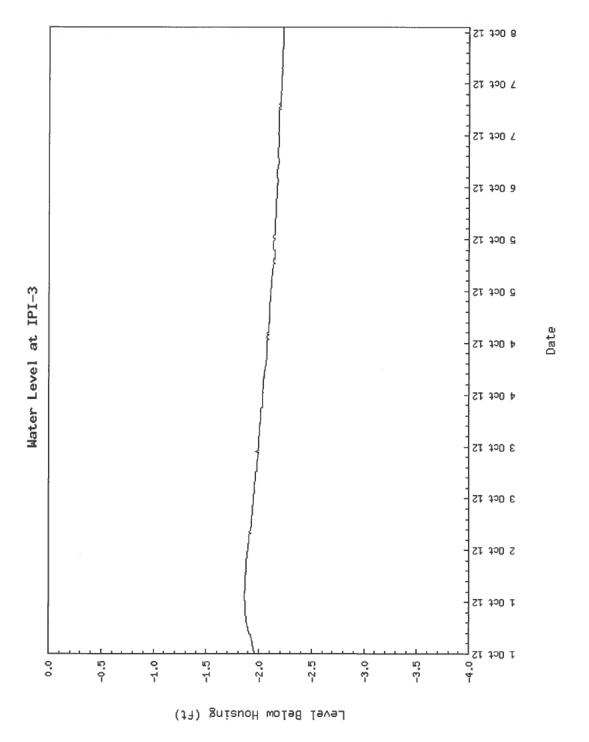
Figure 5. Water-Level Data: Water Level References for the Bottom of Housing of IPI-3.

Figure 5 shows water level in feet with respect to the bottom of the IPI-3 housing. A water level of 0 feet would indicate that the water is at the bottom of the IPI-3 housing; a positive value indicates the housing is submerged or partially submerged. Negative values, as shown in Figure 5, indicate that the water level remains below the bottom of the IPI-3 housing.
