**Documentation of Peak Restoration Activities
Attachment D**

*Vermilion Parish School Board v.
Louisiana Land, et al*

*2014 Supplemental Data/Expert Report
Michael E. Pisani, P.E.
David G. Angle, P.G.*

Attachment D-2
Documentation of Restoration Work

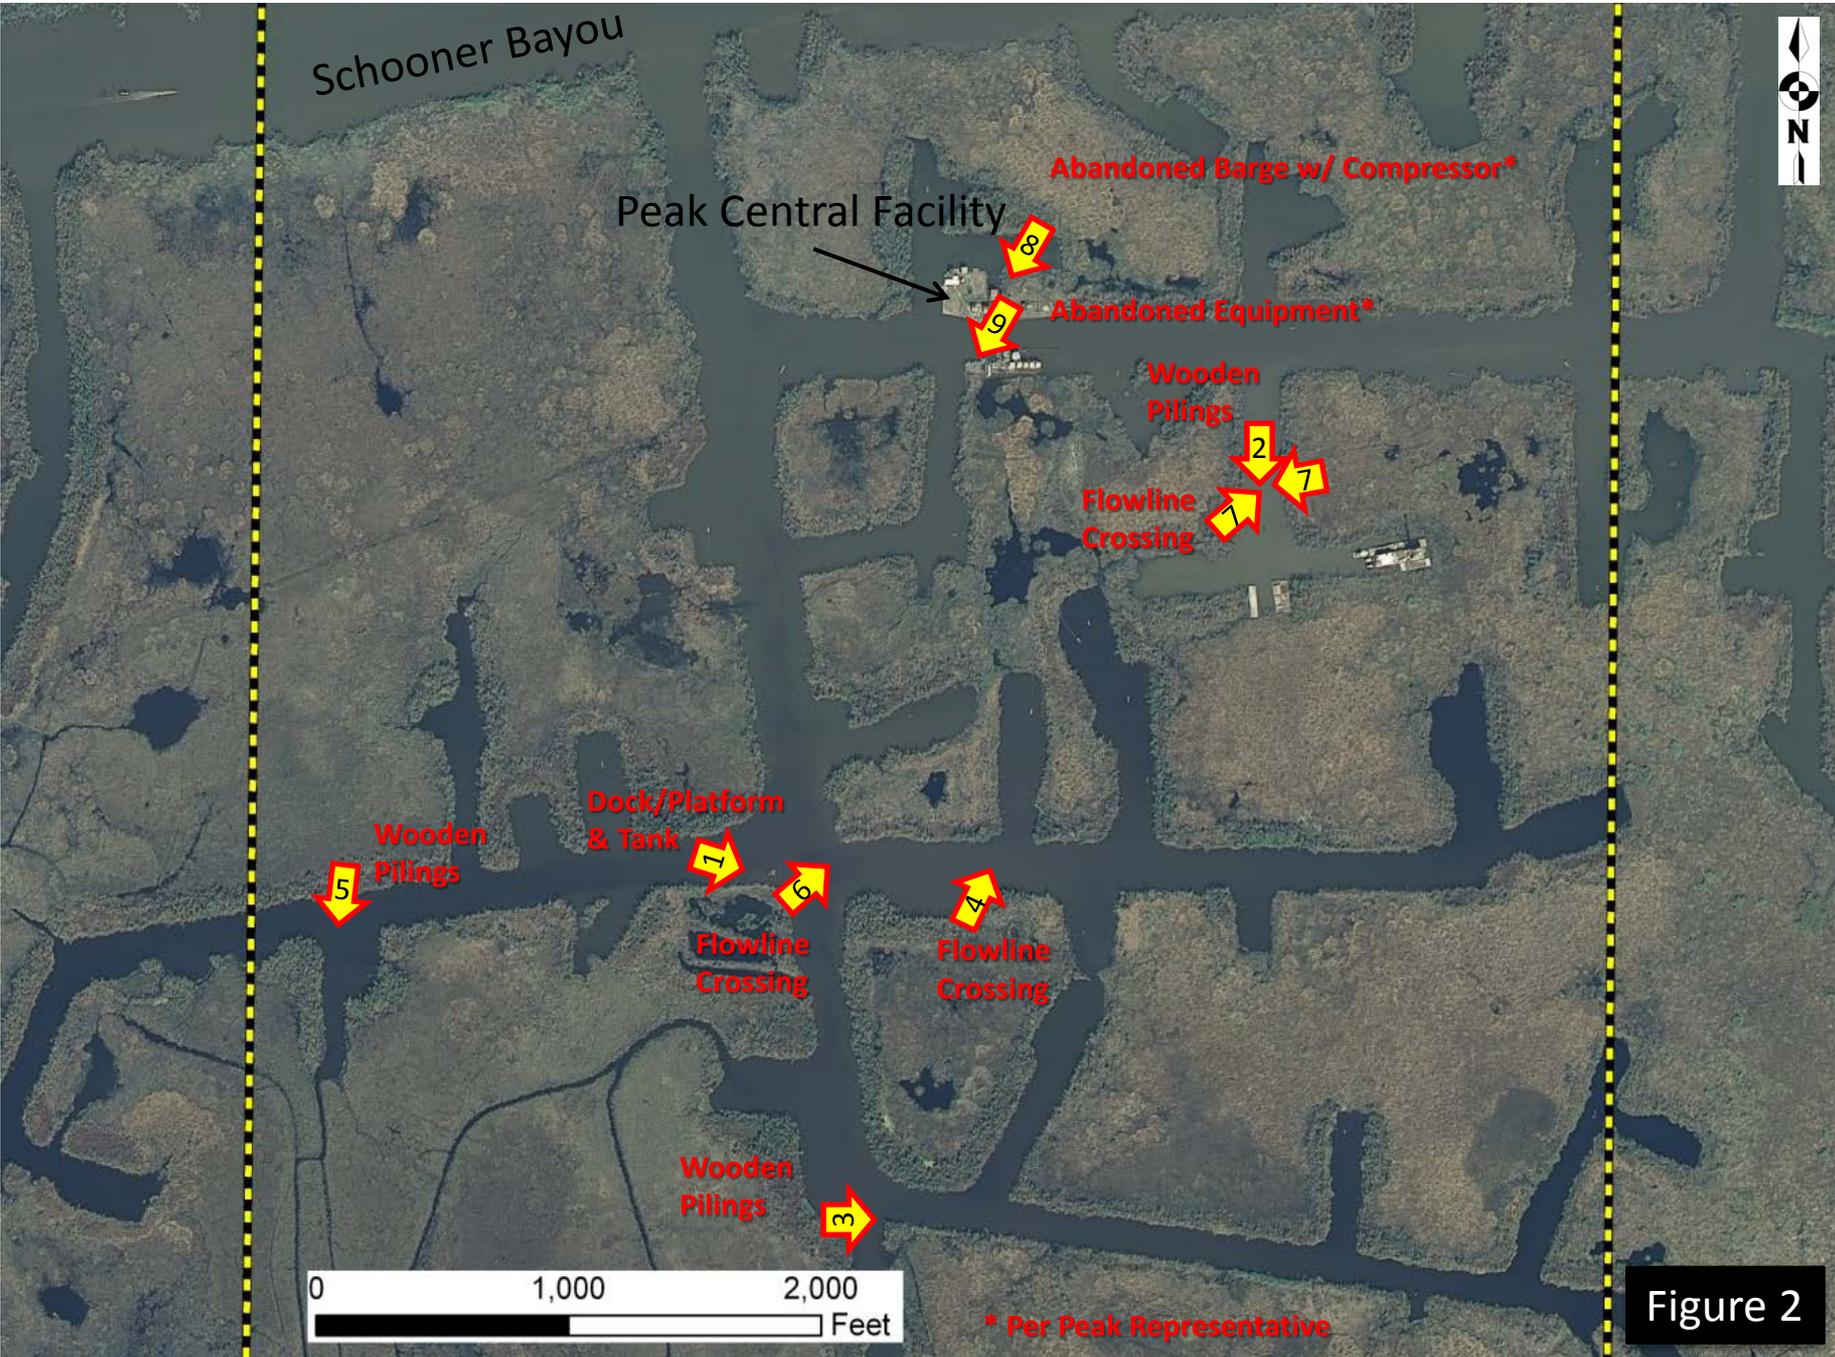
Mobilized barges equipped with oilfield restoration equipment (cranes, excavator, cutters, etc.)

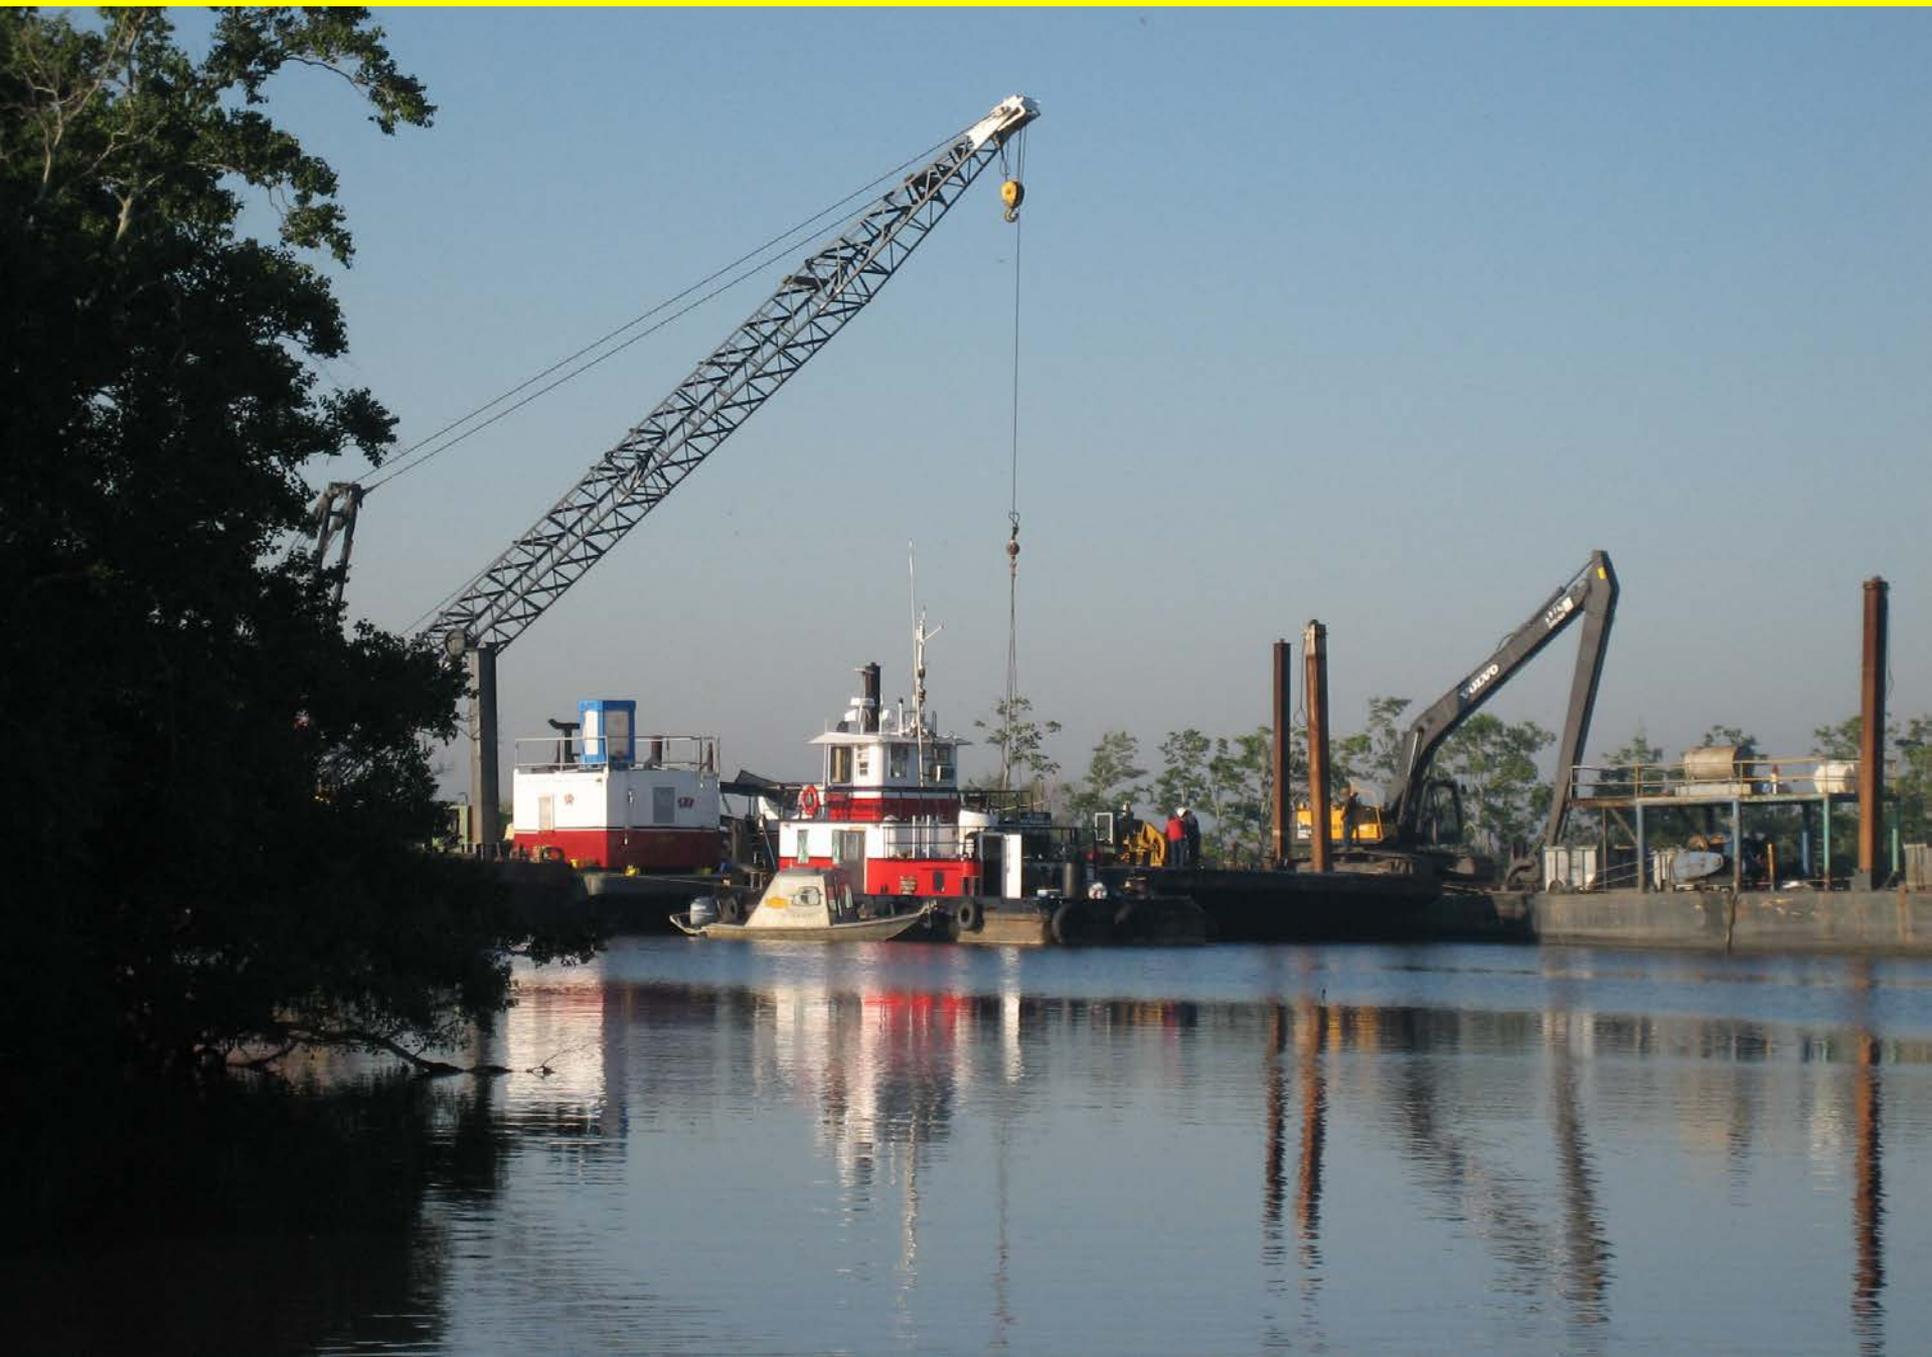
Tank Removal at the main facility

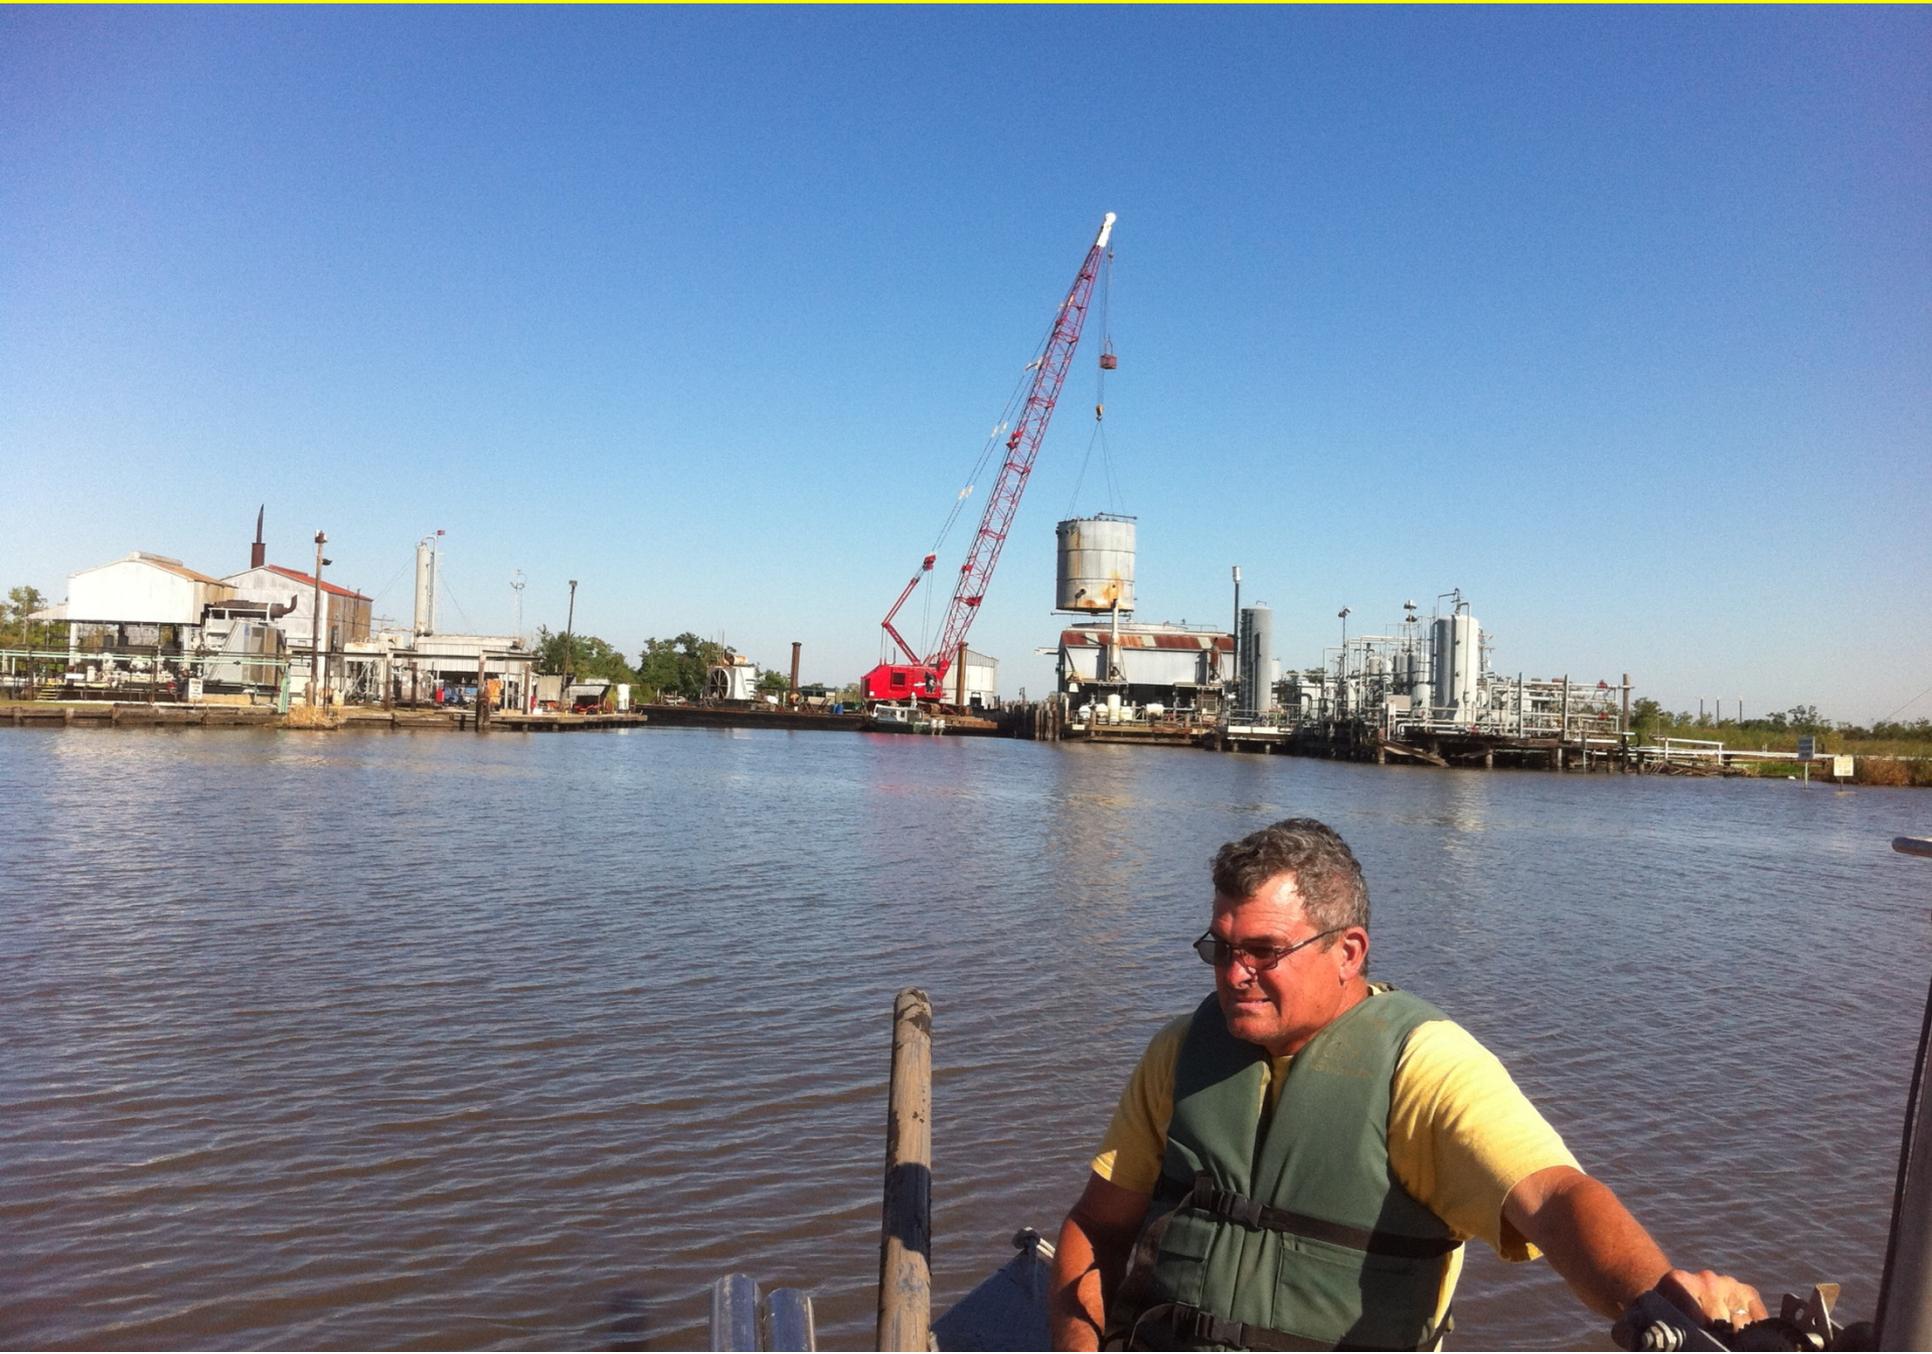
Stock pile of flowlines/debris for offsite disposal at the main facility

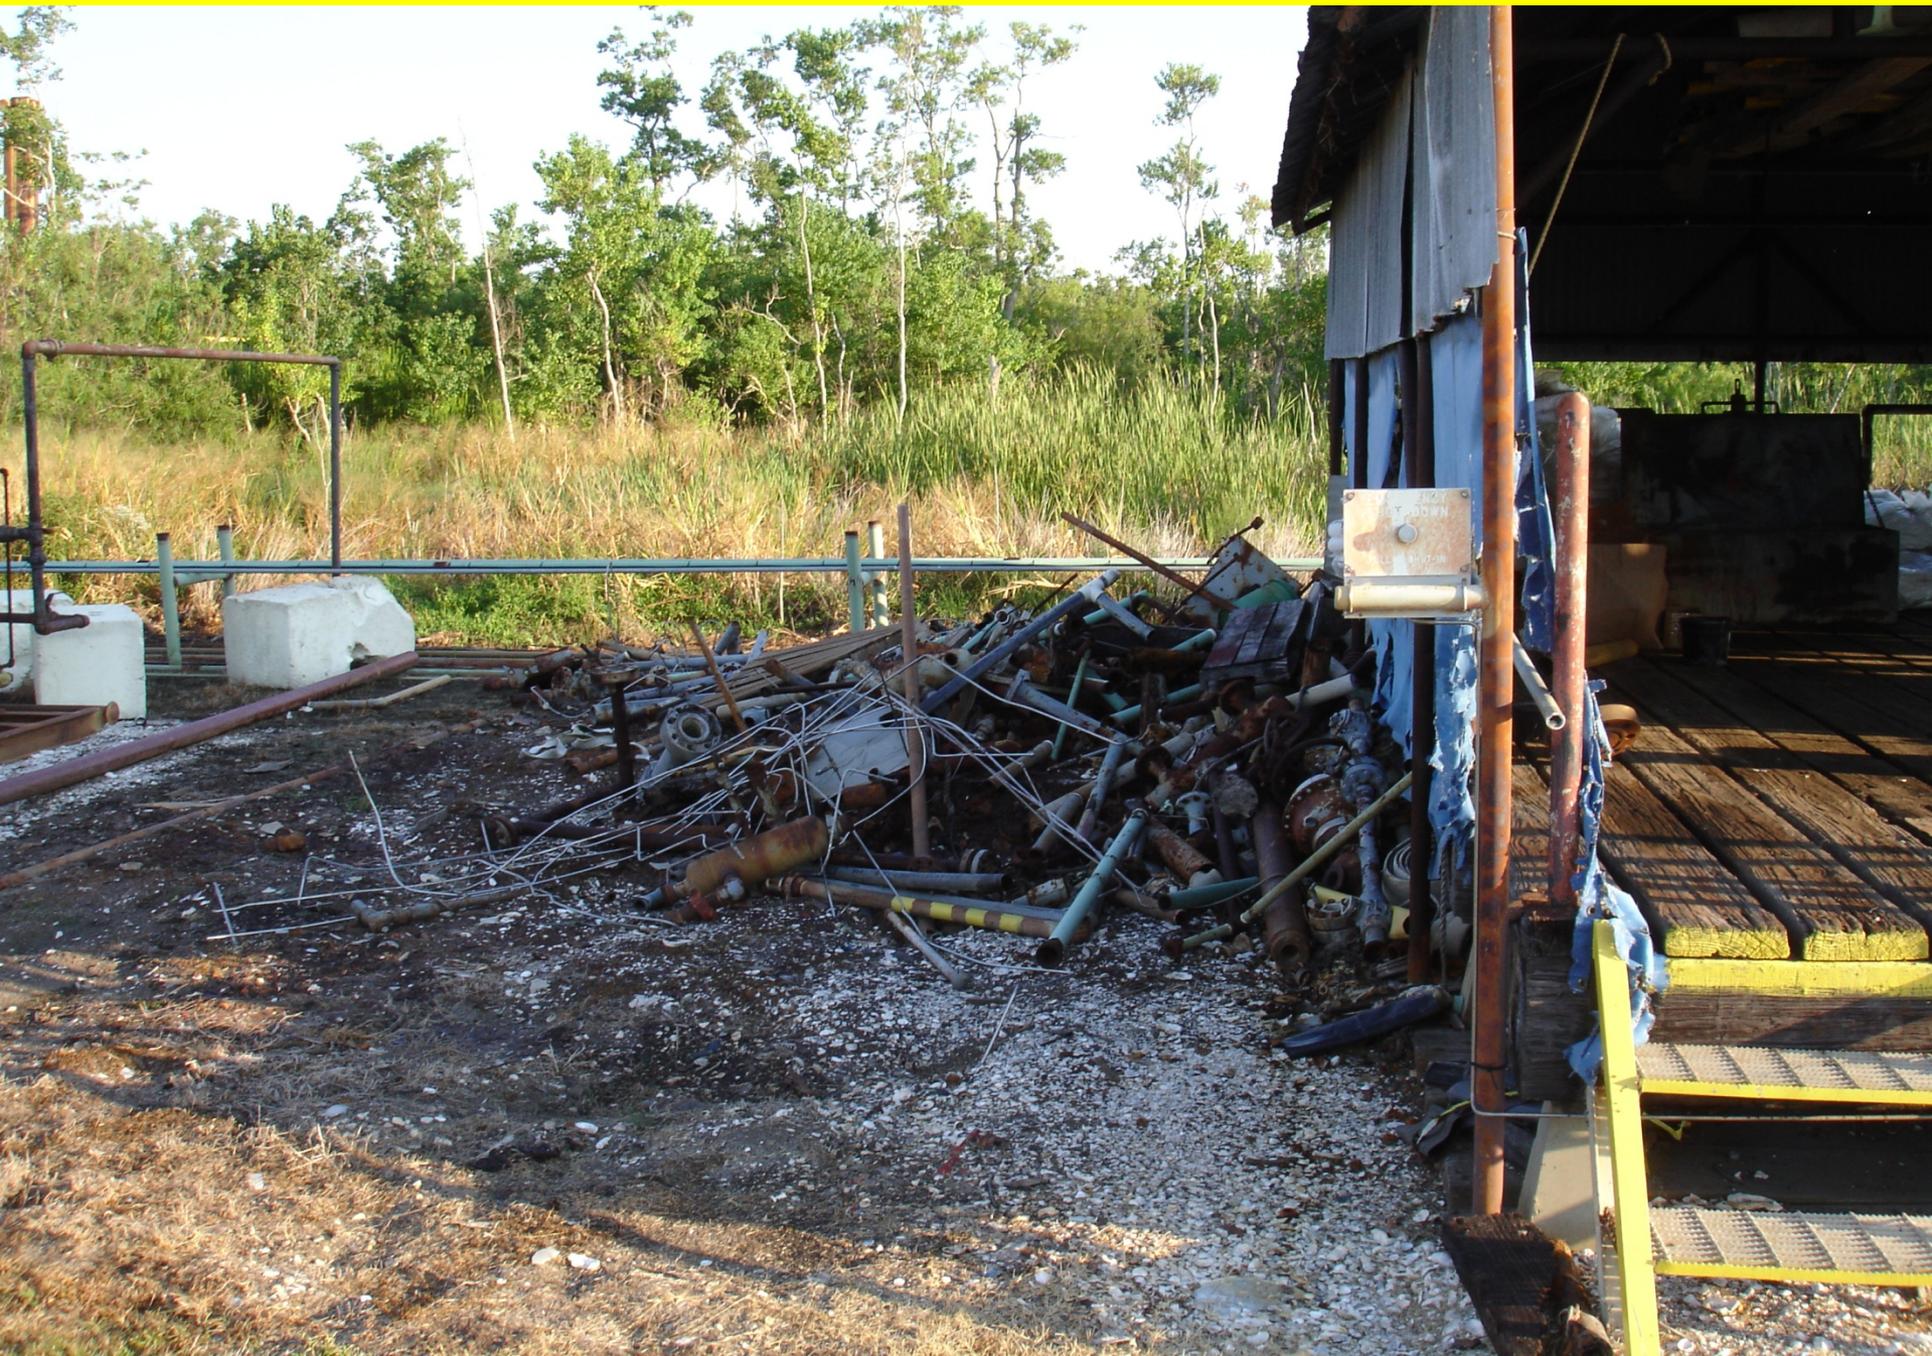
Heavy equipment removal at the main facility

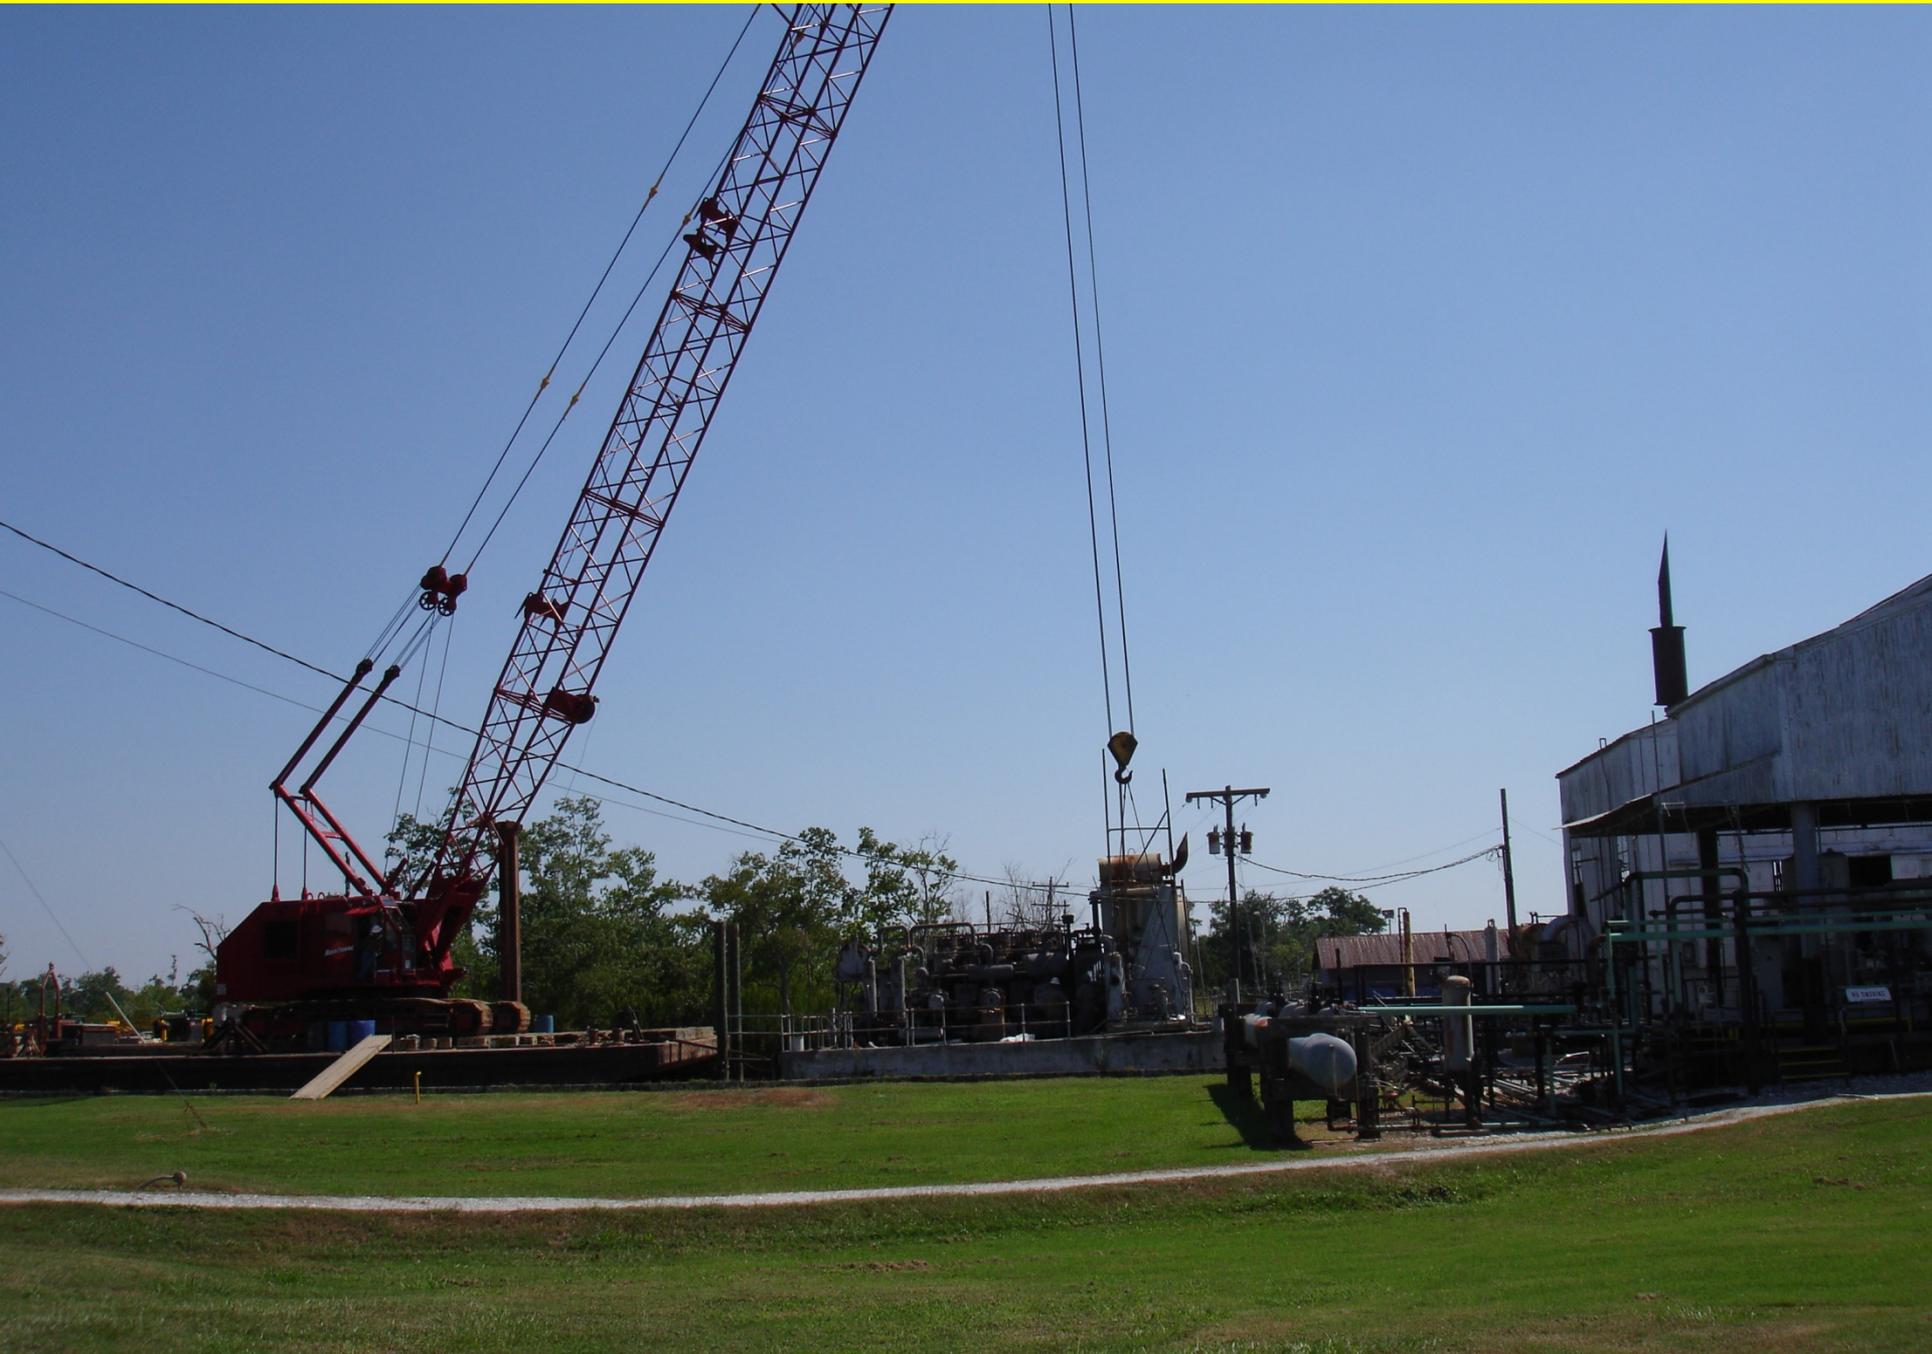
Transport of floating compressor foundation for disposal from the main facility

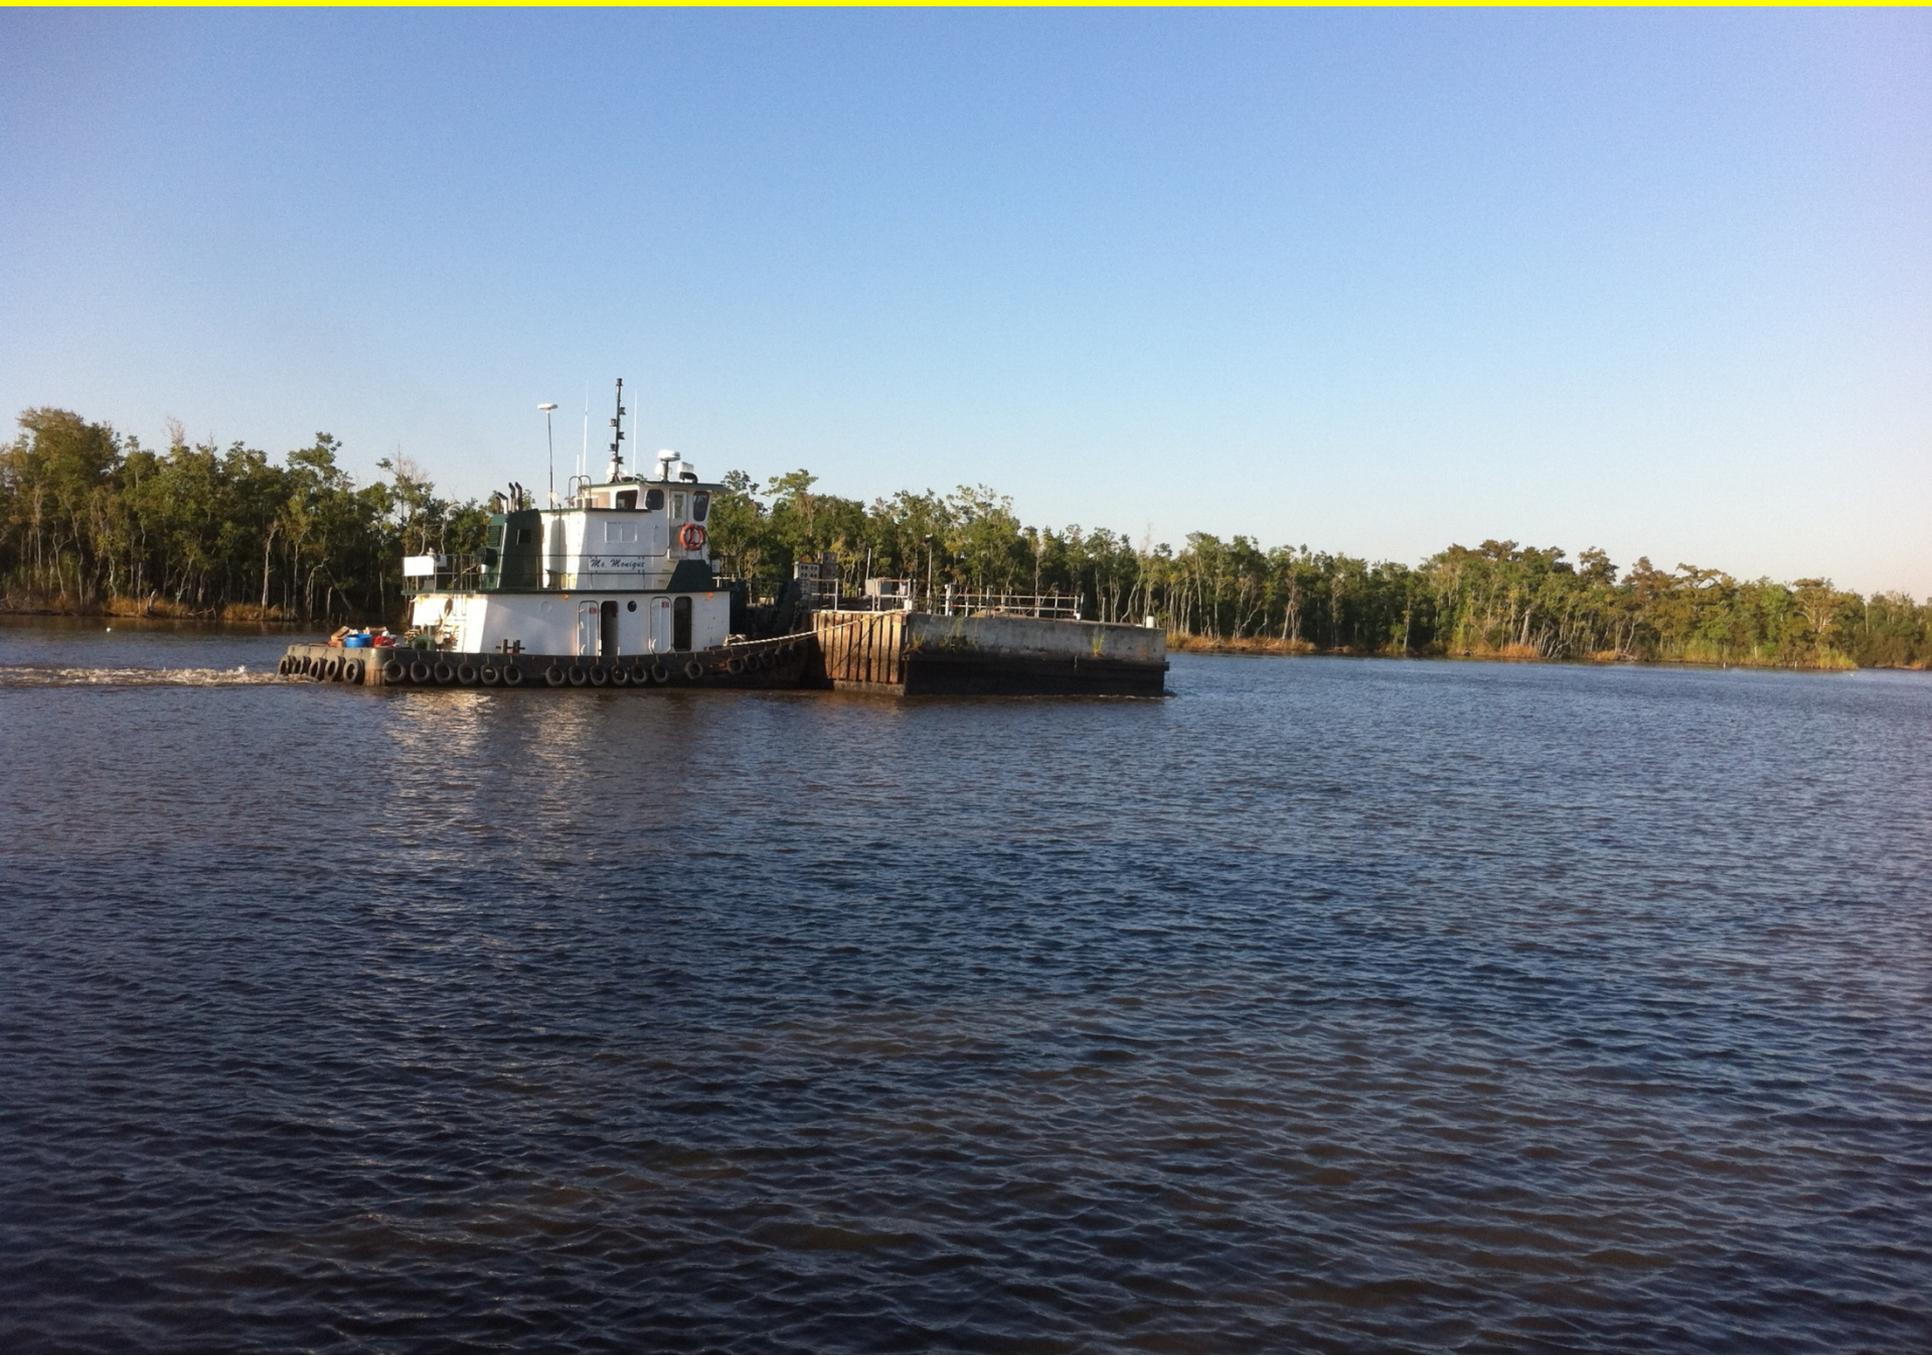
Removal of piers/cribbing at Tank Battery "B"

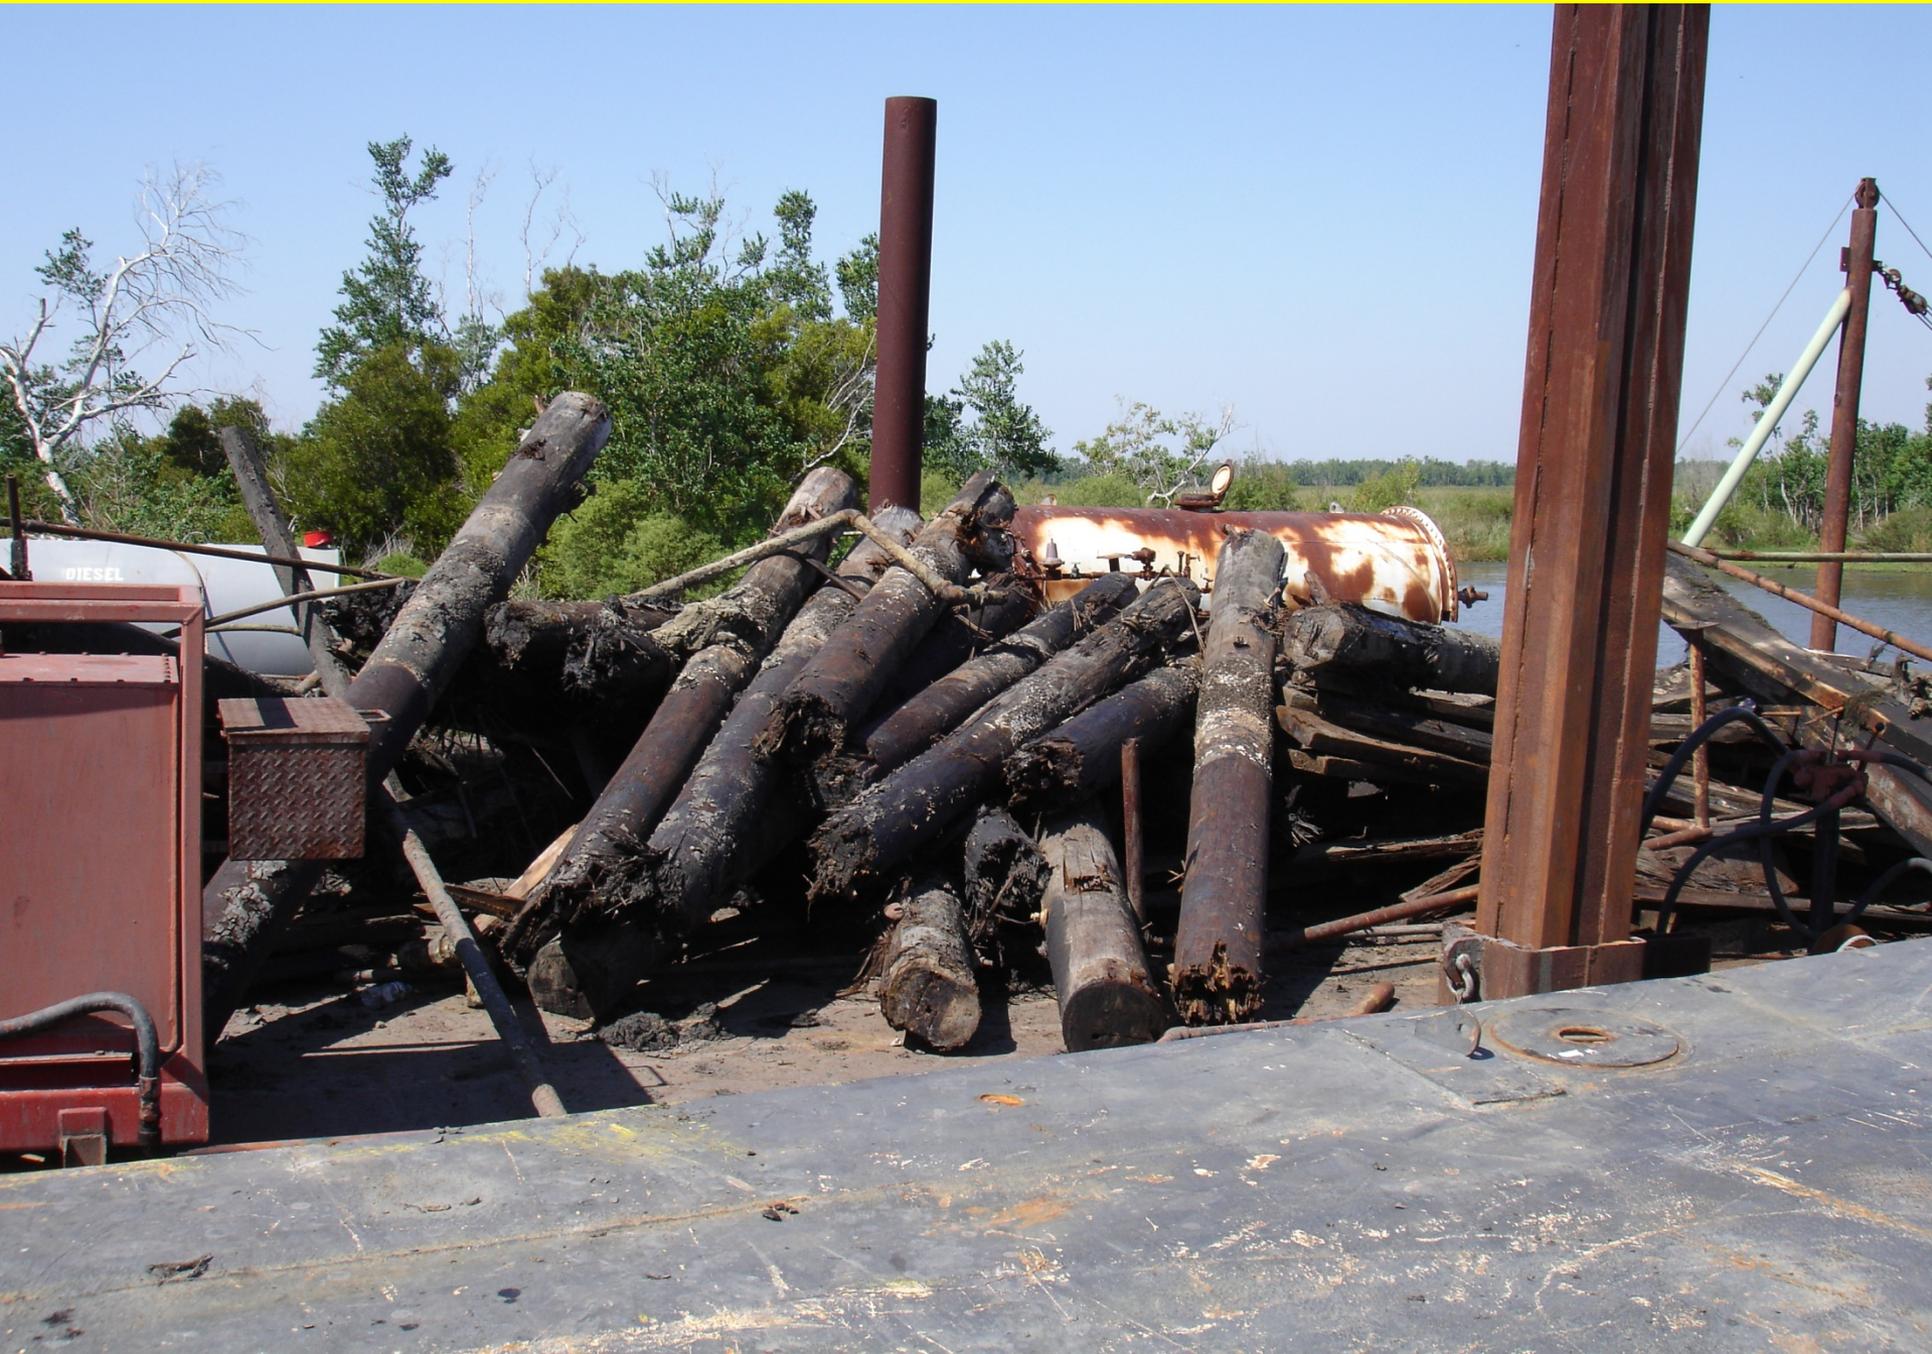
Long-stick excavator employed to remove flowlines

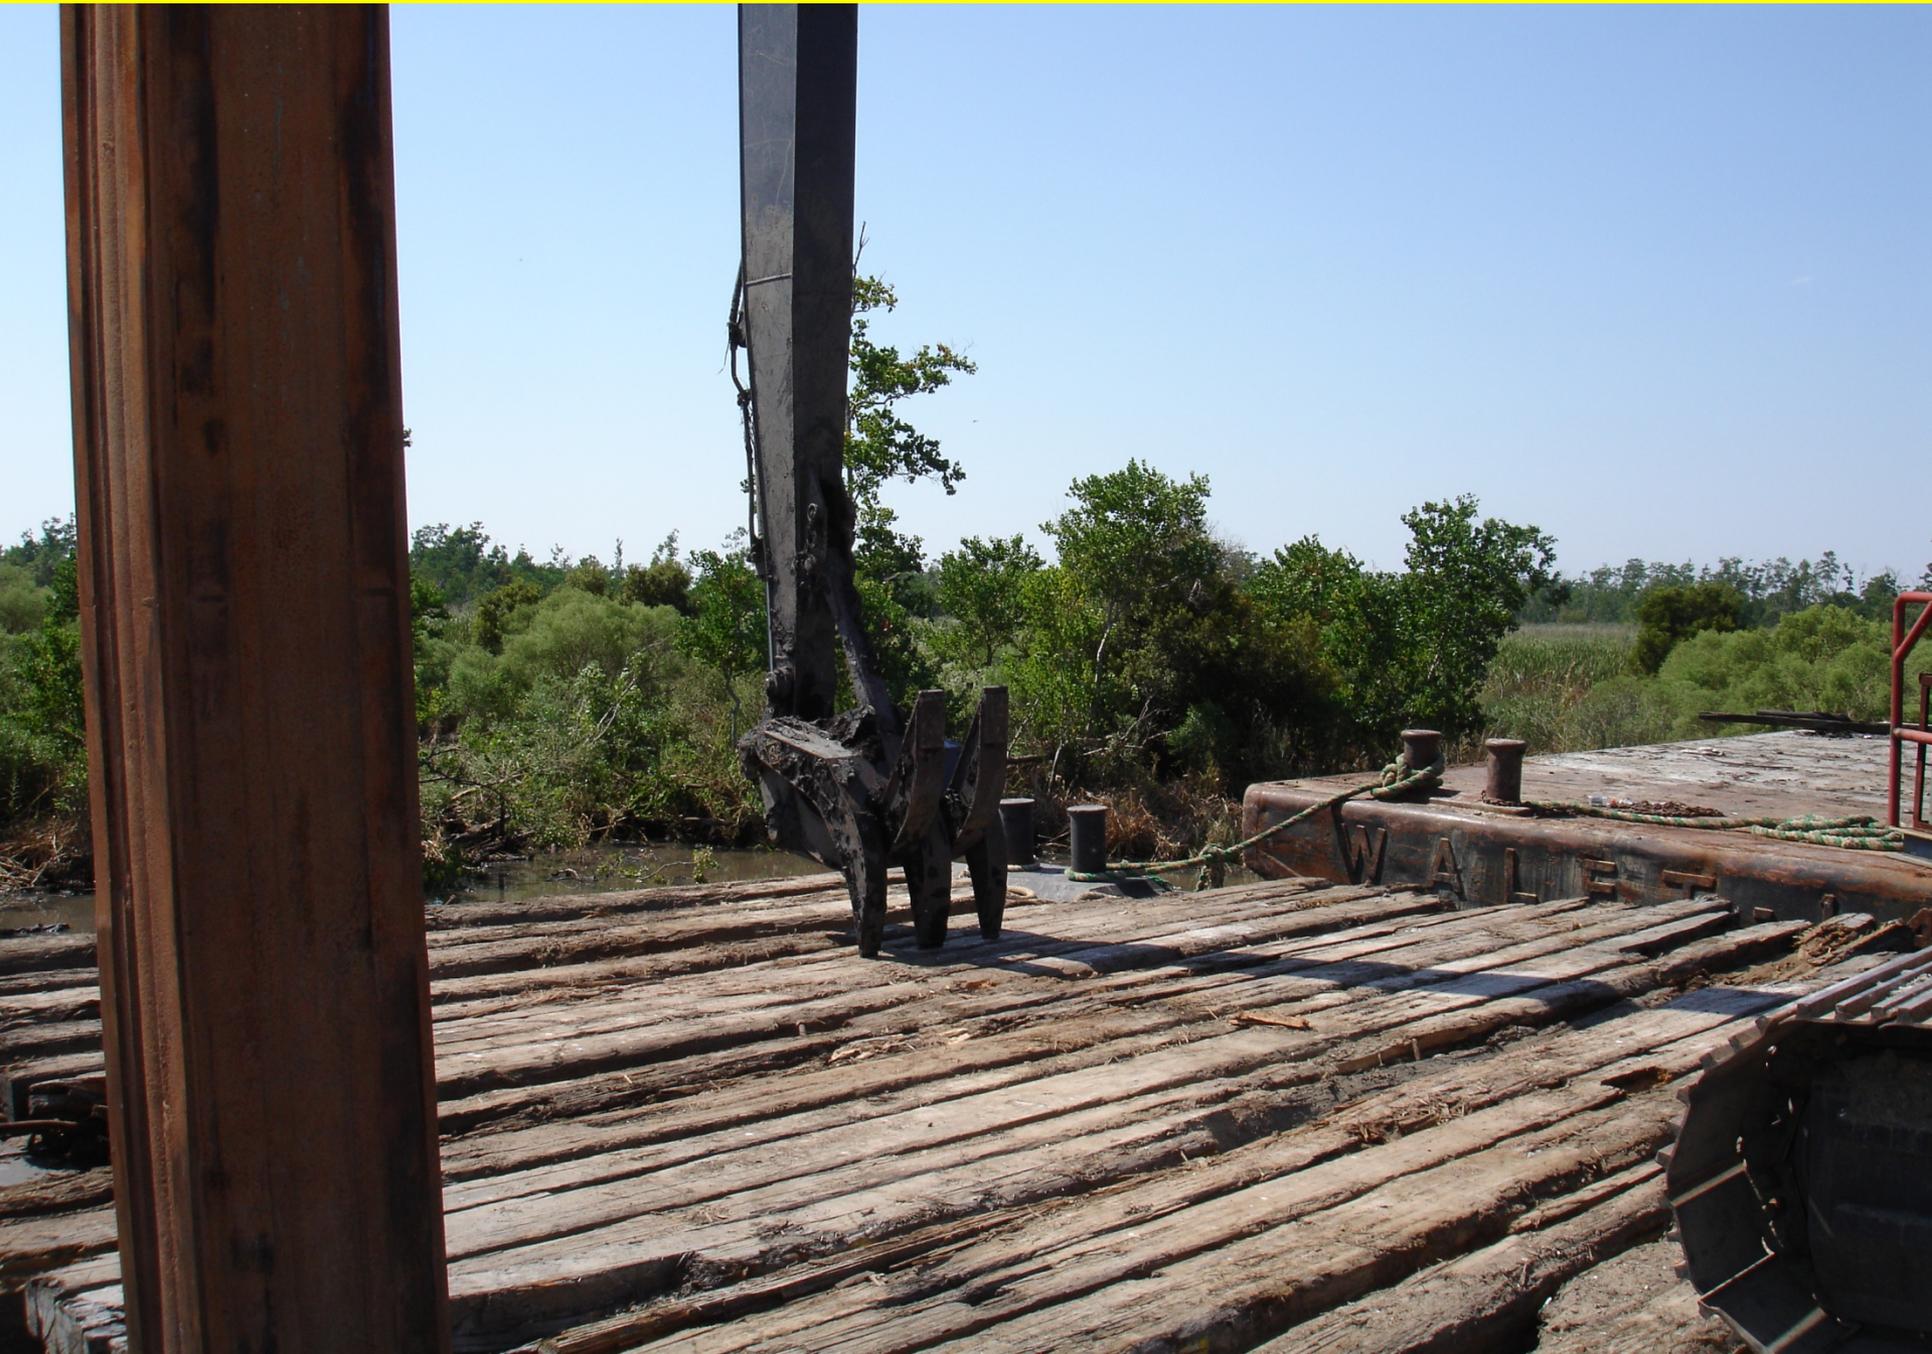
Long-stick excavator employed to remove flowlines
