**Documentation of Peak Restoration Activities
Attachment D**

*Vermilion Parish School Board v.
Louisiana Land, et al*

*2014 Supplemental Data/Expert Report
Michael E. Pisani, P.E.
David G. Angle, P.G.*

Attachment D-2
Documentation of Restoration Work

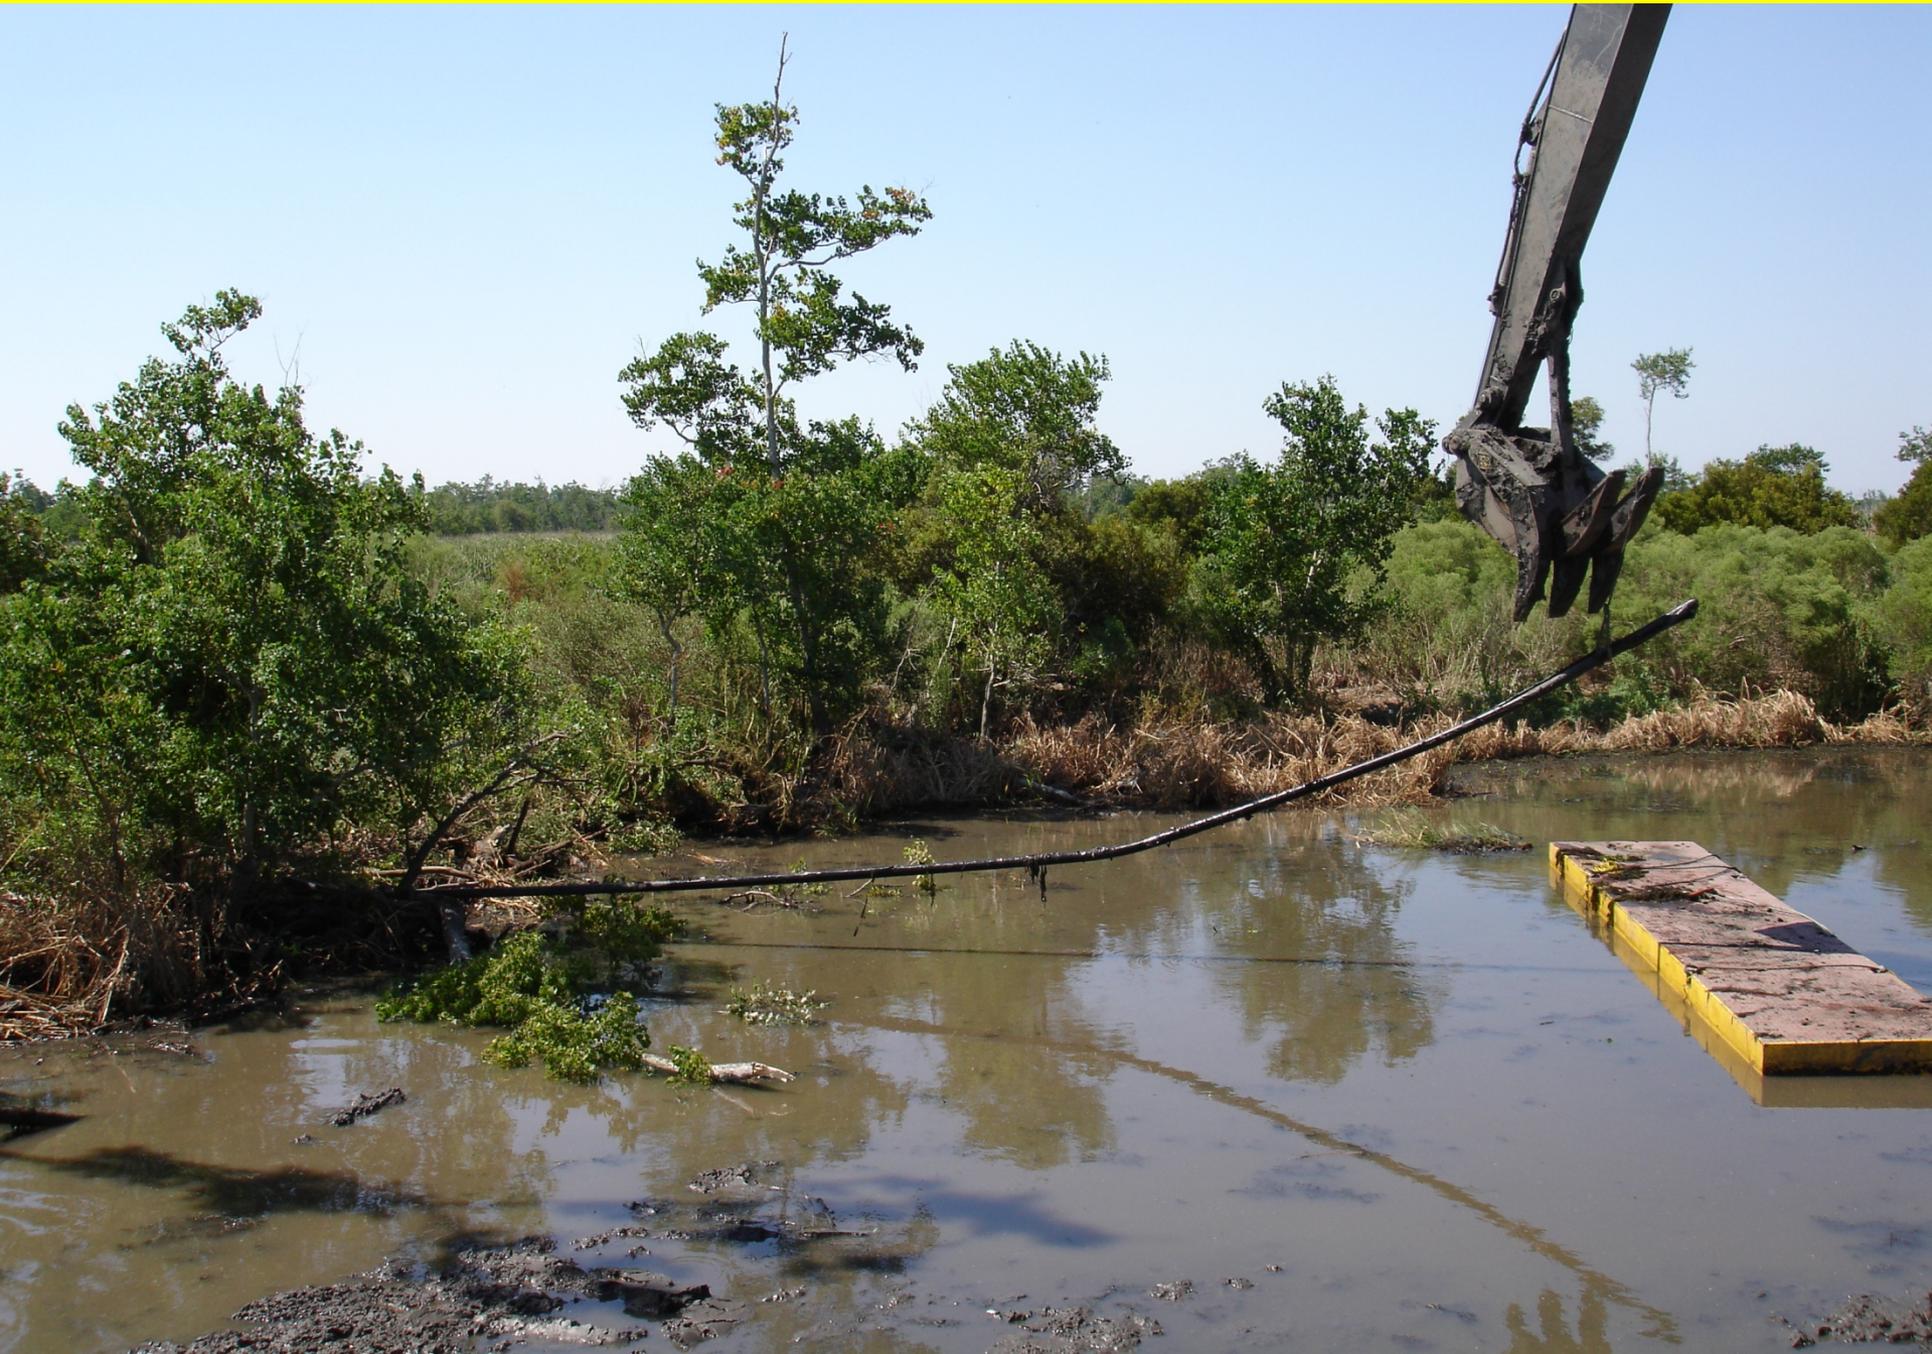
Stockpile of flowlines for disposal

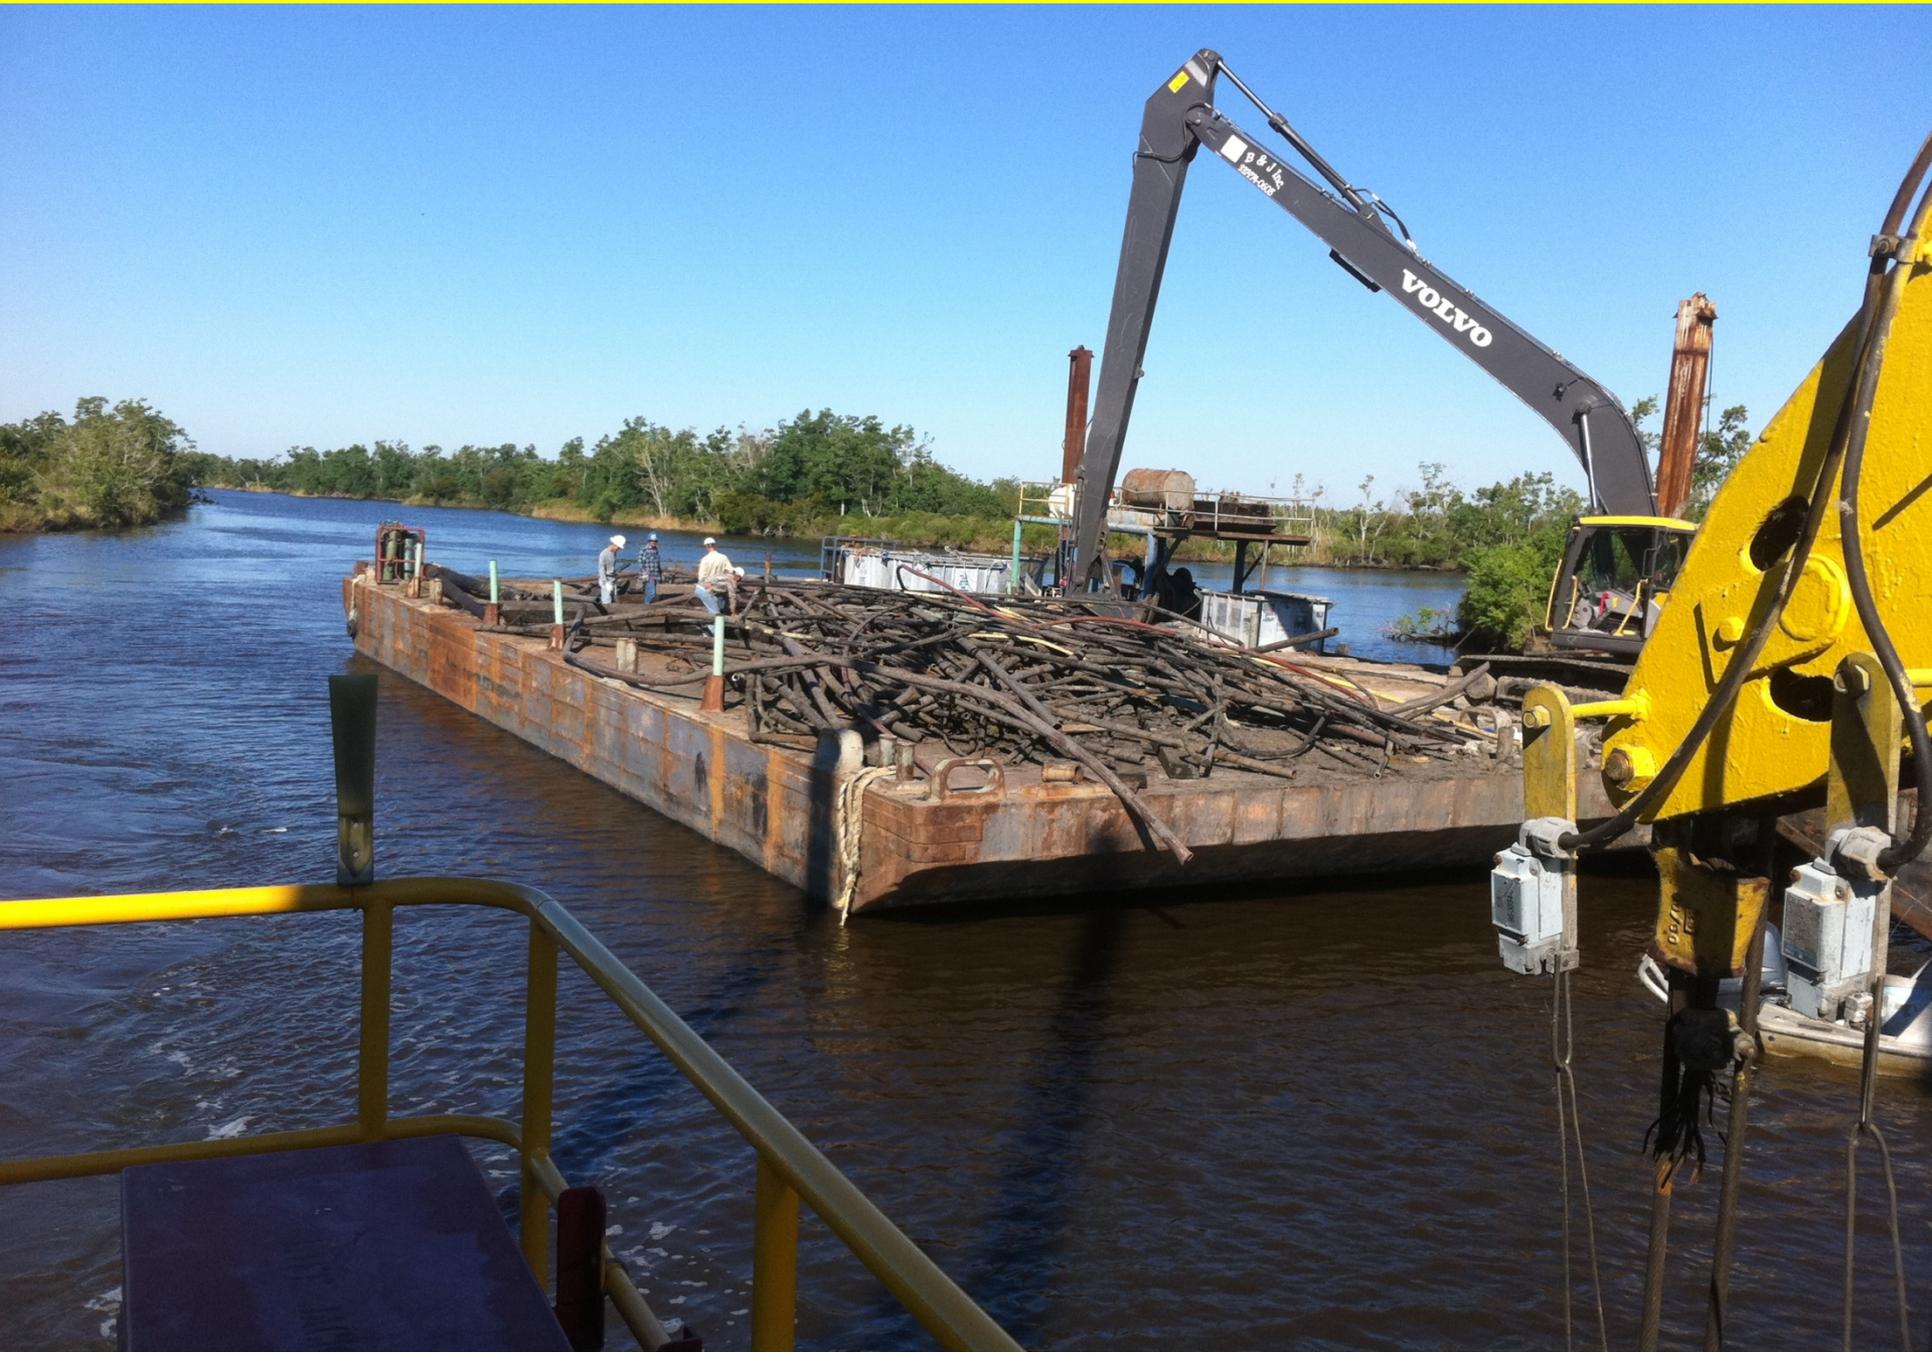
Cutting flowlines into manageable size sections
