INCIDENT ACTION PLAN

| Location Bayou Corne Sink Hole | | Control Level | Operational Period | |

RE: In-Place Inclinometer, Tiltmeter, and Water-Level Monitoring System, Napoleonville Dome Weekly Report: February 23, 2013 Through March 1, 2013

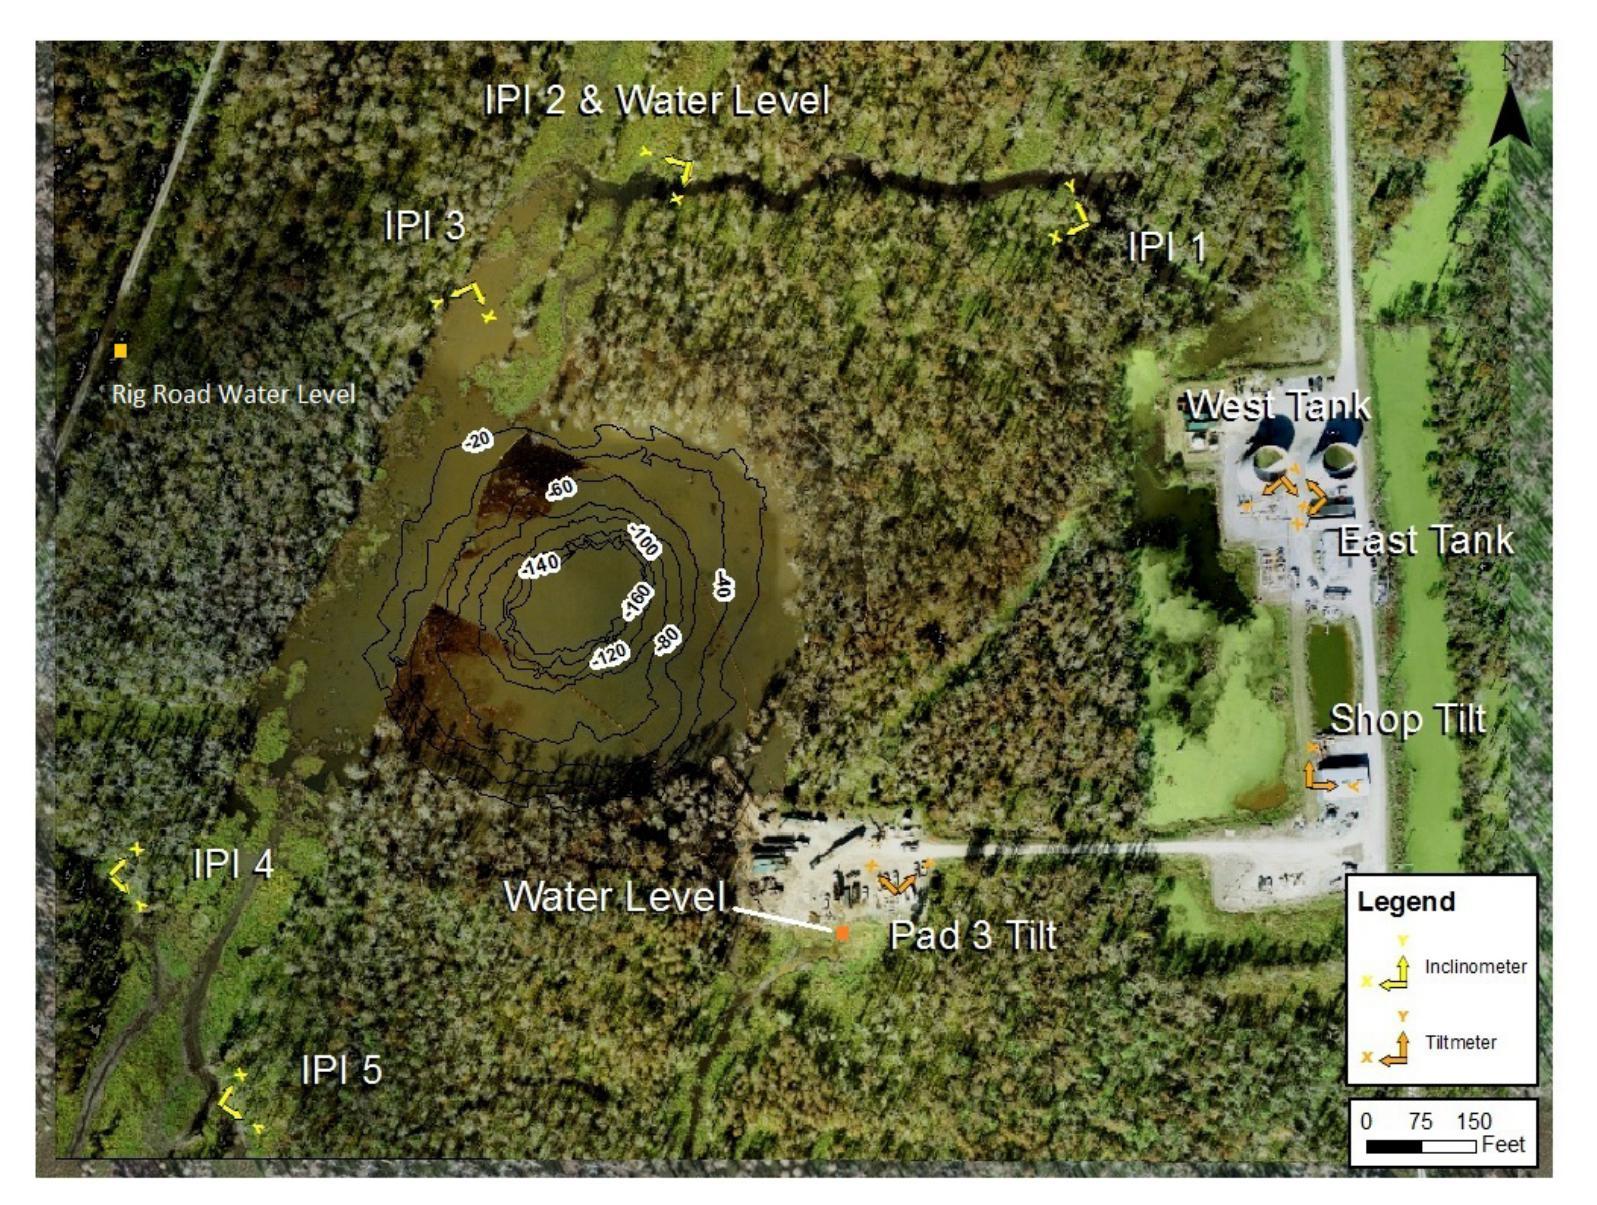
Figure 1. Monitoring Locations.

The Pad 3 water-level transducer was relocated on February 20. The map in Figure 1 has been updated to show the new location of the transducer. Visual field inspections indicate an obvious subsidence boundary on the western side of Pad 3. The transducer was previously located within the region where subsidence was visually evident; however, it was moved to the new location because of concerns of losing it in a sloughing event. It is now located outside of the region where subsidence is visually evident (the central and eastern portions of Pad 3), approximately 10 feet south of the middle of the southern edge of Pad 3. Figure 1 also shows the location of the Rig Access Road transducer, which is about 25 feet east of the edge of the newly-constructed berm on Rig Access Road at drilling pad ORW-8 (B-15).

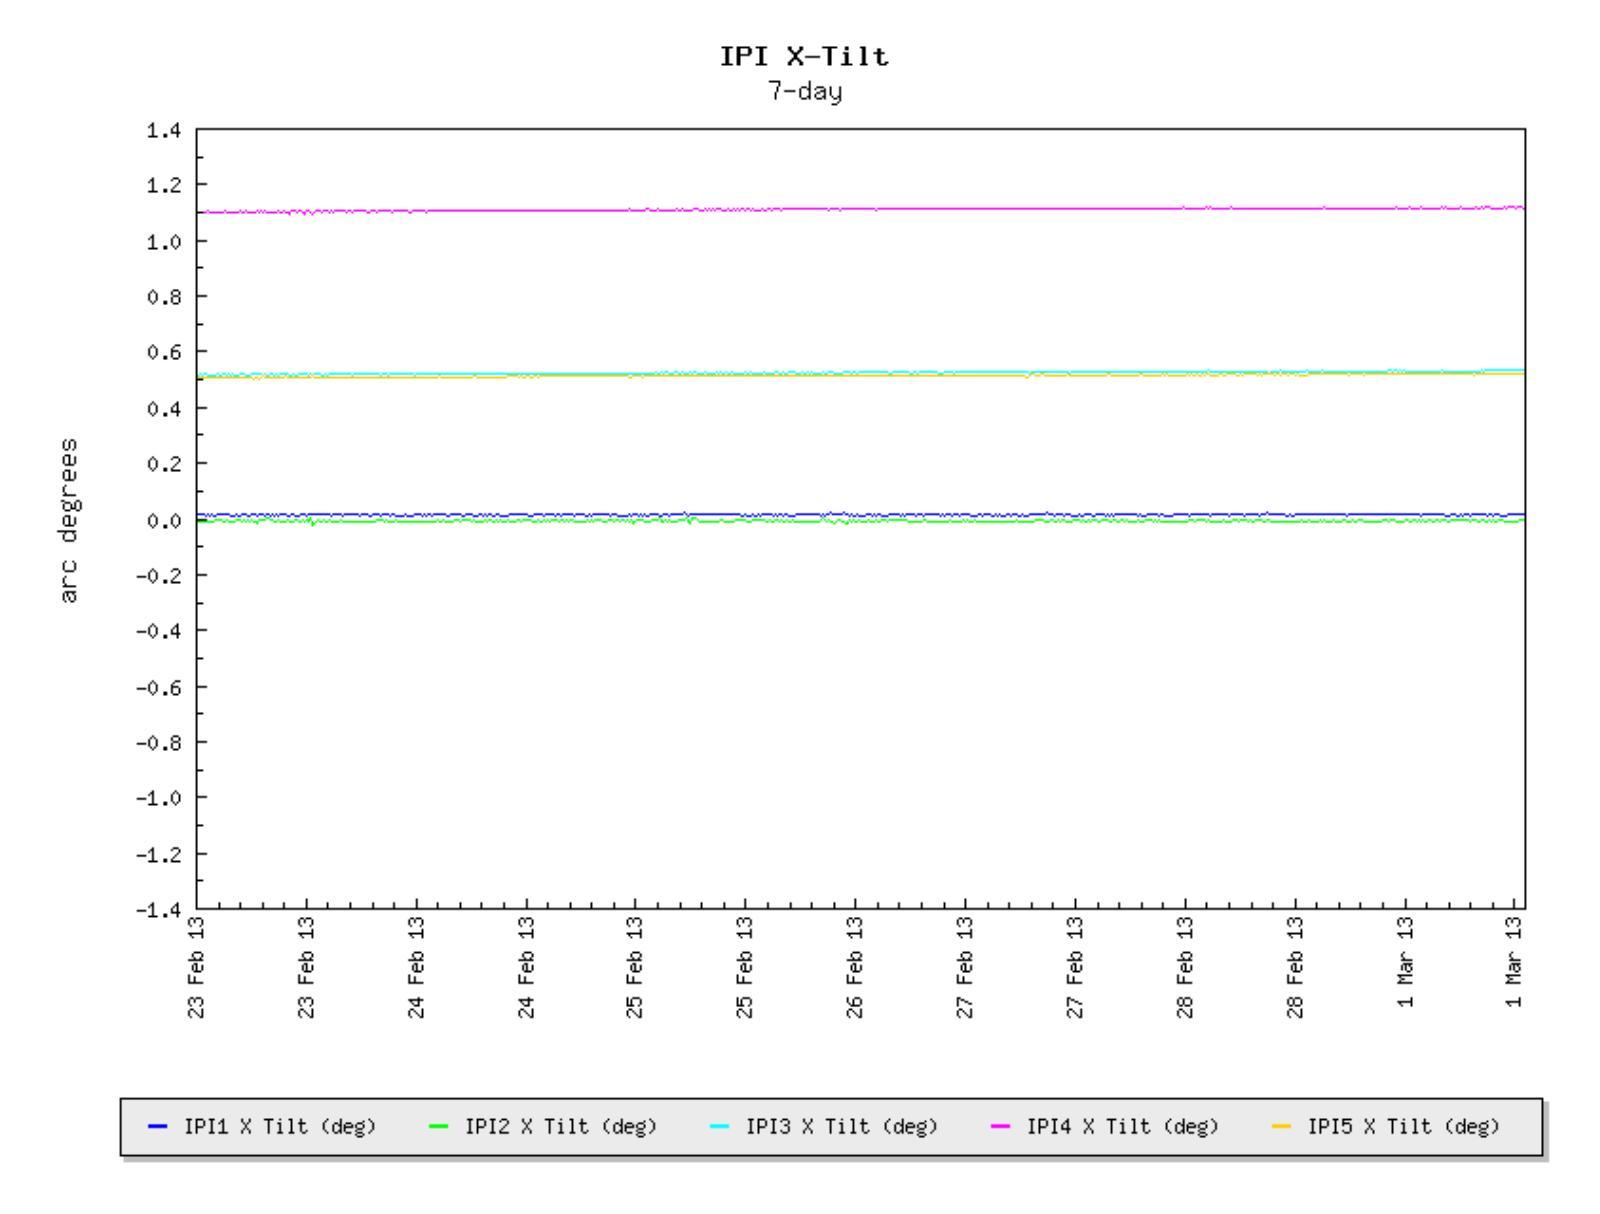
Figure 2. Inclinometer X-Direction Temporal Trends.

Monitoring locations are illustrated in Figure 1. Graphs illustrating the tilt data, as recorded by each instrument, are provided in Figures 2 through 4. The IPI data for the X-directions and Y-directions are plotted separately in Figures 2 and 3, respectively. The tiltmeter data for both the X- and Y-directions are plotted in Figure 4. A condition reflecting no changes in ground movement plots as a horizontal line on these graphs. Note that the instruments installed are very sensitive; they can measure ground tilt to less than 1/100 of a degree. Alarm levels are set at \pm 1.0 degree for IPI-1, IPI-2, IPI-3, and IPI-5 and at 0.5 \pm 1.5 degree for IPI-4. Tiltmeter alarms are set at \pm 0.5 degree. All IPIs and tiltmeters appear to be stable.

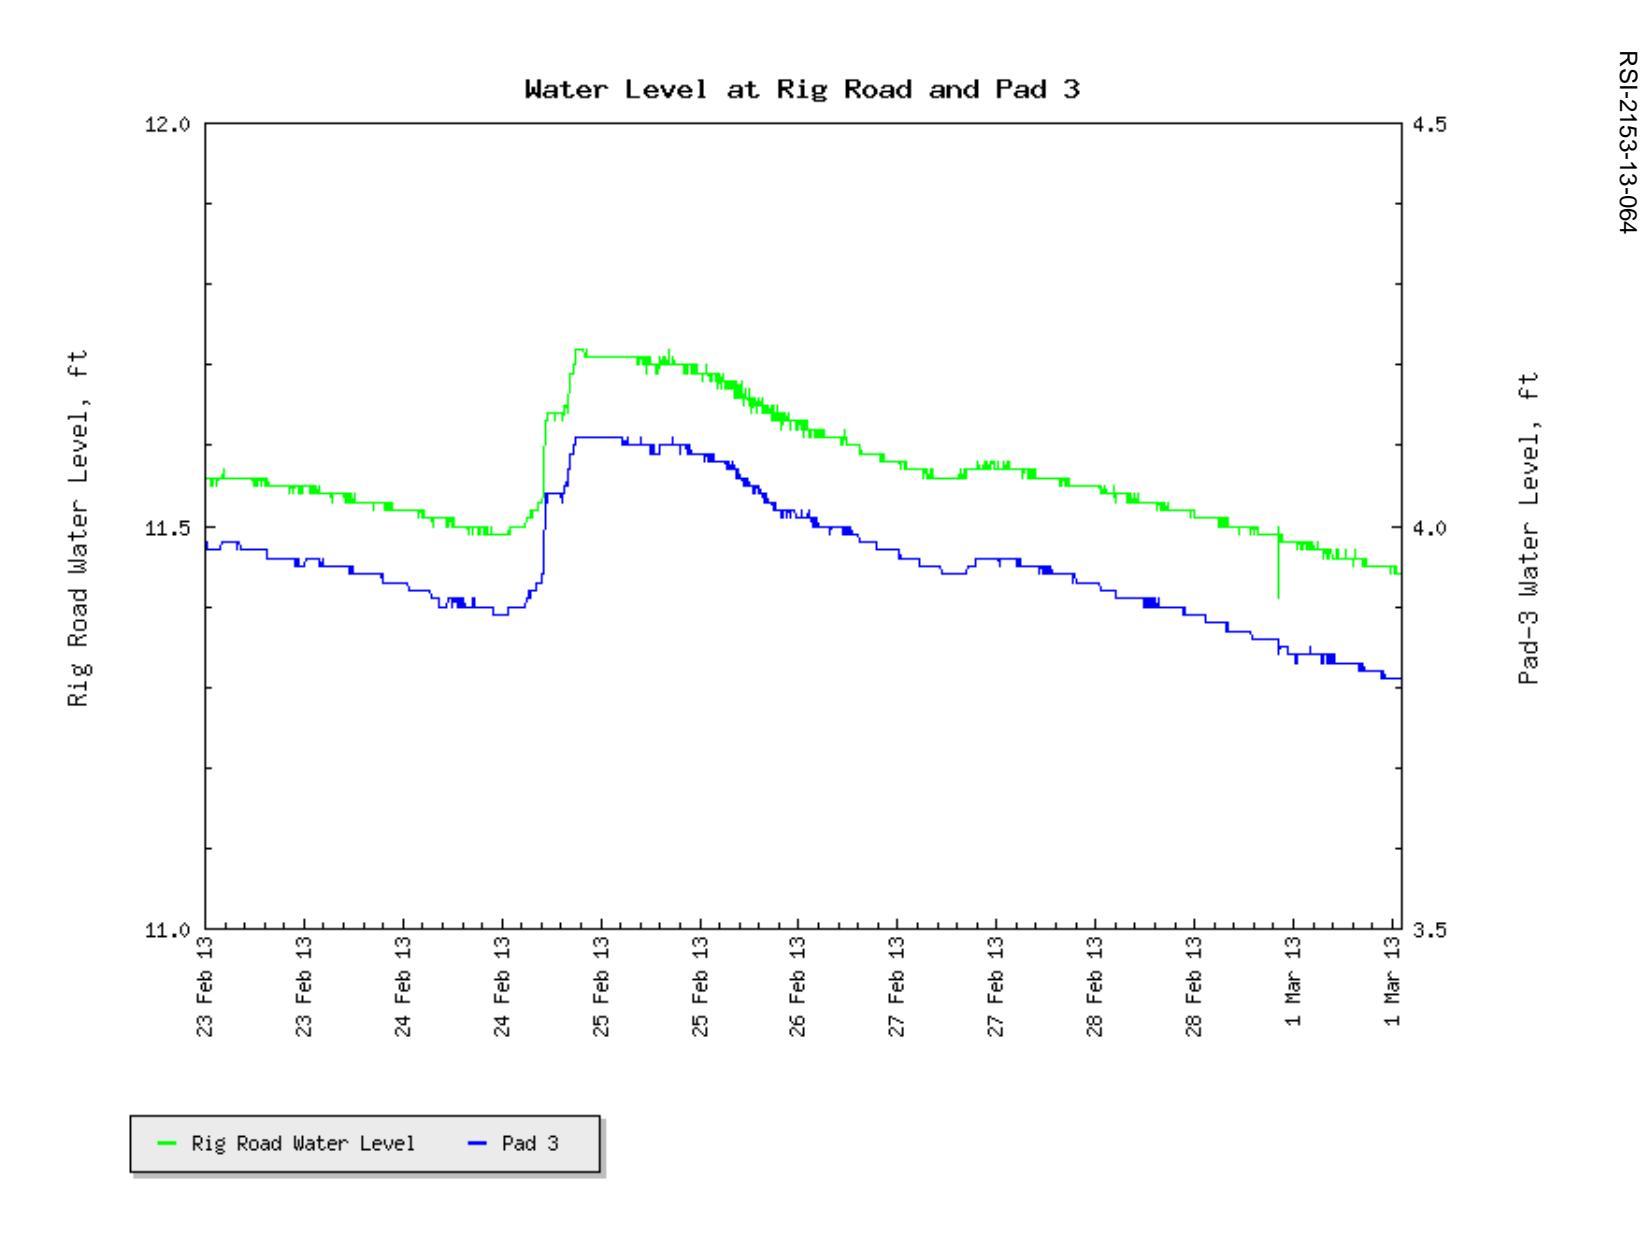
Figure 5. Water-Level Temporal Trends Comparing Rig Access Road Data to Pad 3 Data.

Figure 5 shows water levels recorded at Rig Access Road and IPI-2. Figure 6 shows water levels recorded at Rig Access Road and Pad-3 (Rig Access Road water level is shown in both figures for comparison to the other sites). Figure 7 shows water levels with respect to zero

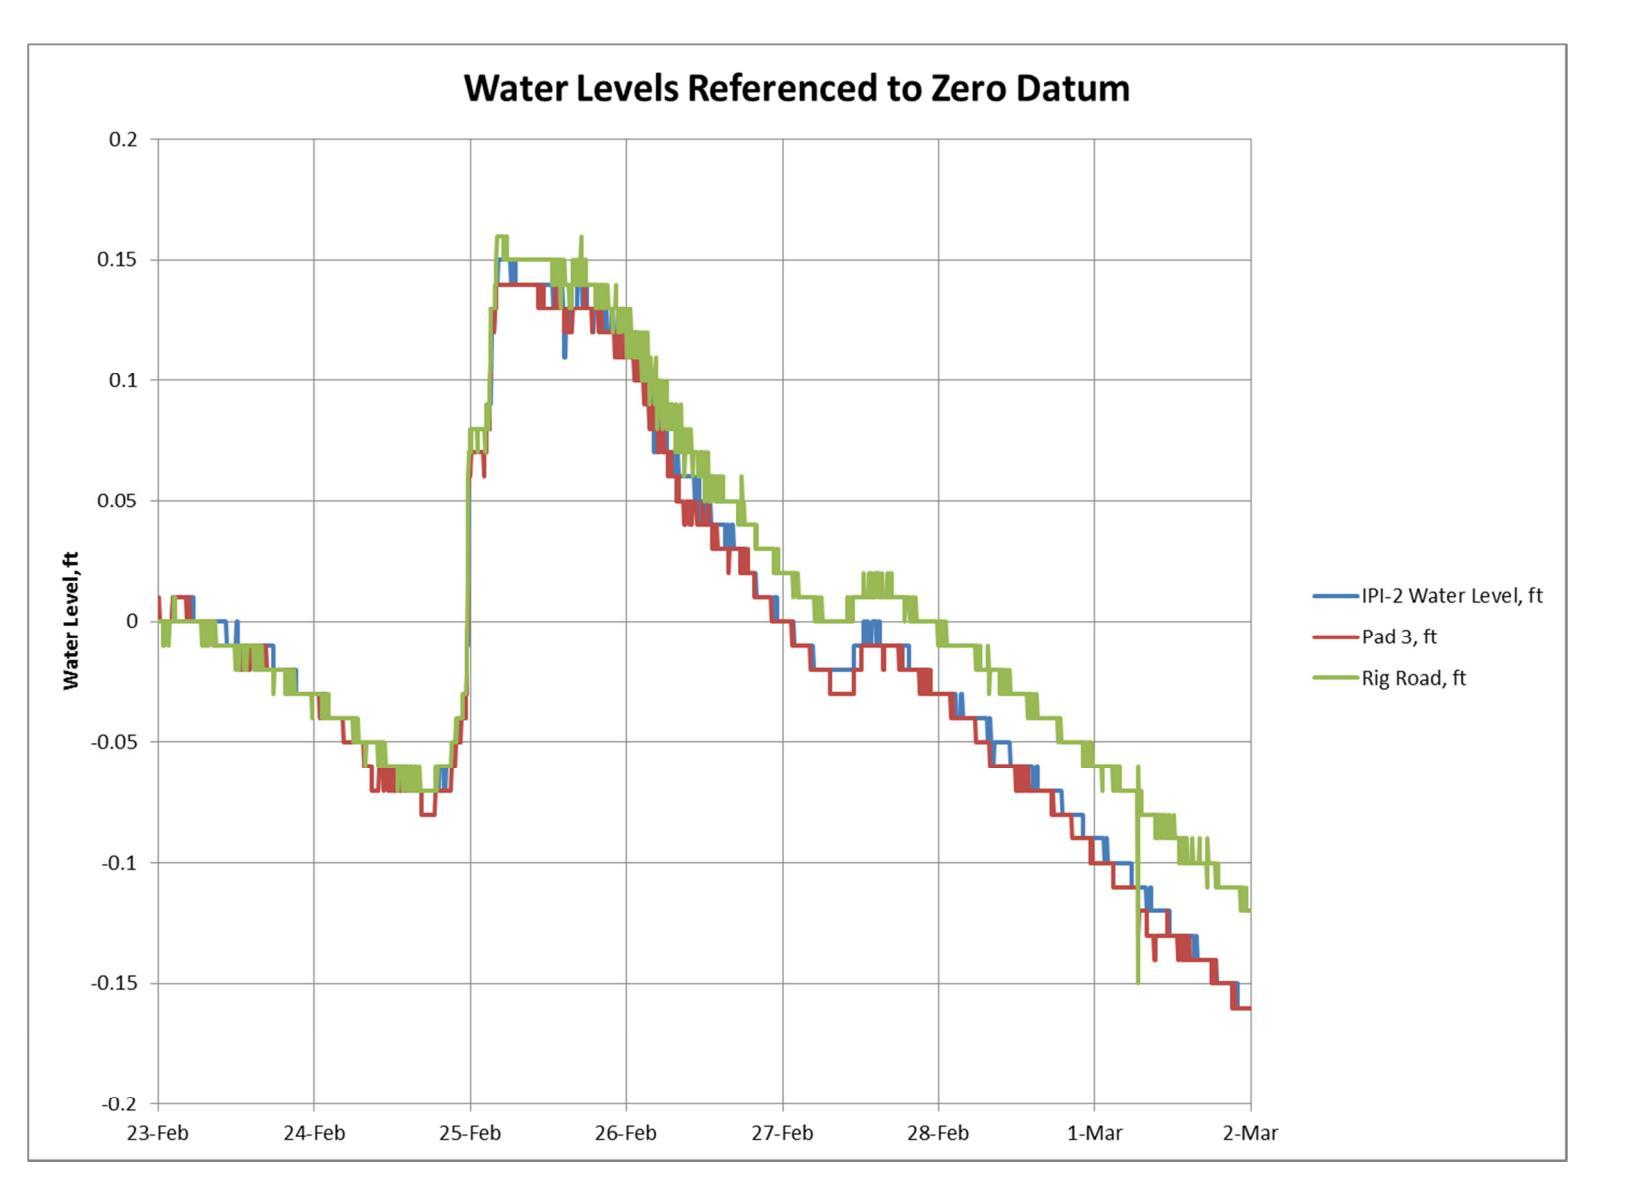
Figure 7. Water-Level References to Zero Dataum.

datum. While IPI-2 and Pad 3 water levels maintain the same change throughout, the water level at Rig Access Road appears to change by 0.04 foot to 0.05 foot through the week with respect to the other sites and is probably caused by differential subsidence at the Rig Access Road transducer. Although the data from Pad 3 and IPI-2 indicate that there is no relative differential subsidence at these locations, it is possible that they are subsiding at the same rate and, thus, water levels would not show any differential subsidence. Figure 8 illustrates these changes by comparing the difference in water levels at IPI-2 and Pad 3, and the differences at IPI-2 and Rig Access Road. The subsidence rate at Rig Access Road appears to be roughly linear over time. Note that the transducer mounting post at Rig Road is driven into native soils approximately 20 to 30 feet from the edge of fill used to construct the new berm.
