US DOT PHMSA AID <u>S</u>ituational <u>A</u>wareness <u>f</u>or <u>E</u>mployees: SAFE Bulletin¹ Flange Assembly Failures²

49 C.F.R. Part 195 Transportation of Hazardous Liquids by Pipeline

Summary: The Pipeline and Hazardous Materials Safety Administration's (PHMSA) Accident Investigation Division (AID) is issuing this SAFE Bulletin to provide inspectors with information on accidents caused by flange assembly failures in hazardous liquid (HL) and gas transmission (GT) pipeline systems as well as information about a potential pipeline safety concern related to incorrectly marked ULMA manufactured A105 flanges.

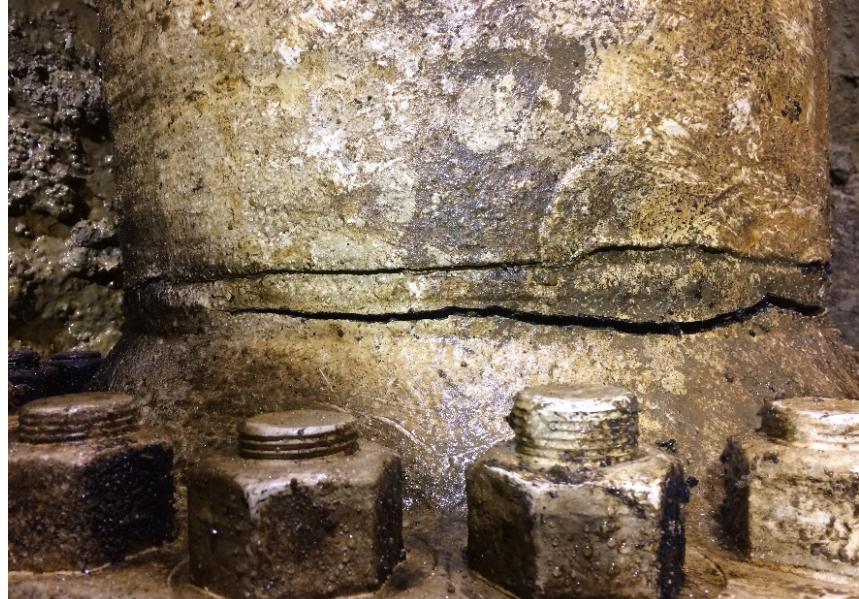
The cause of the release was due to a circumferential crack in the body of the flange (Figure 2) adjacent to the girth weld between the flange and the pipeline located on the upstream side of the mainline valve. The failed flange was made of carbon steel and installed in 1949.

Figure 2 Circumferential crack in the body of a 1949 carbon steel flange. Photo provided by Operator.

The pipeline repair consisted of installing a 6-feet long flanged spool segment immediately upstream of the mainline valve. This fabricated assembly was hydro-tested prior to installation. The pipeline was returned to service on January 19, 2017 at 8:48 p.m. CT.

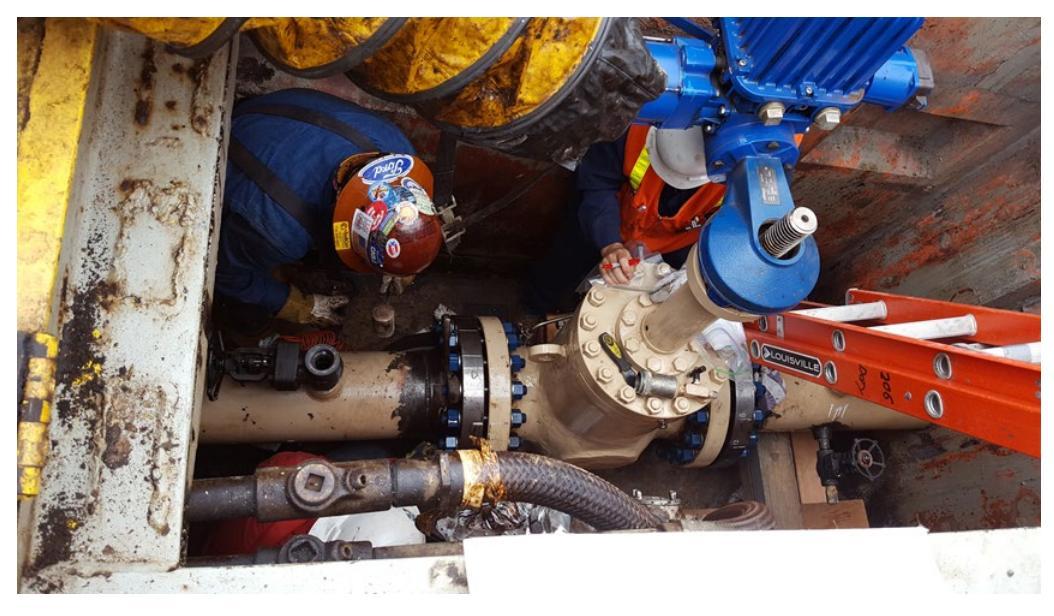
Figure 3 Valve box 7002, source of the leak of crude oil. Photo provided by Operator.

The cause of the failure was due to an inadequate connection of flanges in valve box 7002. There was a visible gap between the flanges and the gasket. Three of the nuts on the underside of the flange were loose, and further investigation revealed that torque measurements were not adequate in several other flange nuts in the same valve box.

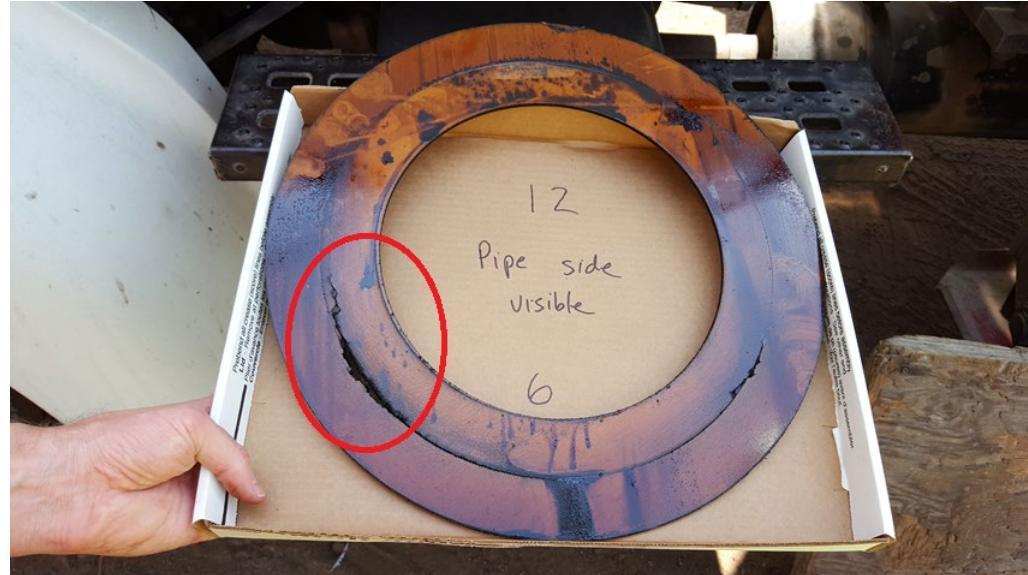
The examined gasket (Figure 4) had a fracture matching the edge of the raised faces of the flanges. Fine circumferential lines were present in the upper half of the gasket, but few or no such lines were observed near the bottom of the gasket.

Figure 4 Removed gasket from the pipeline in valve box 7002. Photo provided by Operator.

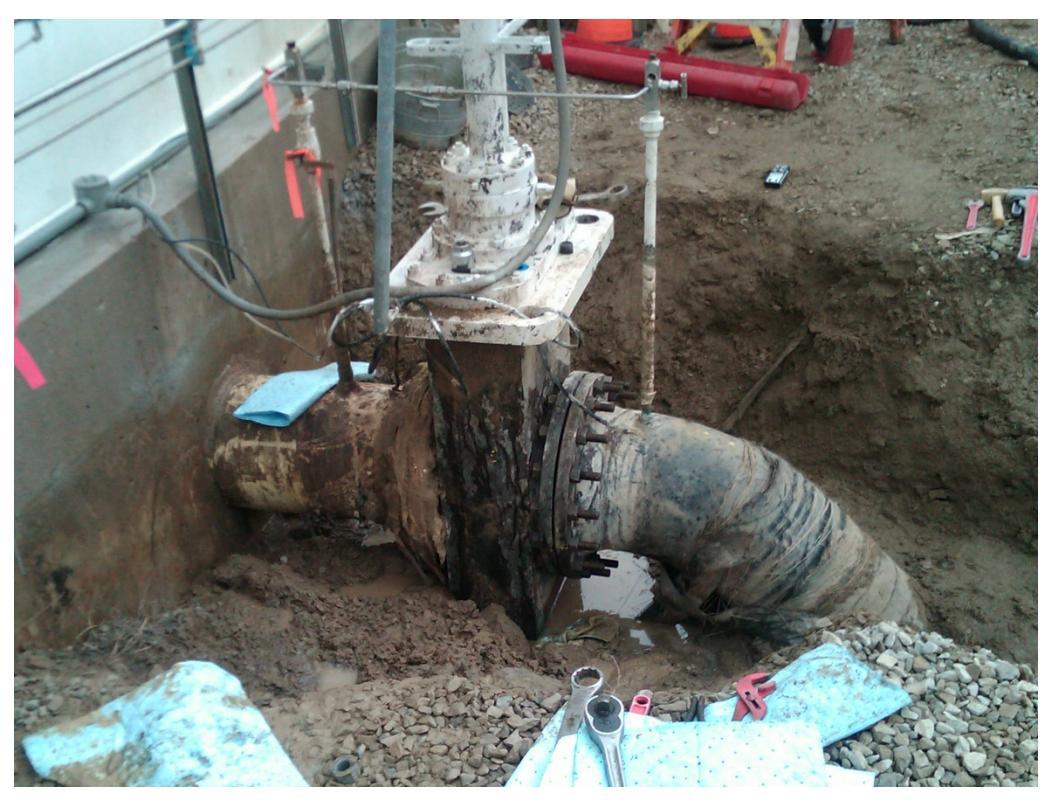
The gasket failed due to misalignment during construction in 2002. Figure 5 shows the failed flange assembly after digging operations, while Figure 6 shows the gasket (inside and outside) with signs of misalignment.

Figure 5 Failed flange assembly after digging operations. Photo provided by Operator.

The pipeline was shut down for five days to make repairs. A boom was placed in Bauer Drain and recovery wells installed to collect free product. The operator removed 4,500 tons of non-hazardous impacted soils from this site.

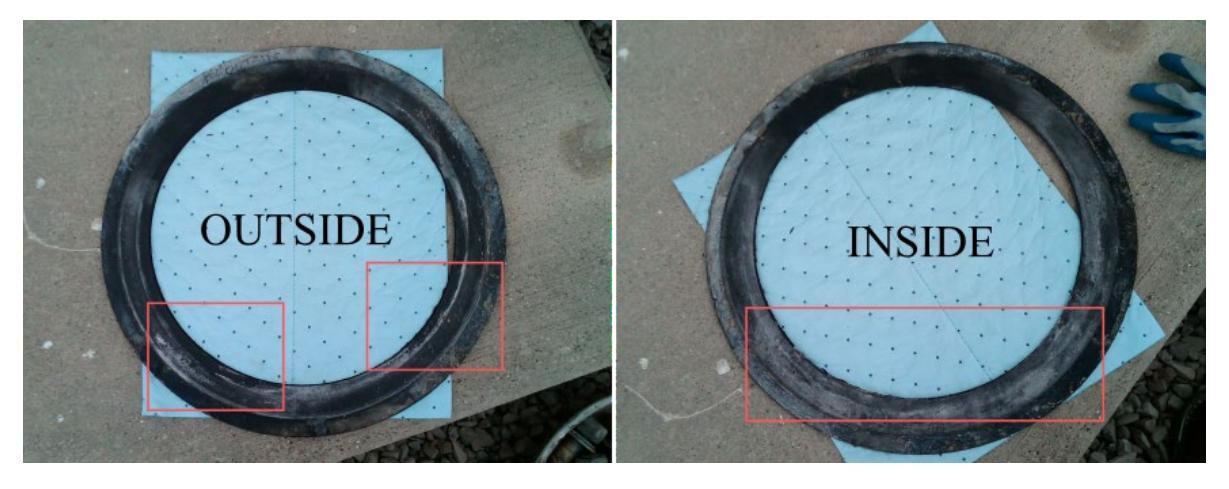
Figure 6 Outside and inside of gasket showing signs of excessive wear (red rectangle insets). Photo provided by Operator.
