FALSE RIVER WATERSHED STUDY: DISCHARGE BAYOU AND THE CHENAL DRAINAGE NETWORK ASSESSMENT

Report detailing data collection and modeling effort for the False River Watershed, prepared for the Department of Natural Resources and False River Watershed Coalition, by C.H. Fenstermaker & Associates, LLC.

July 3, 2013

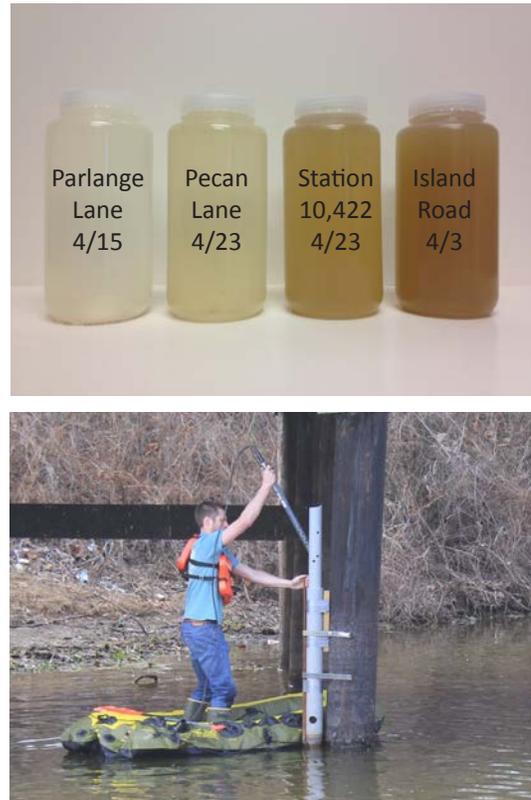
Figure 21 - Data Collection Equipment

Water level and turbidity data were collected using YSI data sondes, and hand collected water samples were analyzed by the Wetland and Aquatic Biogeochemistry Lab at the Department of Oceanography and Coastal Sciences in the School of Coast and Environment at Louisiana State University (Figure 21).

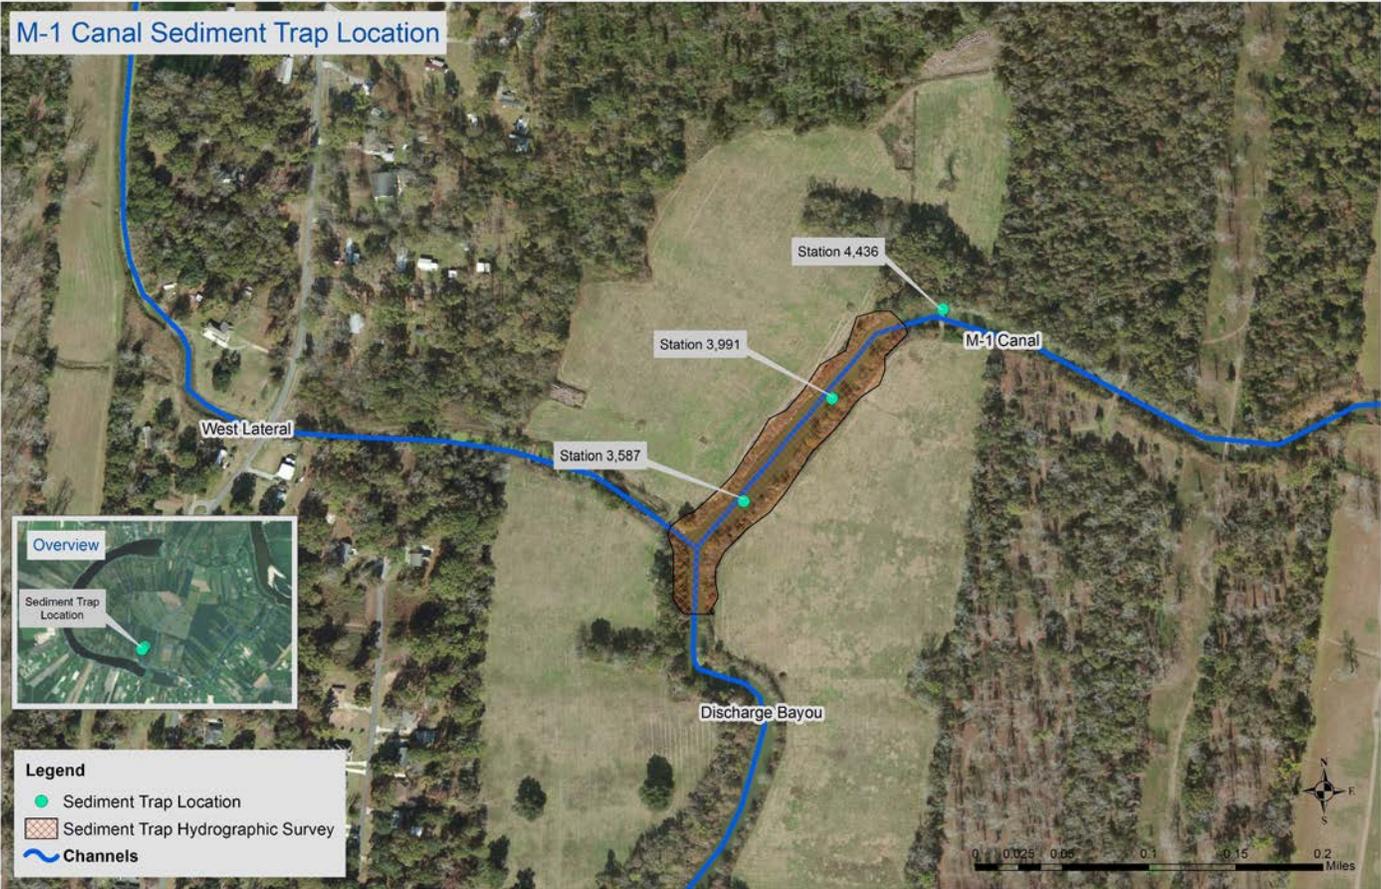
Figure 35 - M-1 Canal Sediment Trap Location

Velocities in the M-1 Canal sediment trap during a 10-year, 6-hour storm event peak around 2.0 feet per second (ft/s) as shown in *Figure 34*. This is a reduction of approximately 0.5 ft/s caused by the wider and deeper channel. As previously discussed, the majority of the False River Island watershed soil is clays and silts which have a settling velocity of less than 0.10 ft/s (Table 5). Therefore, the sediment trap effectively collected larger sized sediment (sands, gravel, etc.) and the finer sediments (silts and clays) are able to bypass the sediment trap. *Figure 35* shows sediment trap location along M-1 Canal.
