# Lake Providence Watershed Council

## MANAGING LAKE PROVIDENCE WATERSHED RESOURCES

*2023 Update*

*An Annual Report to the Louisiana Legislature*

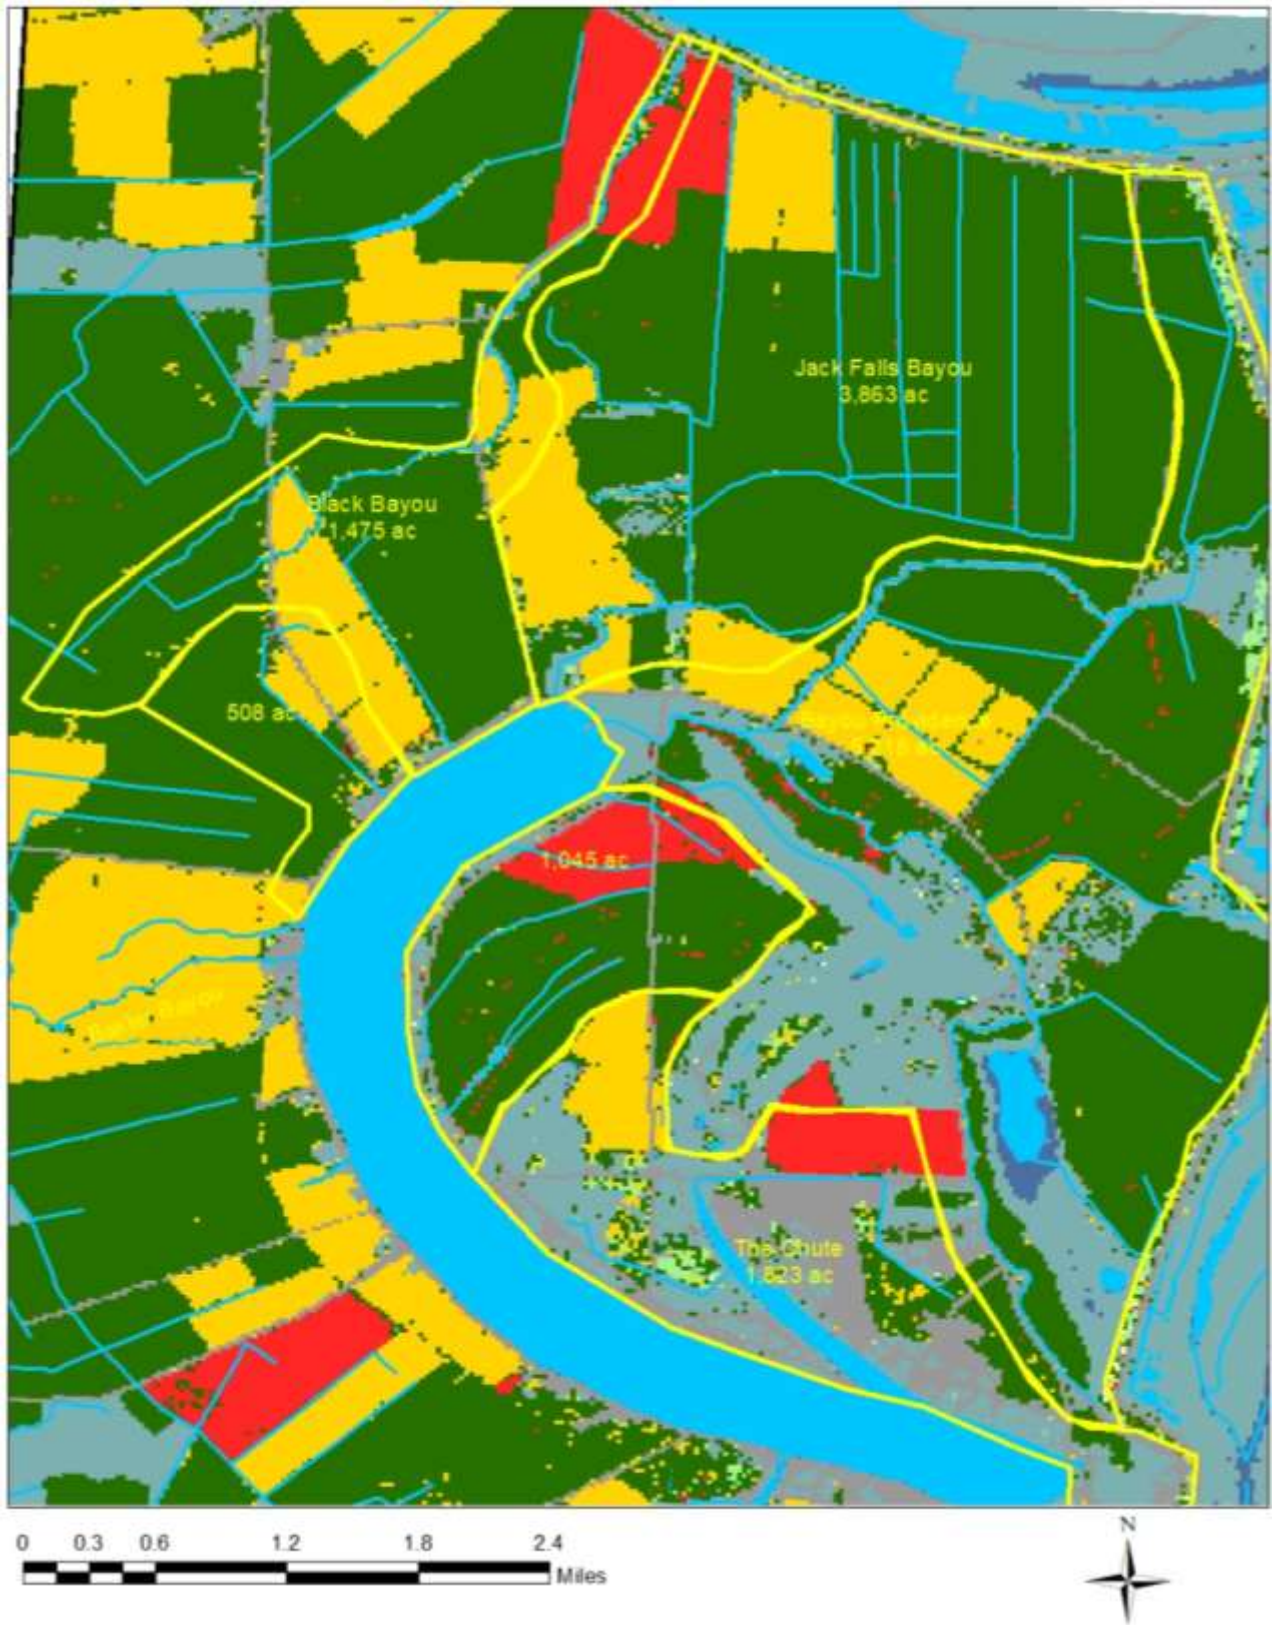
Figure 1: Lake Providence subbasin. Colored in yellow are field planted in 2022 in corn, in green soybeans, and in red cotton. All other areas represent undeveloped or developed land and open water (data: USDA CropScape)

It is acknowledged that the greatest threat to the viability of the lake is the large amount of sediment that continues to enter at the north end from Jack Falls Bayou (Figure 1). This waterway takes runoff from approximately 4,500 acres of agricultural land. So far, the council has not developed a plan to address this. Any remedy will be expensive and require a sacrifice of private lands. Some possible remedies are diversion of some of the runoff to outlet, sediment basins, or more intense soil stabilization measures.

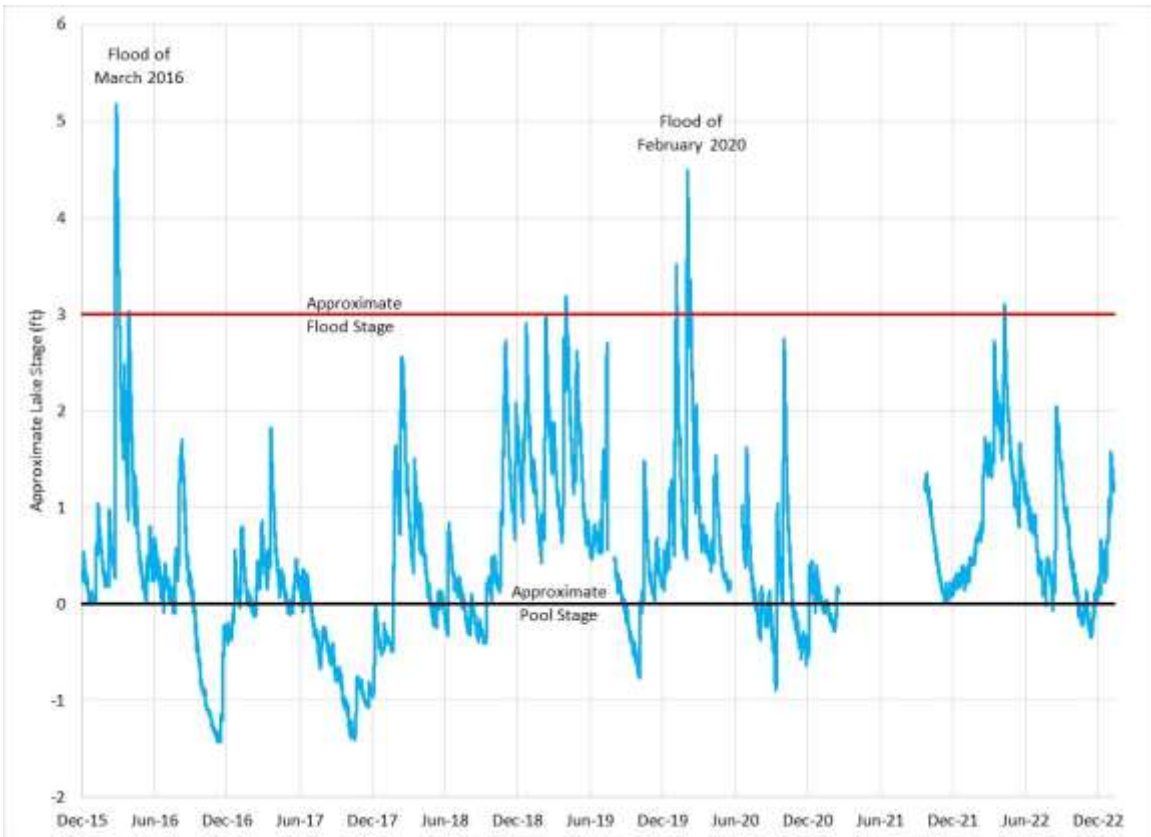
Figure 2: Recorded lake stage in feet above approximated pool stage (~90 ft.NAVD29).

The lake monitoring gage installed at the former swimming pier by the Louisiana Geological Survey was moved to a new location in September 2021 after a portion of the pier received damaged (e.g. collapse) during the June 2021 flood resulting in the gage no longer being able to be accessed from shore. The new location of the gage is on a private pier. Due to the pandemic restrictions and because the gage was not accessible for an extended period of time, some data (most of 2021) was lost, including that for the flood on June 2021 (Figure 2). To display the data of the 2021 flood, Figure 3 shows the stream stage data from the Corps gage on Tensas Bayou at Transylvania, LA.

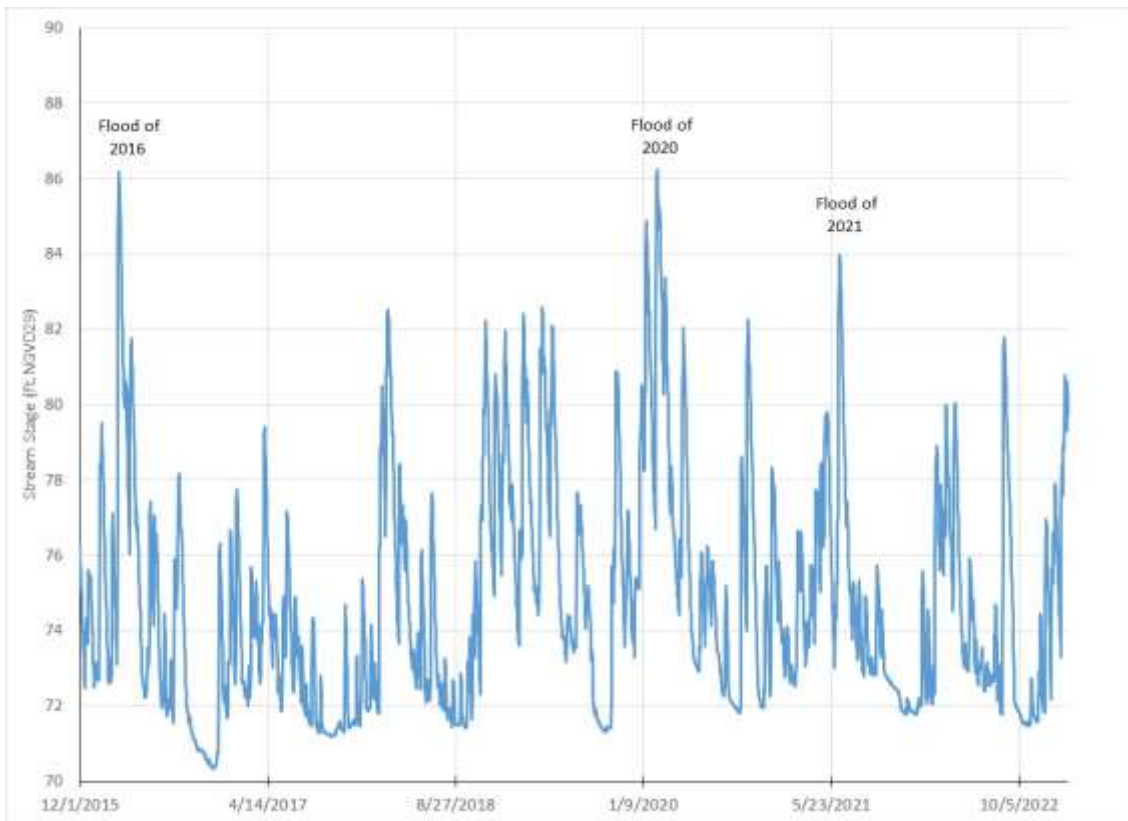
Figure 3: Recorded stream stage in feet (NAVD29) at the gage on Tensas Bayou at Transylvania.

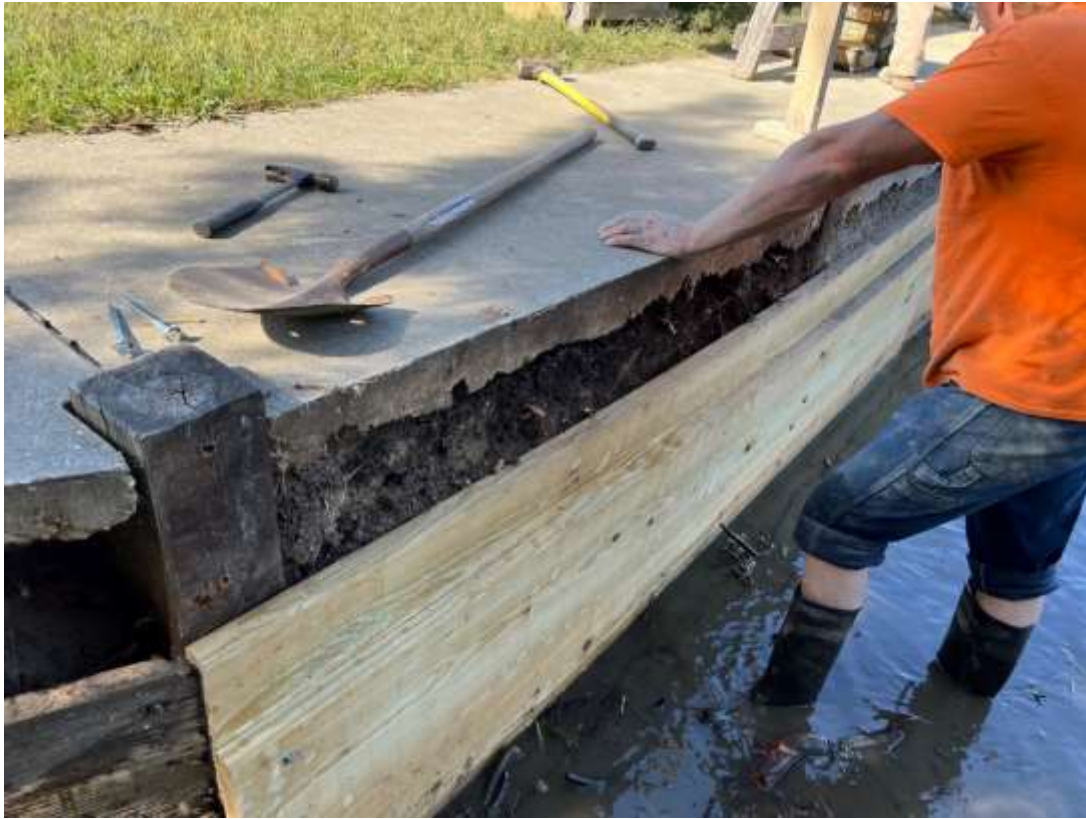
Photo A1: On-going repair at the Tensas Landing boat launch. Photo taken 10/17/2022 by Francis Lensing

In 2022, the East Carroll Police Jury (ECPJ) contracted the repairs to the bulkheads at the Tensas Bayou Landing boat launch (see Appendix A).

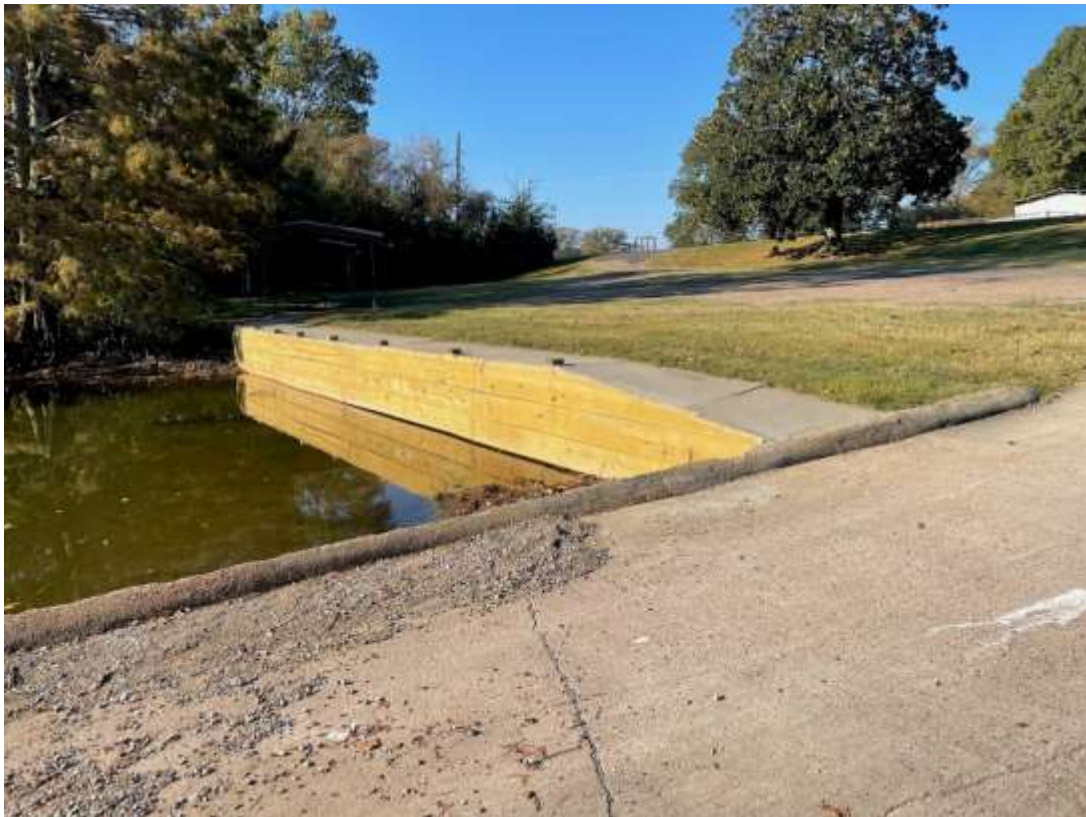
Photo A2: Finished repair at the Tensas Landing boat launch. Photo taken 10/17/2022 by Francis Lensing.

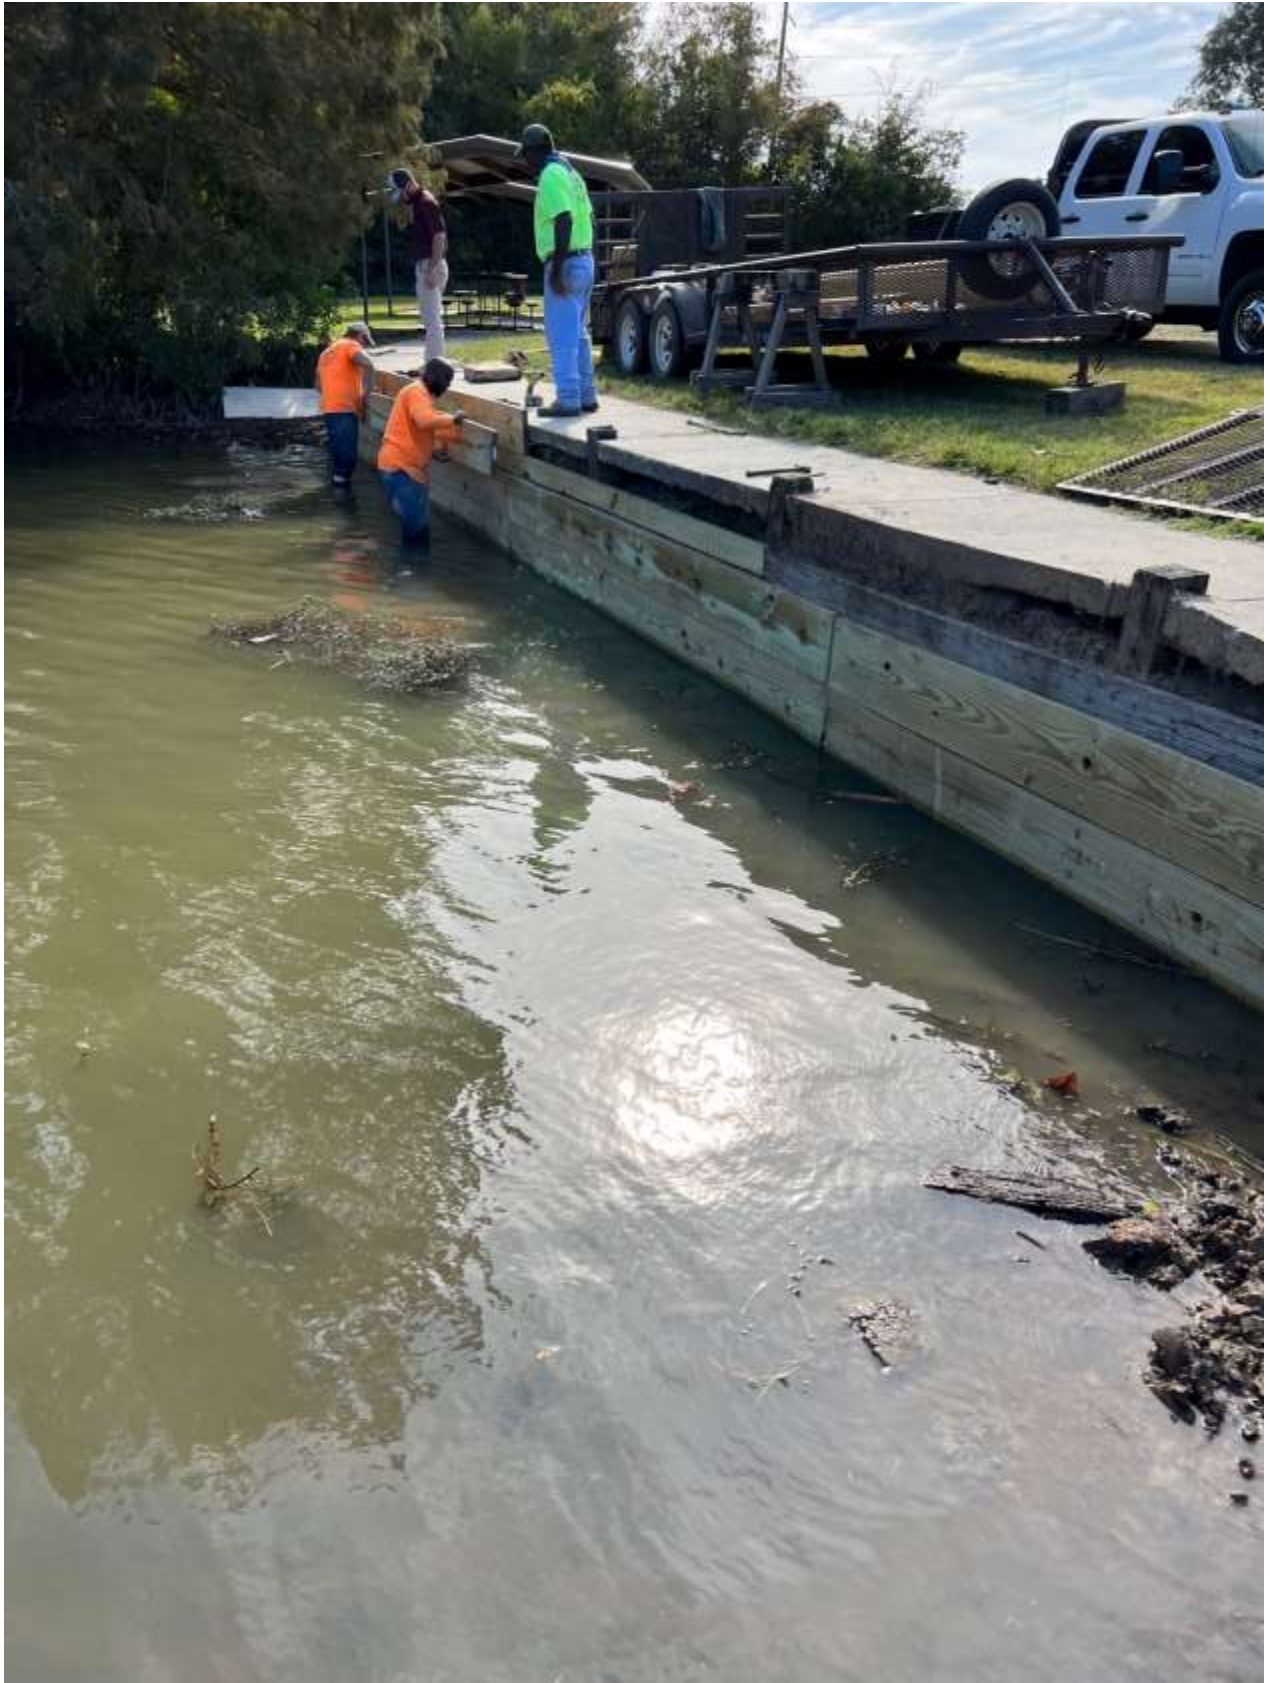
Photo A3: On-going repair at the Tensas Landing boat launch. Photo taken 10/17/2022 by Francis Lensing

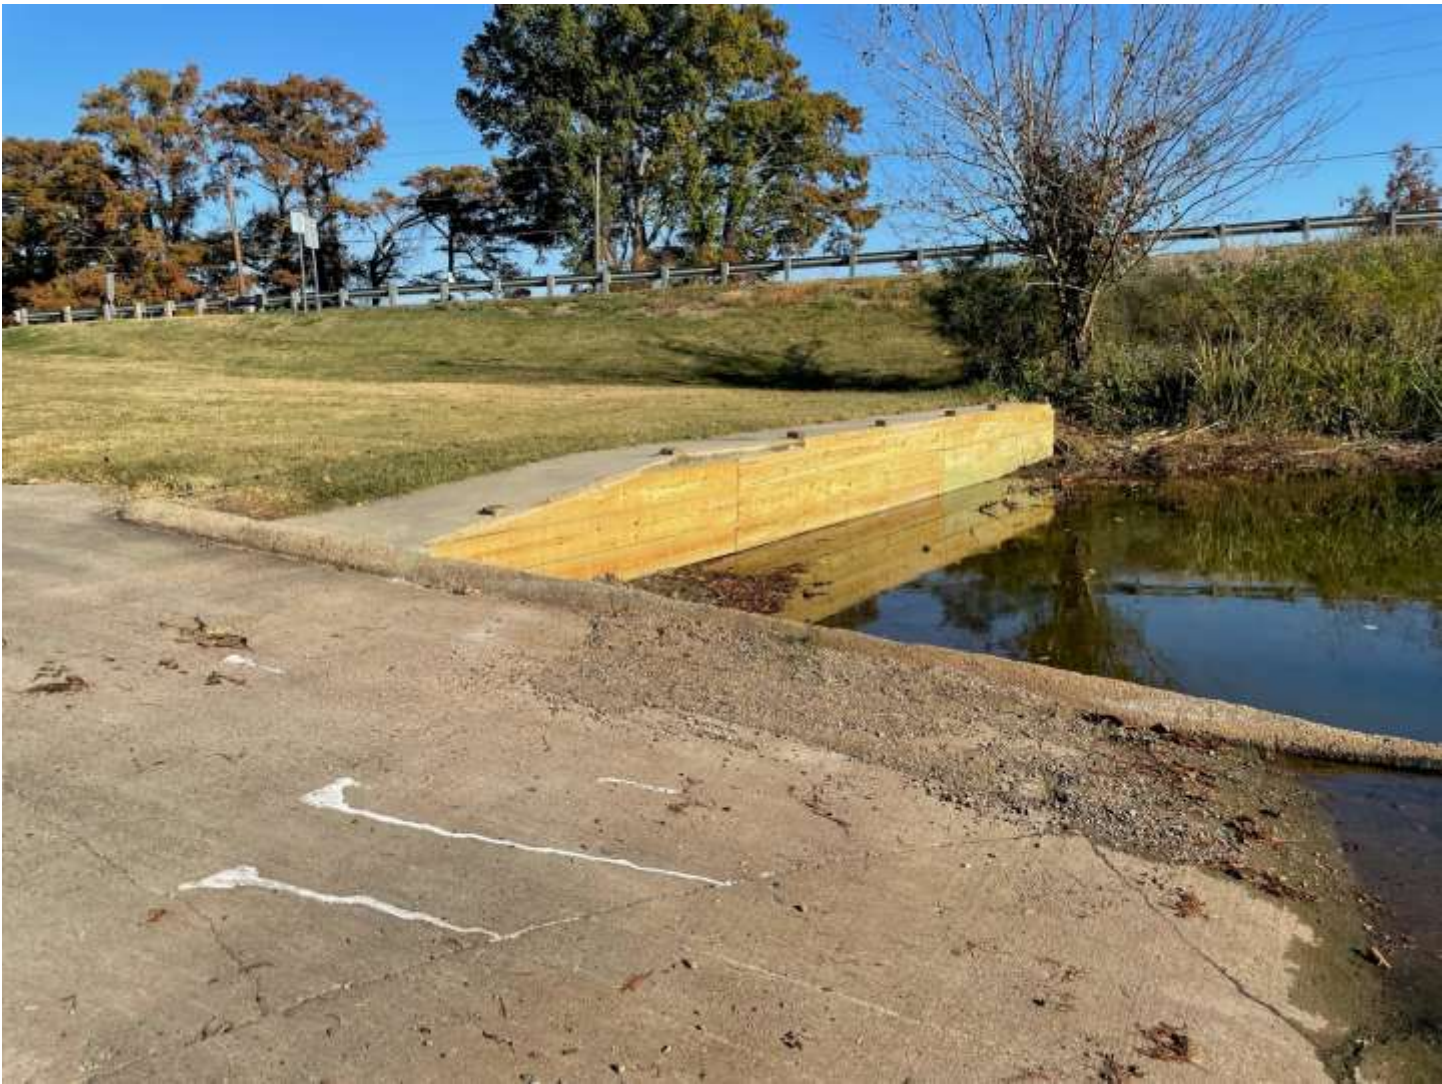
Photo A4: Finished repair at the Tensas Landing boat launch. Photo taken 10/17/2022 by Francis Lensing

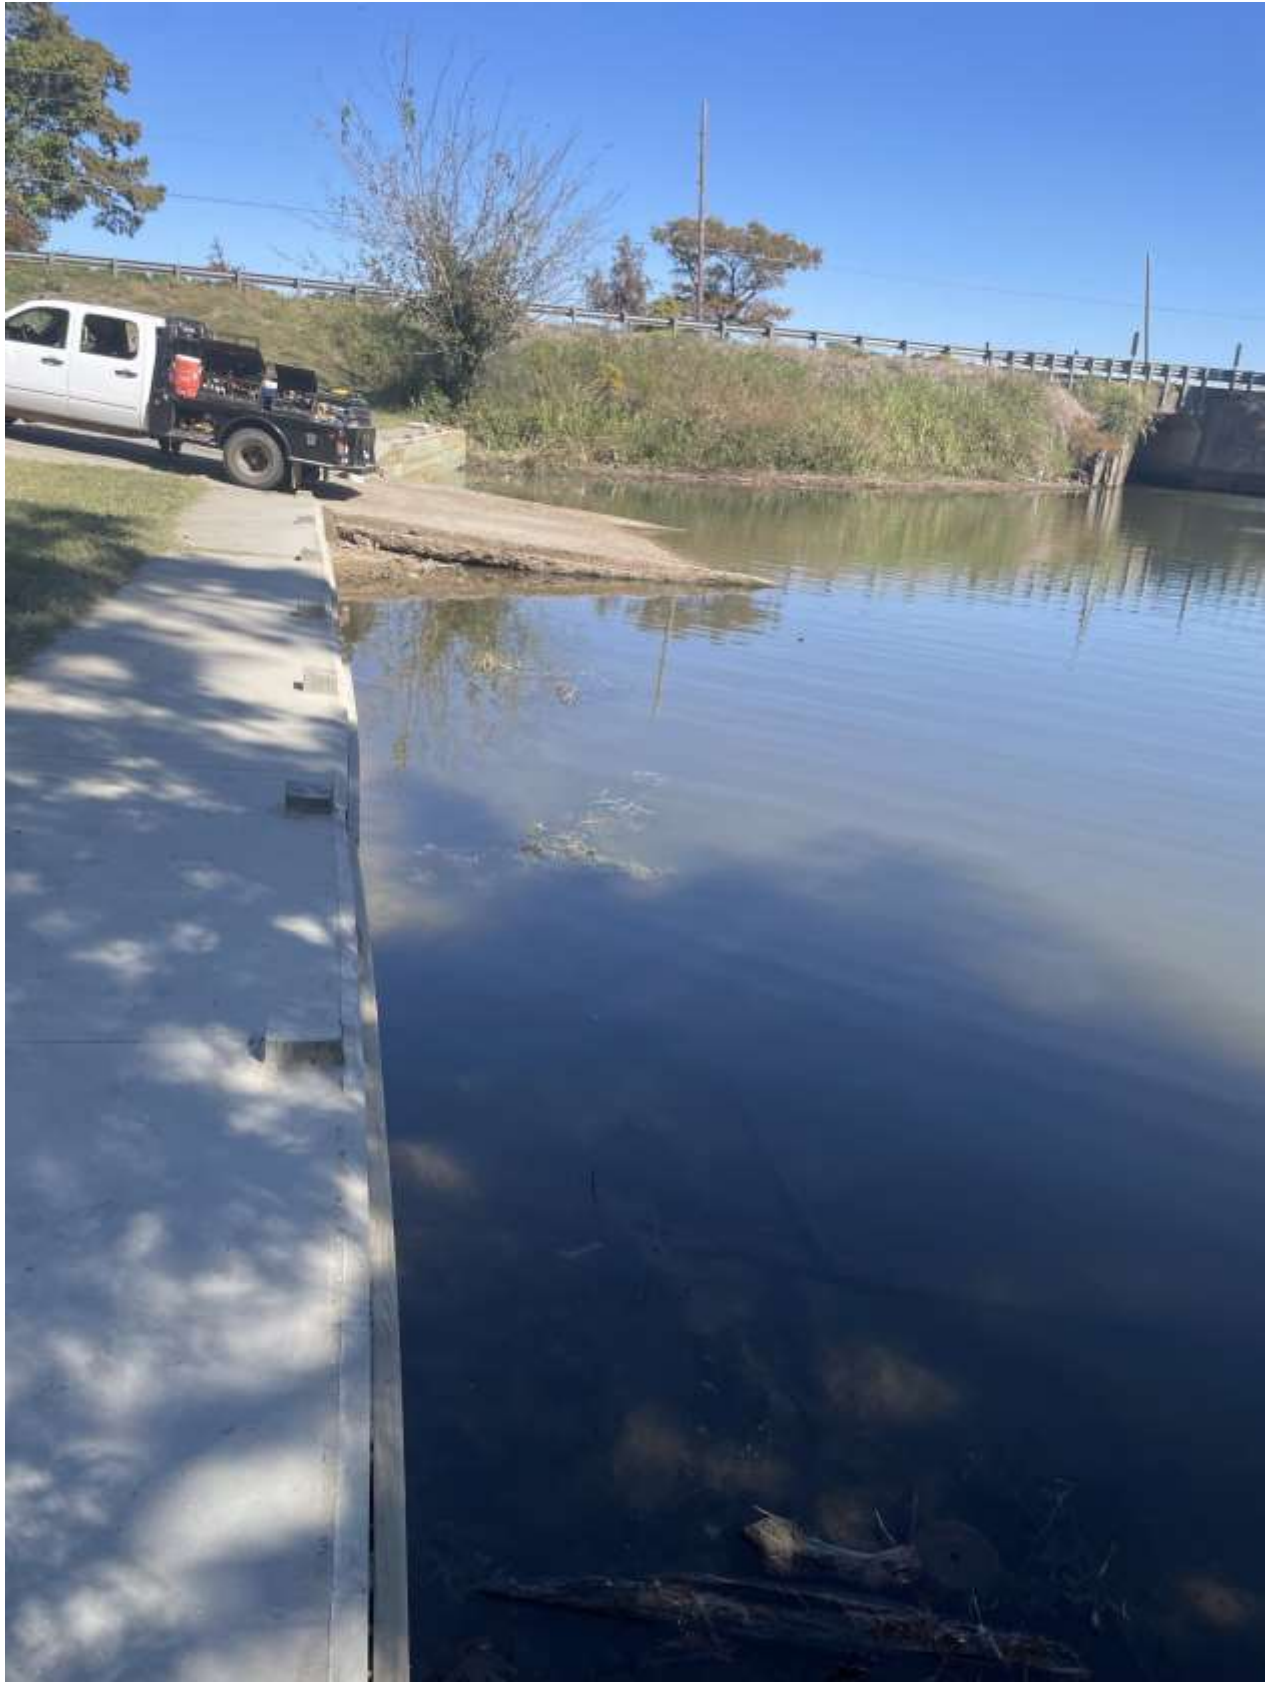
Photo A5: Finished repair at the Tensas Landing boat launch. Photo taken 10/19/2022 by Thomas Van Biersel

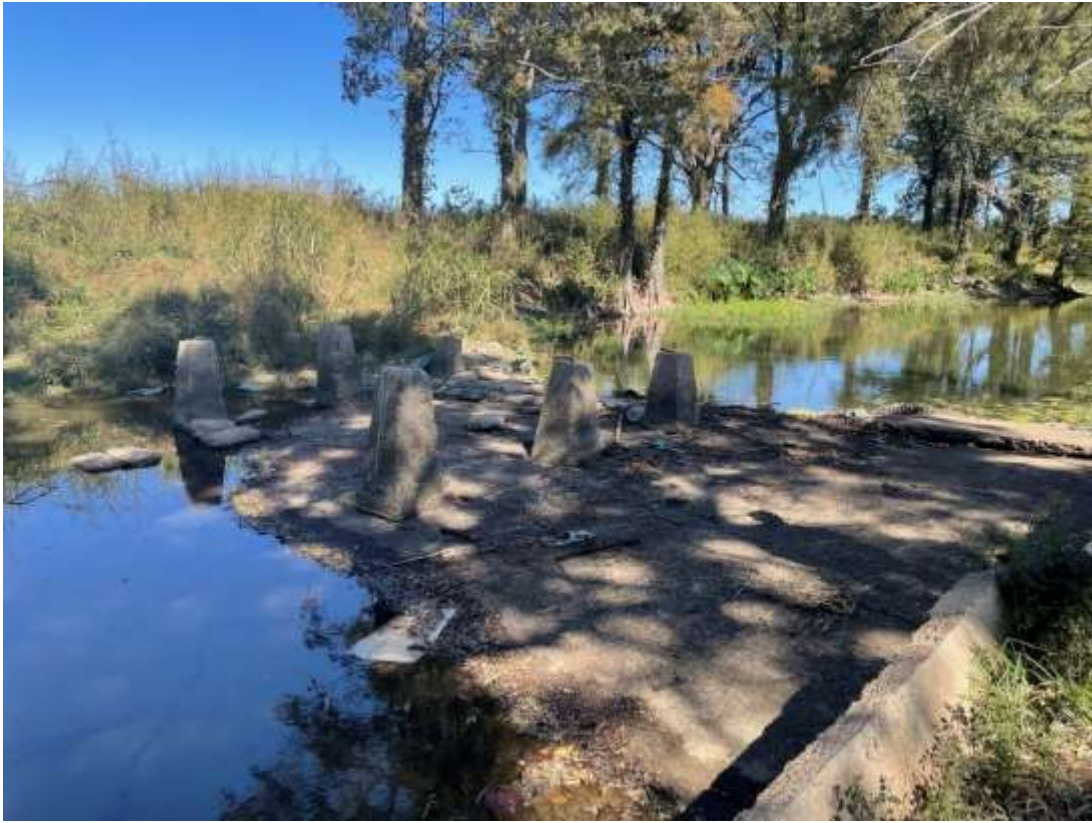
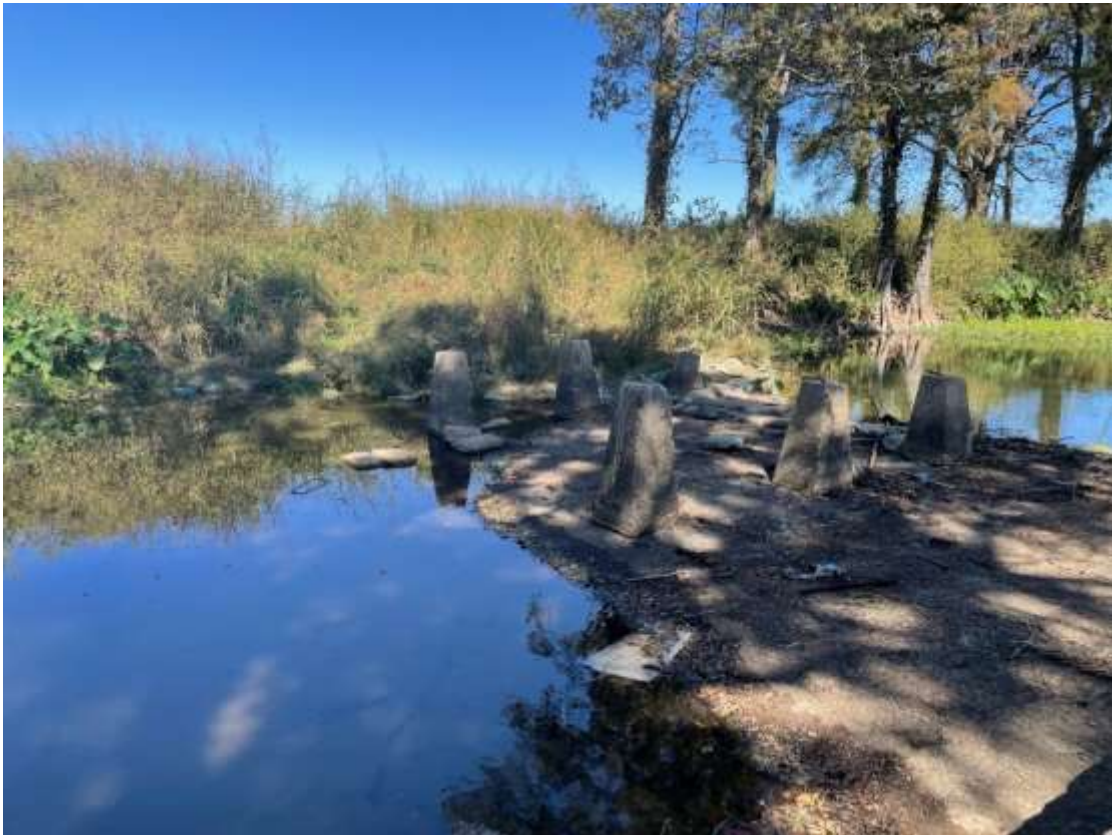
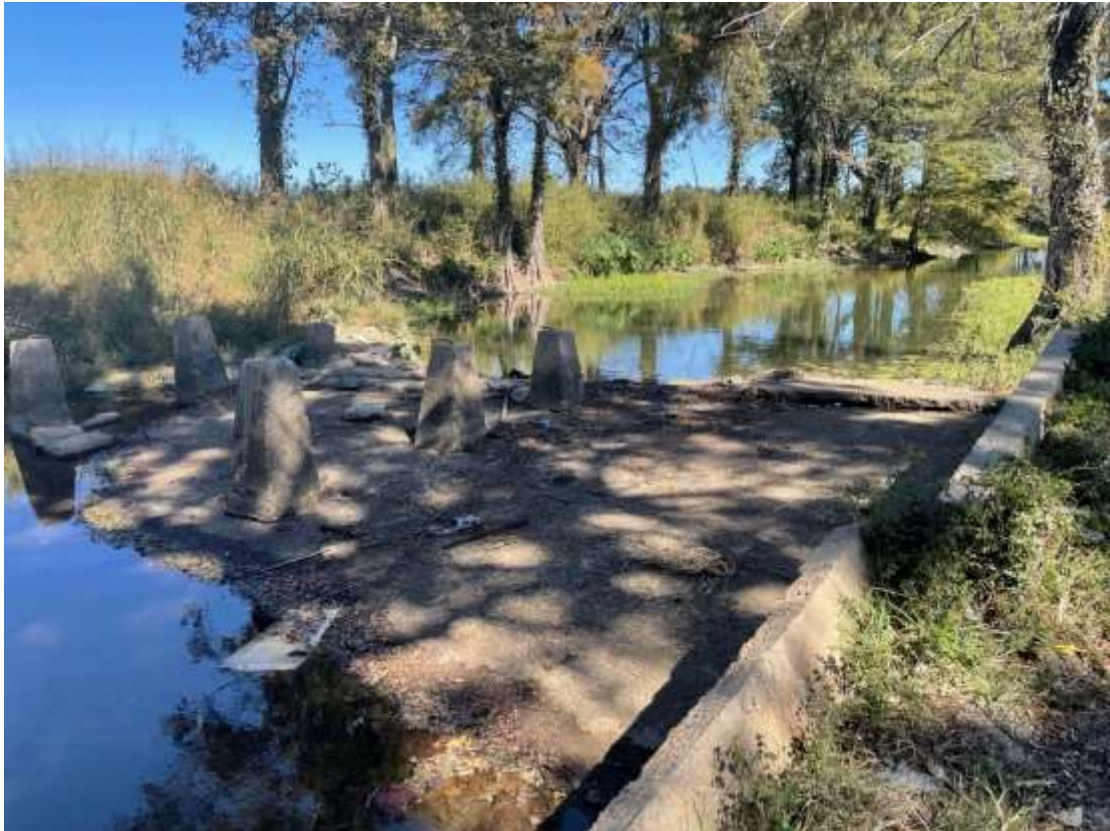
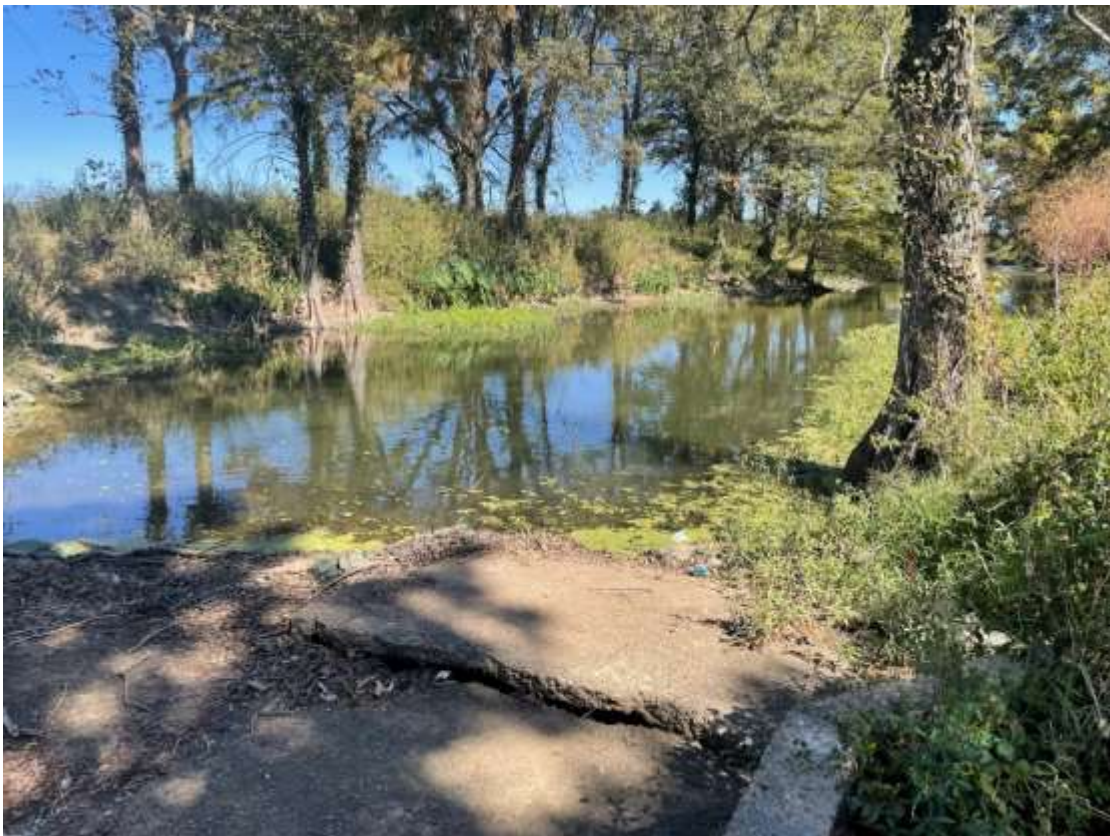
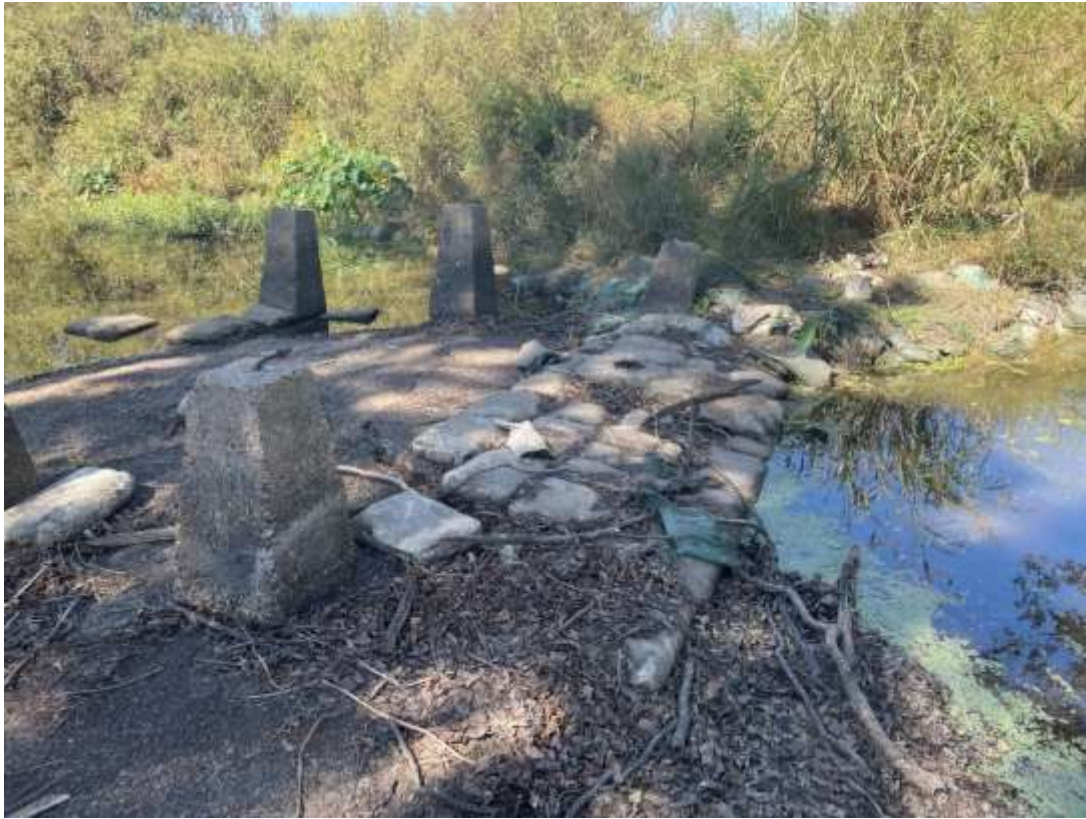
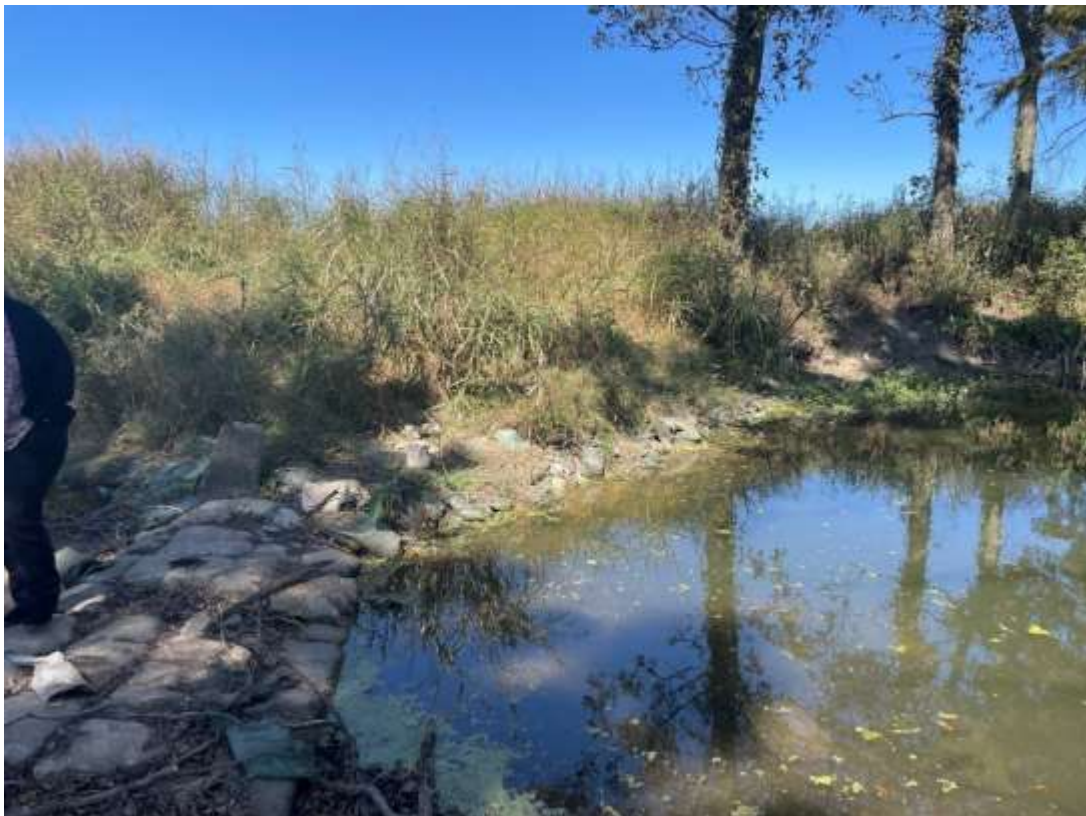
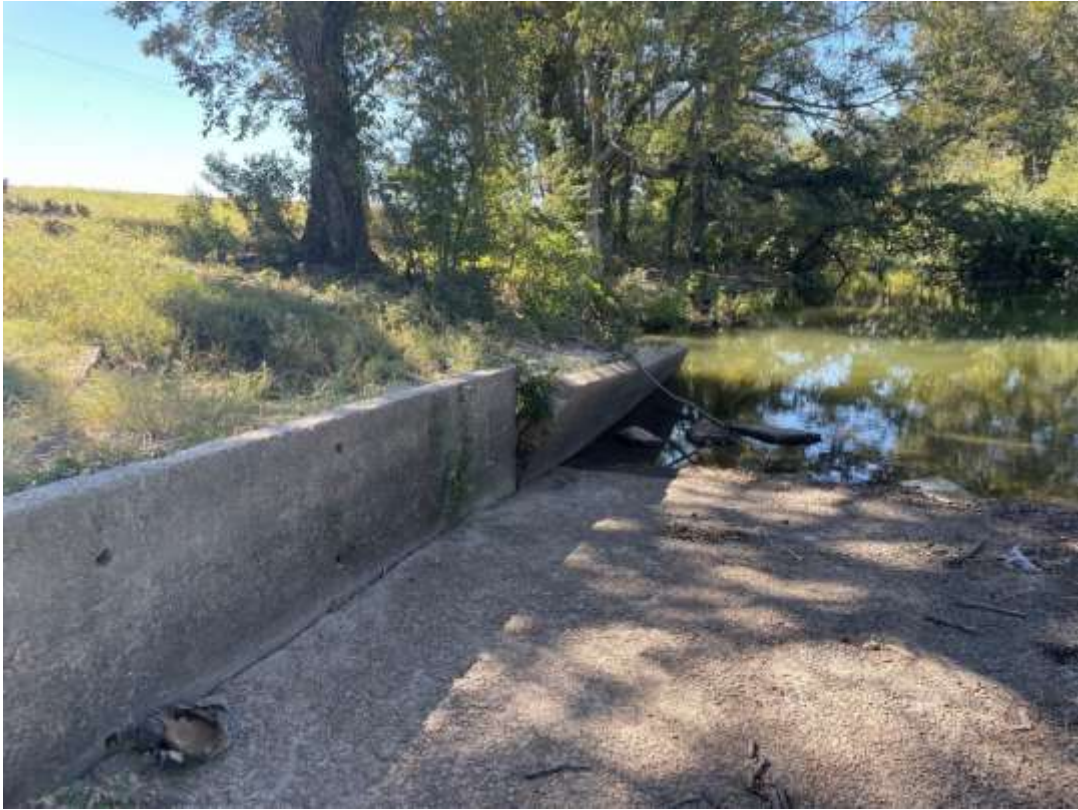
This older weir, which is the primary drain for the lake, does not allow for lake level manipulation (Appendix B). It is in disrepair and being bypassed along its side and underneath its base. In the past, the East Carroll Parish Police Jury has placed cement bags on the structure to maintain its integrity. The East Carroll Parish Police Jury has been in contact with the LDOTD and has hired an engineer to prepare plans to replace the weir. Current estimates suggest that the design work will begin in 2023.

Photo B1: Downstream view across the Tensas Bayou Weir (taken by Thomas Van Biersel on 10/19/22).

The East Carroll Parish Police Jury has been working for the past several years with the Louisiana Department of Transportation and Development to replace the weir on the Tensas Bayou. As reported in previous report, the weir built prior to 1970 to maintain the lake pool level, is in disrepair (see cover page and Appendix B) and currently being partially bypassed. Current estimates suggest that the design work will begin in 2023.

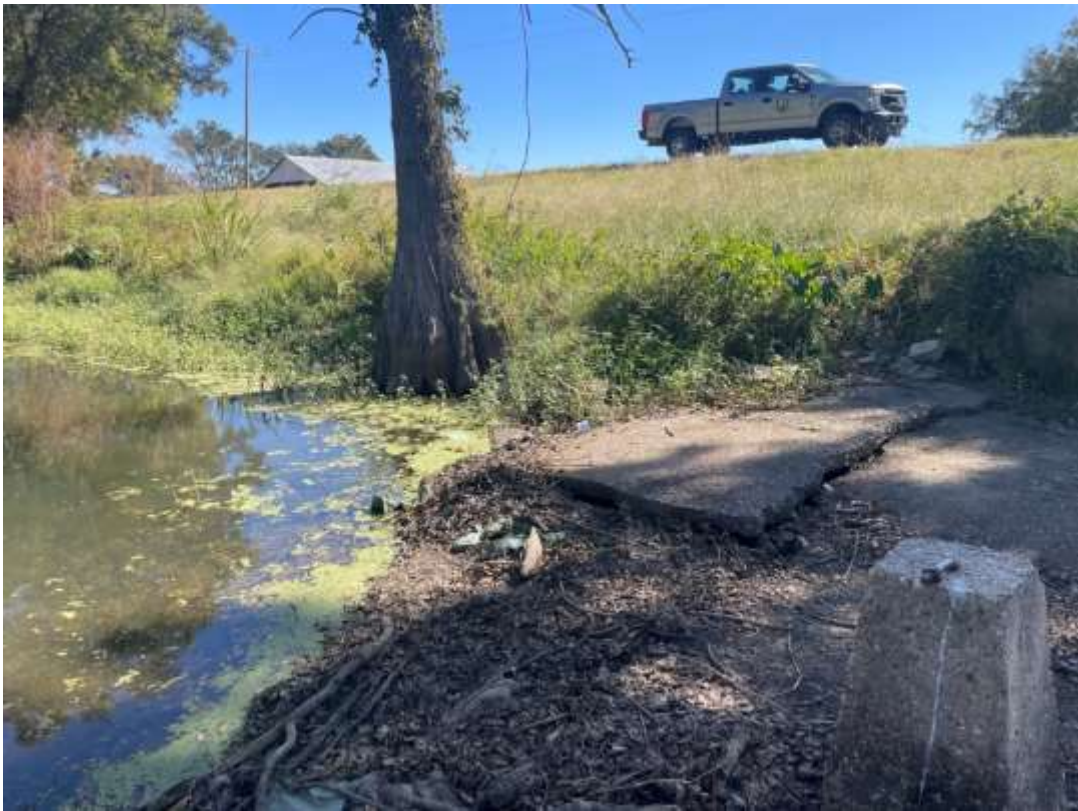
Photo B8: Downstream view across the Tensas Bayou Weir. Notice the dislodged front apron (taken by Thomas Van Biersel on 10/19/22).

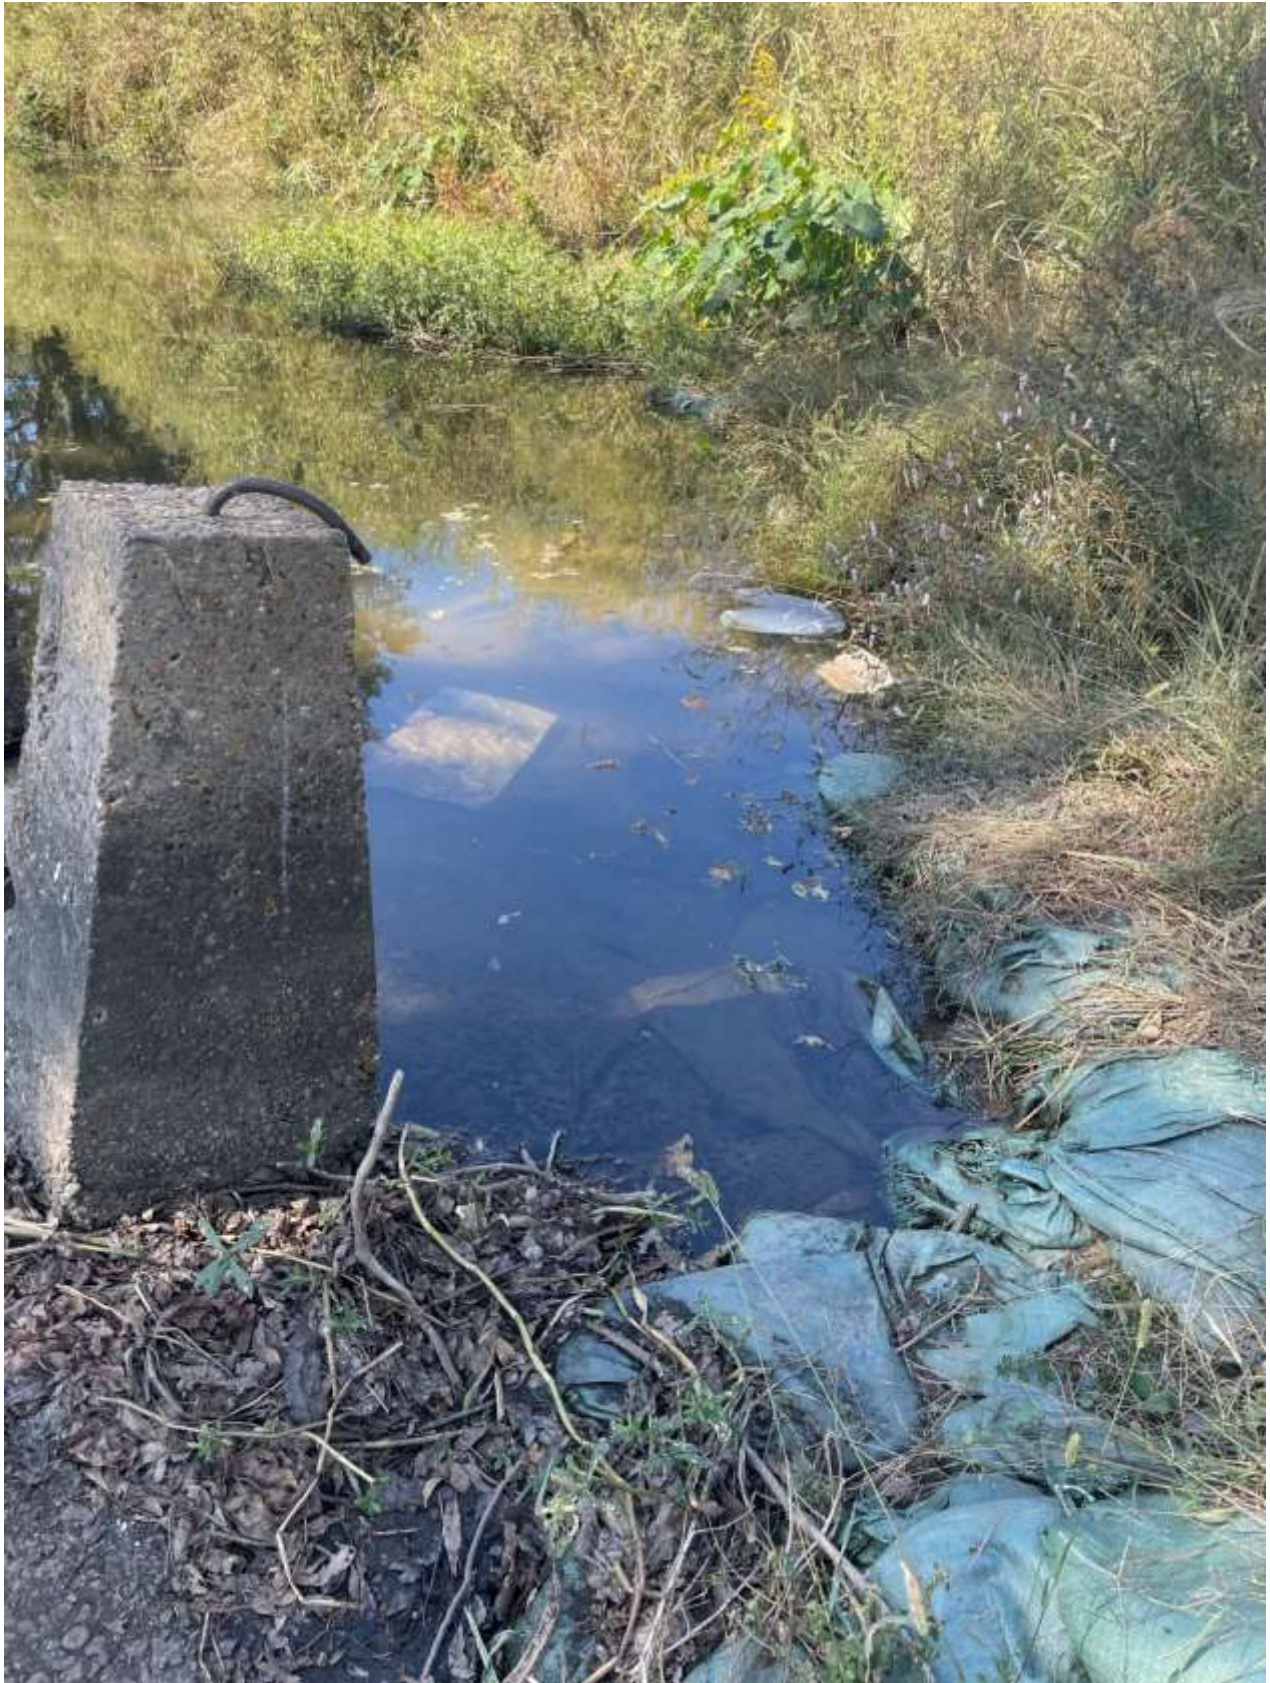
Photo B9: Downstream view across the Tensas Bayou Weir. North edge of the weir where water bypass the structure (taken by Thomas Van Biersel on 10/19/22).
