# Lake Providence Watershed Council

## MANAGING LAKE PROVIDENCE WATERSHED RESOURCES

*2023 Update*

*An Annual Report to the Louisiana Legislature*

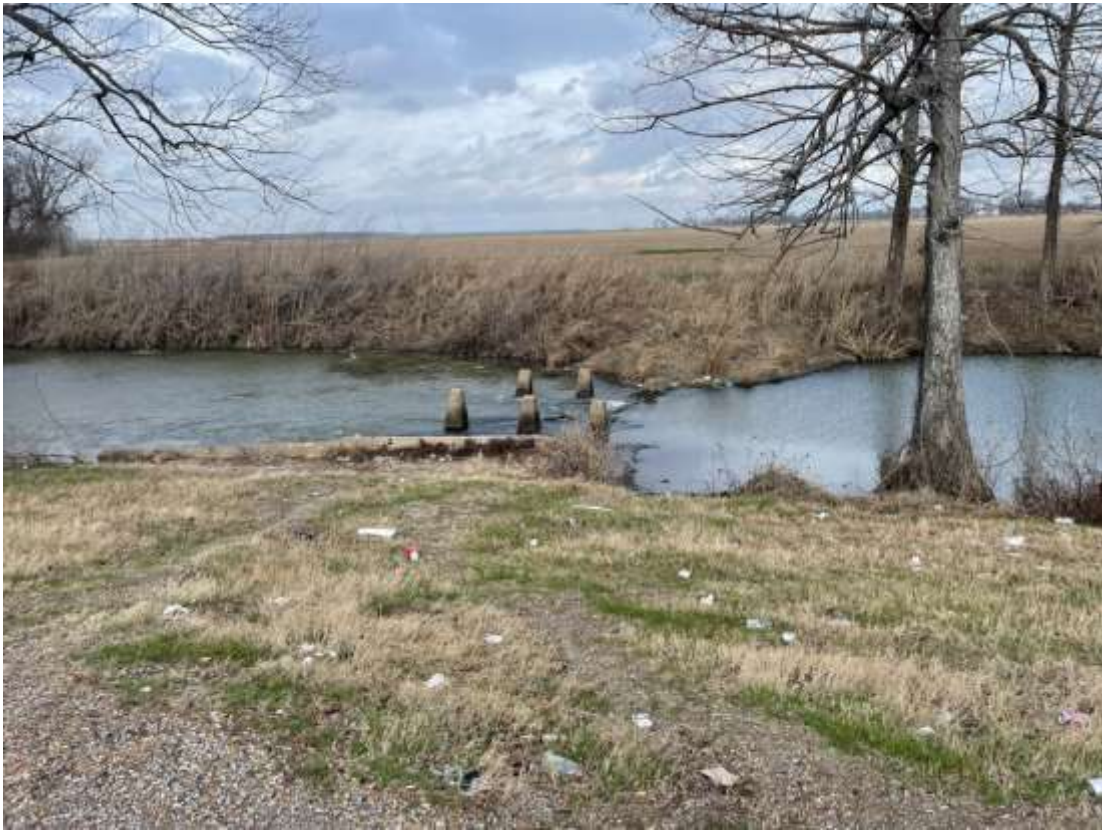
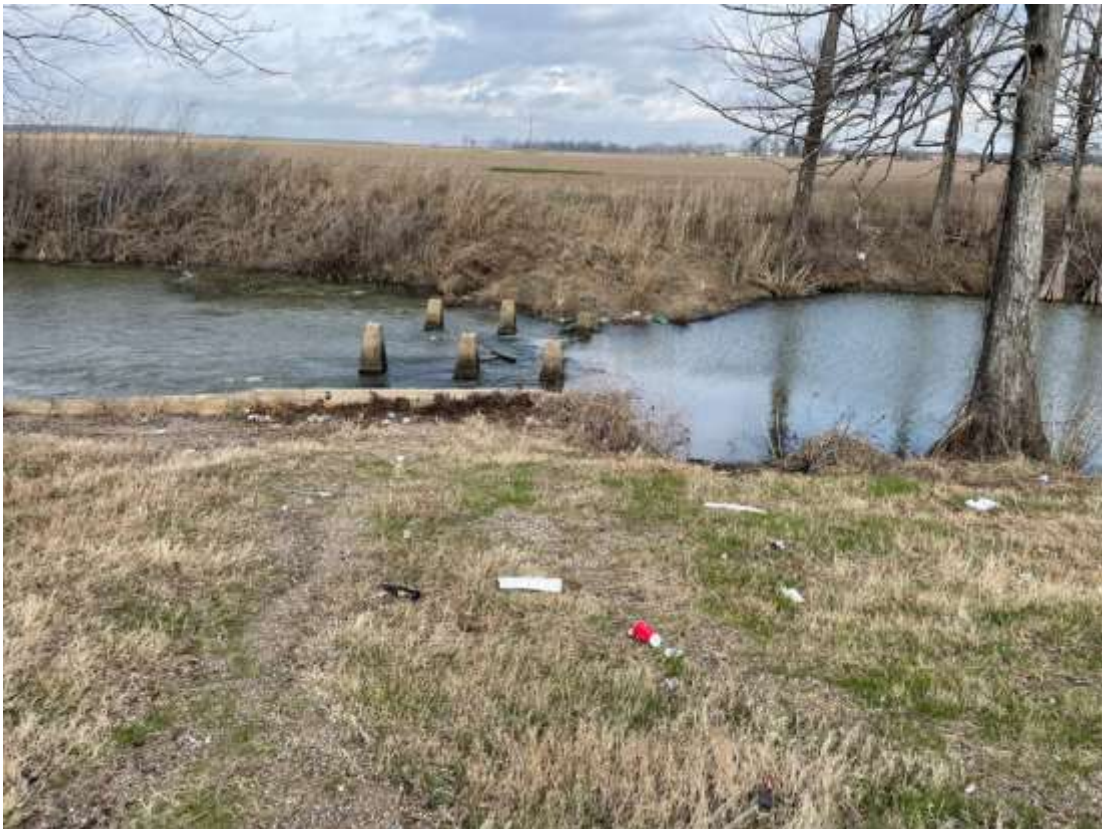
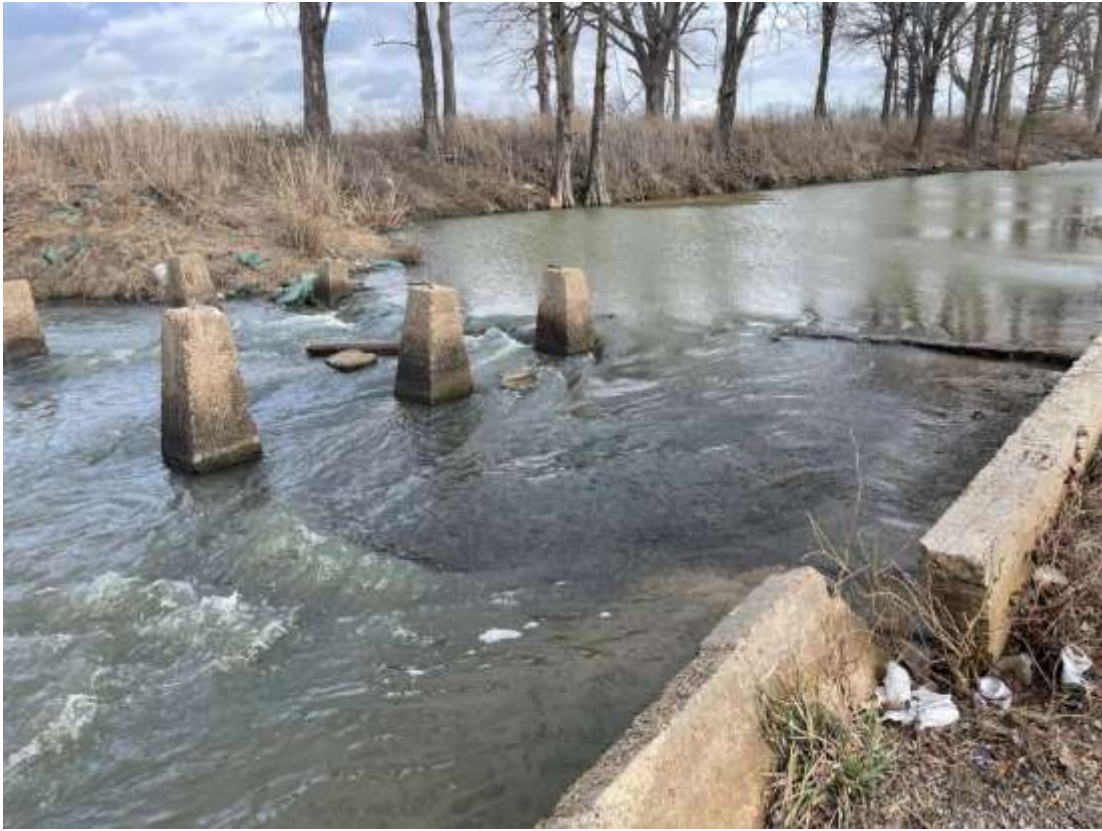
This older weir, which is the primary drain for the lake, does not allow for lake level manipulation (Appendix B). It is in disrepair and being bypassed along its side and underneath its base. In the past, the East Carroll Parish Police Jury has placed cement bags on the structure to maintain its integrity. The East Carroll Parish Police Jury has been in contact with the LDOTD and has hired an engineer to prepare plans to replace the weir. Current estimates suggest that the design work will begin in 2023.

Photo b10: View across the Tensas Bayou Weir (taken by Thomas Van Biersel on 10/19/22).

The East Carroll Parish Police Jury has been working for the past several years with the Louisiana Department of Transportation and Development to replace the weir on the Tensas Bayou. As reported in previous report, the weir built prior to 1970 to maintain the lake pool level, is in disrepair (see cover page and Appendix B) and currently being partially bypassed. Current estimates suggest that the design work will begin in 2023.

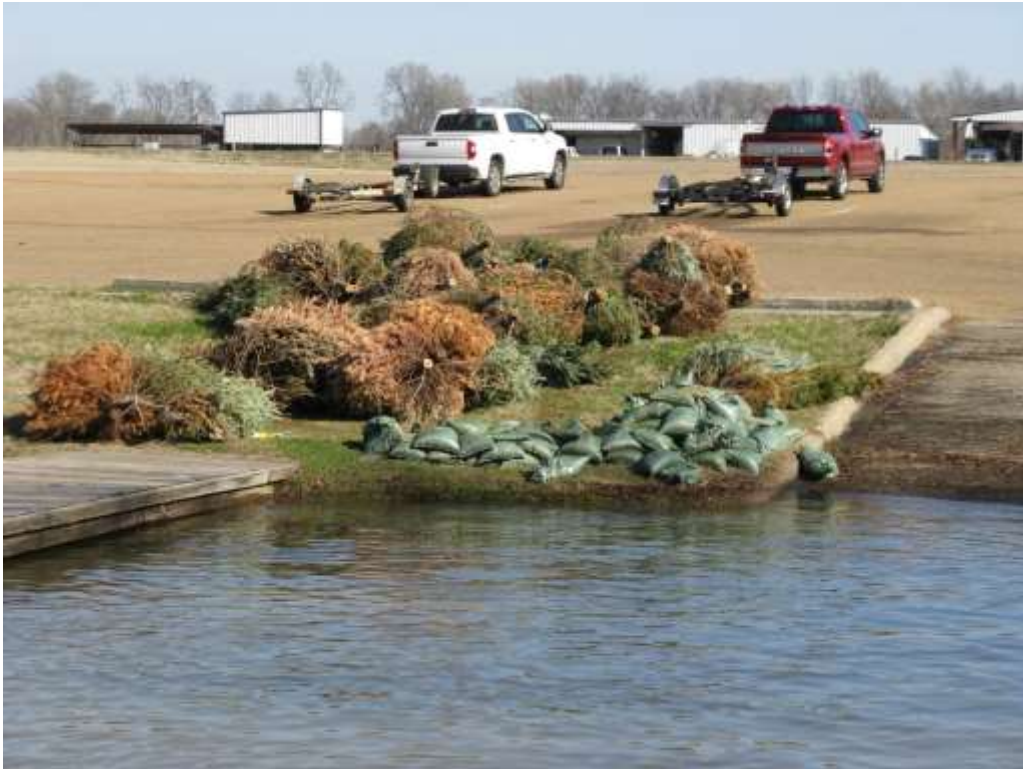
Photo C1: View of some of the tree provided by stakeholders and ballast to make aquatic reefs (taken by Ryan Daniel on 2/6/23).

On February 6, 2023, LDWF, in conjunction with the Lake Providence Bass Club, deployed approximately 100 Christmas trees in four locations (see Appendix C). The tree reefs are intended to provide much needed shoreline and near-shore cover for various sport fish species in LP. The shoreline trees serve as desirable protective cover for young fish, especially recently hatched fry and fingerlings. The absence of native aquatic vegetation in LP makes any additional cover more important for the survival of several species, including Largemouth Bass, crappie, and bluegill. The near-shore reefs are attractive to both young and adult bass and crappie and provide convenient areas for anglers to fish.

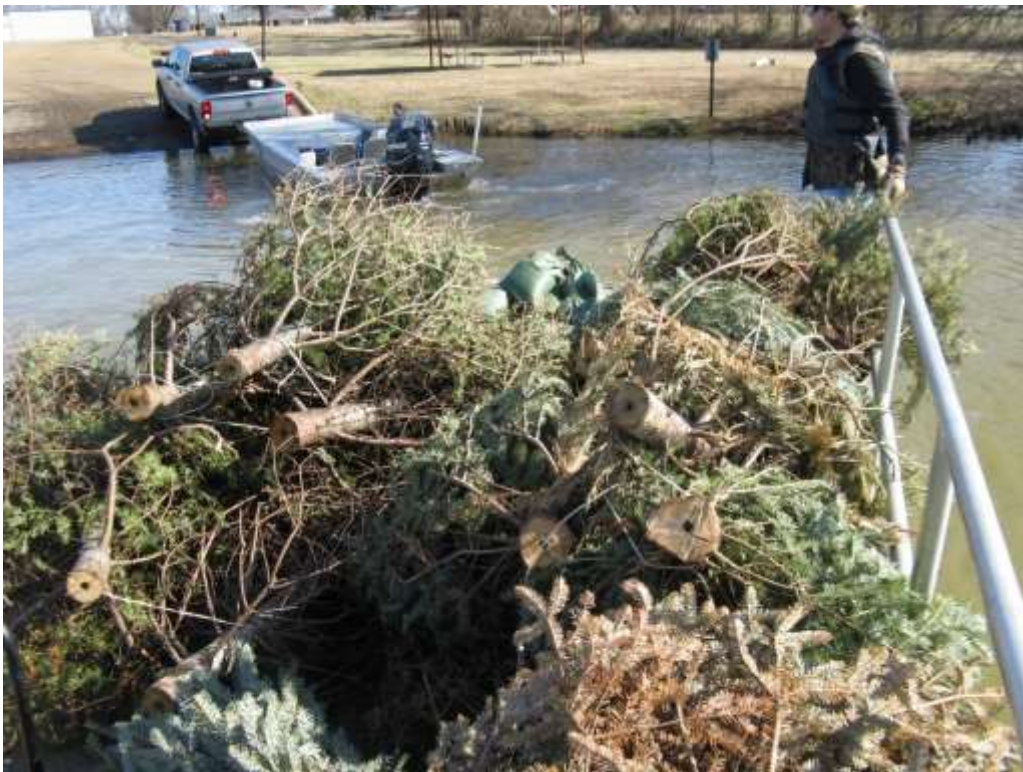
Photo C2: Loaded tree and ballast to make aquatic reefs (taken by Ryan Daniel on 2/6/23).

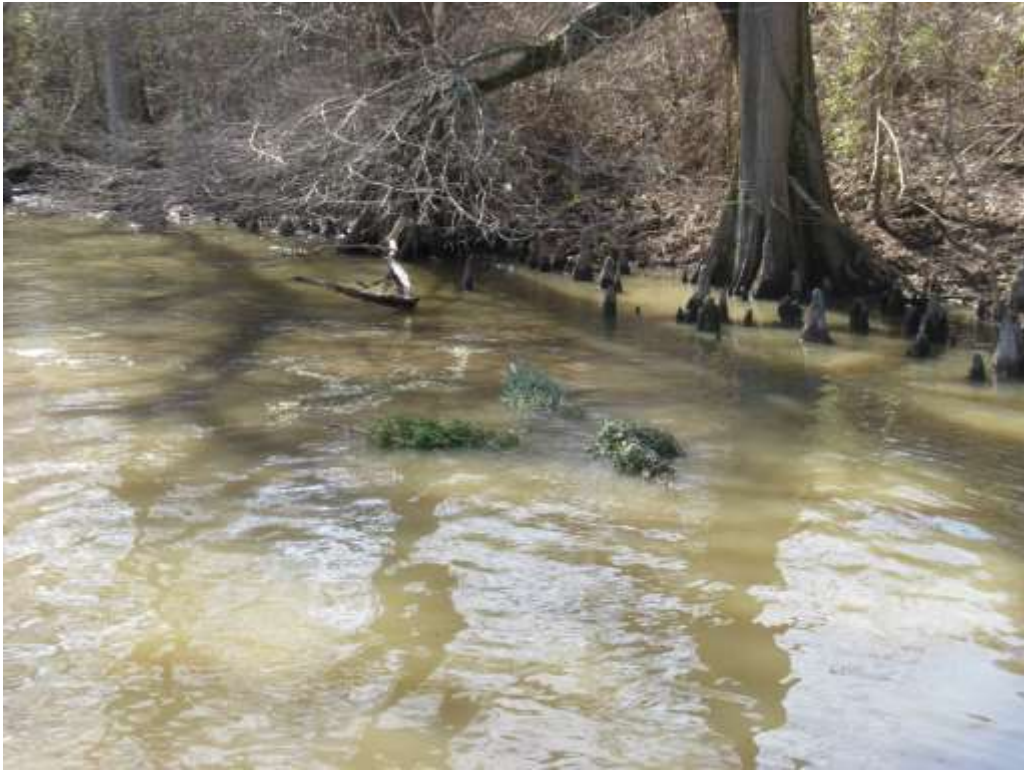
Photo C3: Christmas tree aquatic reef (taken by Ryan Daniel on 2/6/23).
