Lake Providence Watershed Council

MANAGING LAKE PROVIDENCE WATERSHED RESOURCES

An Interim Report to the Louisiana Legislature

April 2016

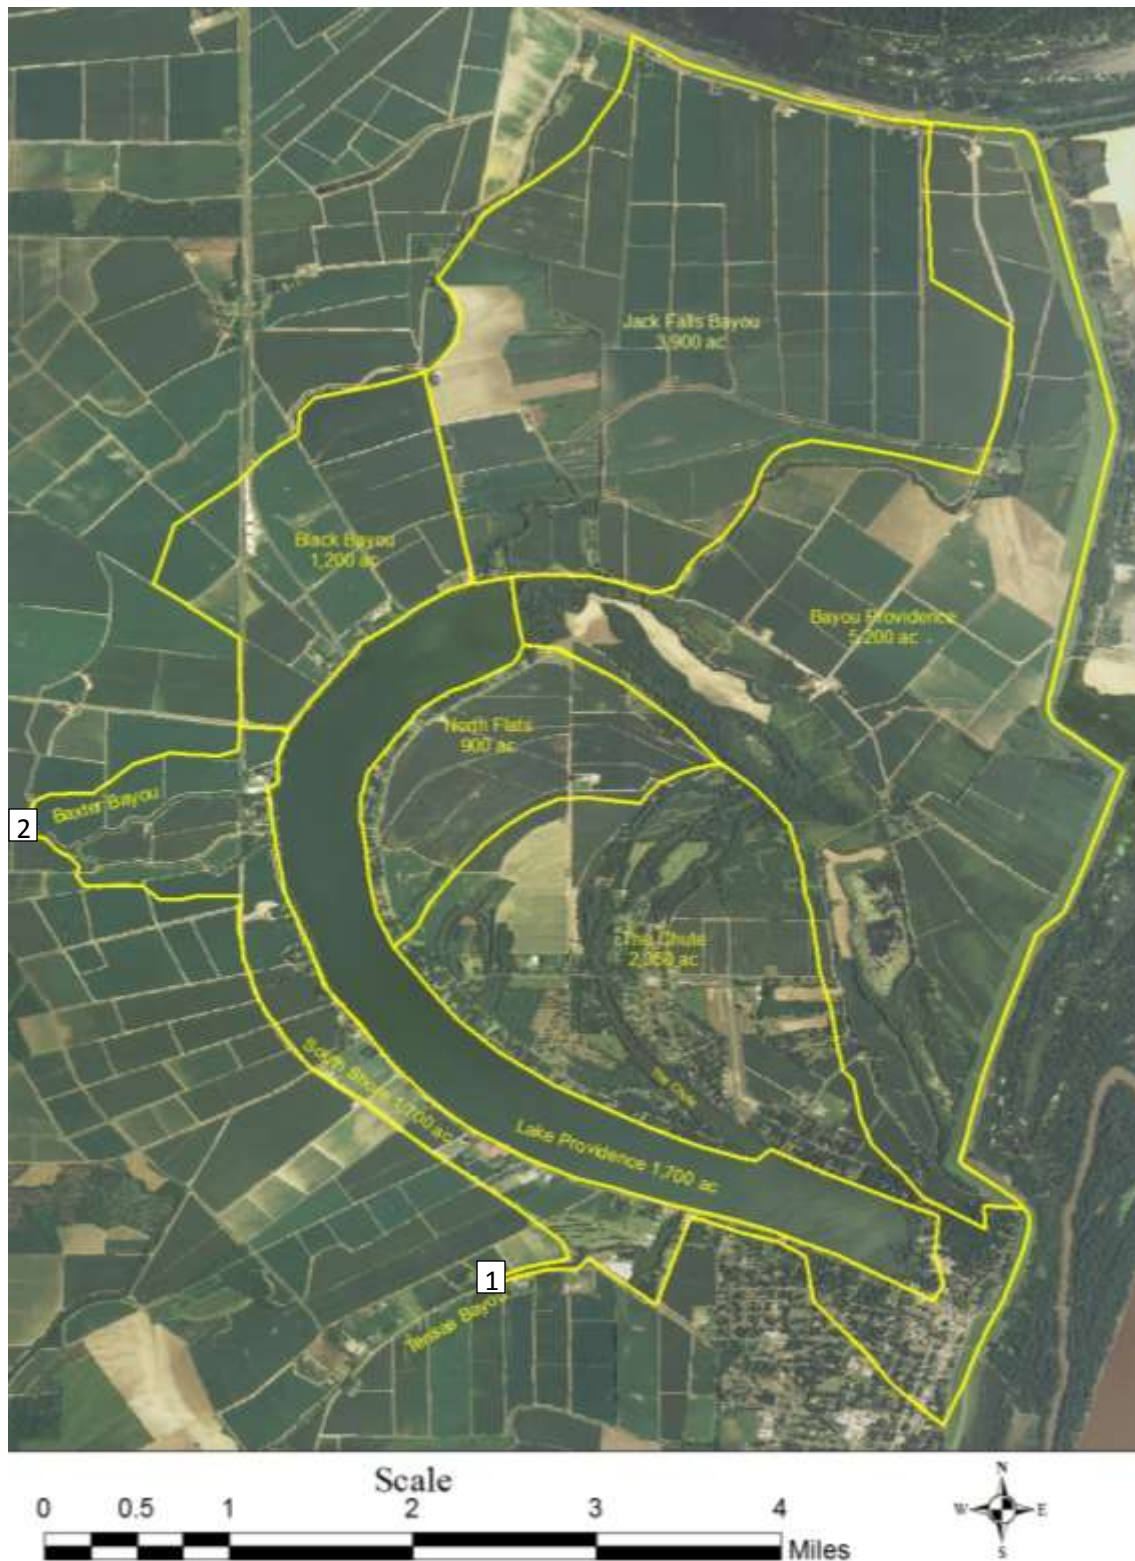
Figure 3: Lake Providence Watershed.

Notes: The yellow lines represent the sub-basin draining into Lake Providence. Box #1 locates the Tensas Bayou structure and box #2 the Baxter Bayou structure.

Alterations along this oxbow lake, and past and on-going activities within this oxbow lake’s watershed have resulted in deterioration of the water quality, aquatic vegetation and fisheries. The approximate extent of the Lake Providence watershed is shown on Figure 3.

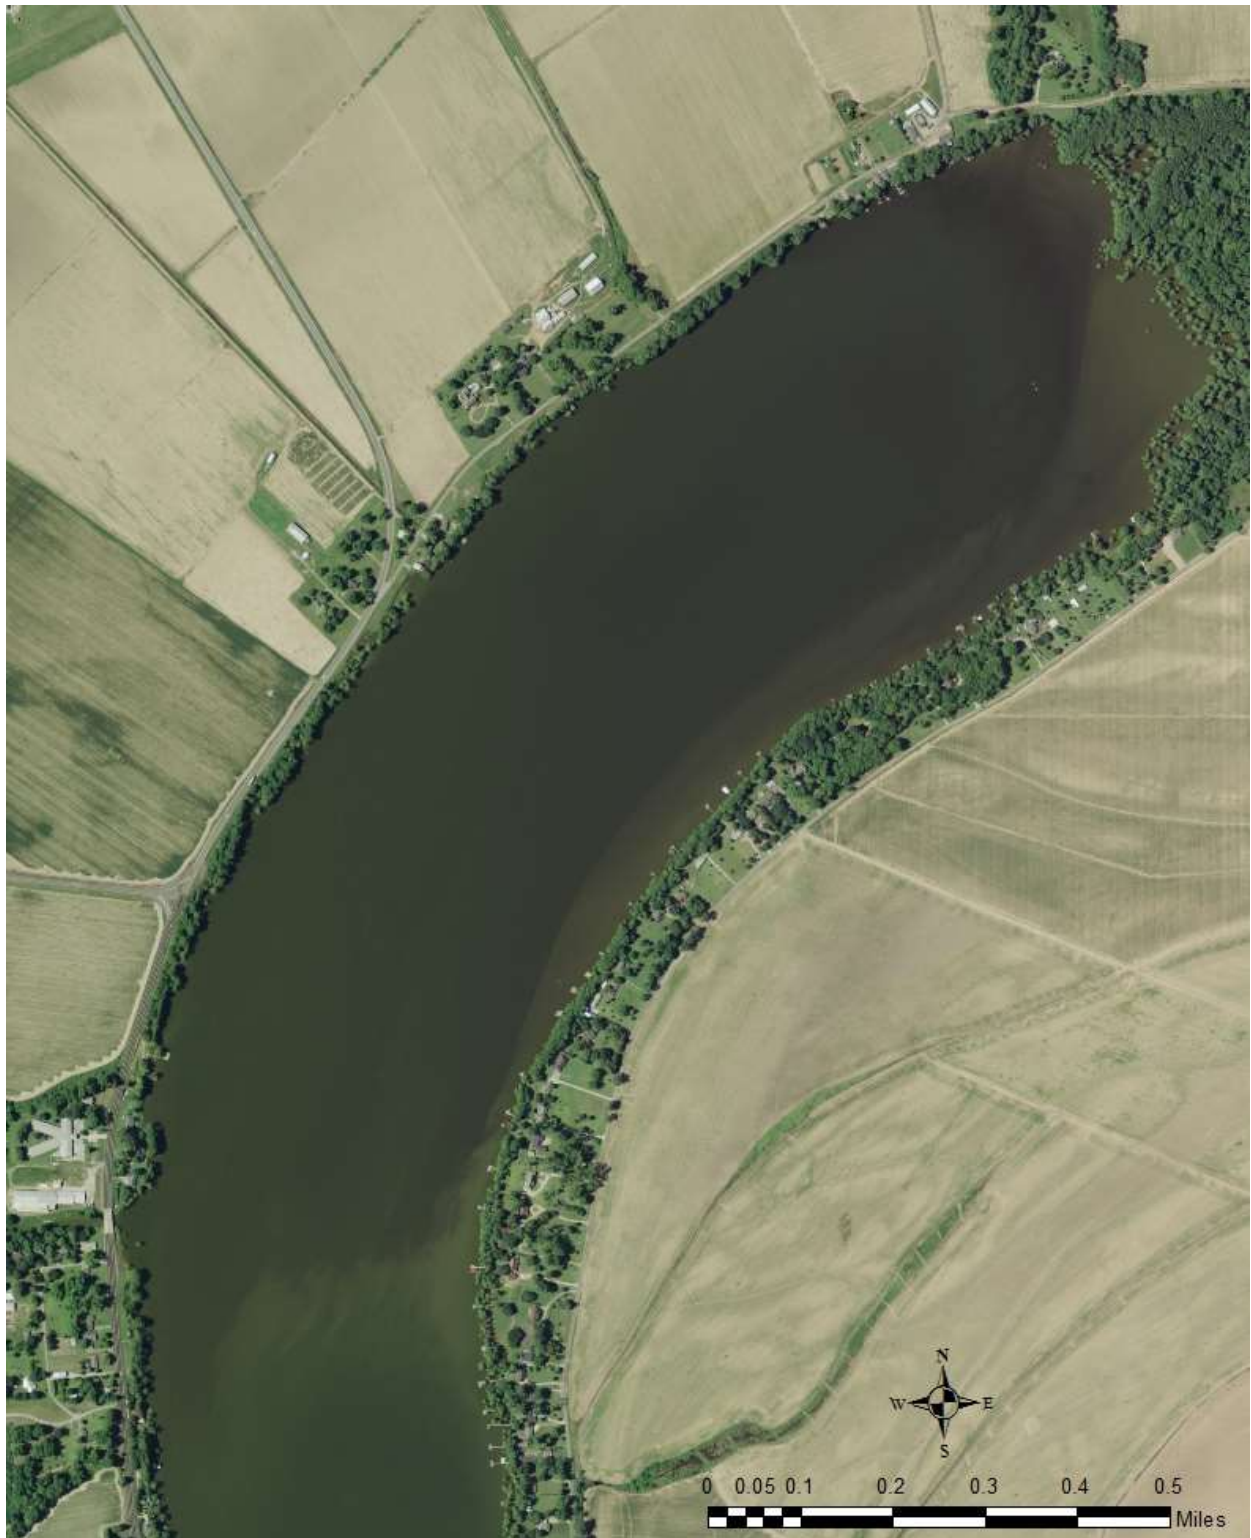
Figure 4: Suspended solids discharging into Lake Providence's North Flat on 12/30/2010.

Source: December 30, 2010 NAIP aerial imagery.

The storm water that enters the north flat of the lake has been identified locally as the worst culprit (i.e. bringing in the most sediment - Figure 4). Local farmers have improved their drainage efficiency over the years and water now drains at a much faster speed. The north end of Lake Providence has had large deposits of silt over many years creating an average water depth of 2 to 3 ft of which was 4 to 5 ft deep 30 years ago. If the same process continues, eventually the north flat will become choked with sediment and emerging vegetation.

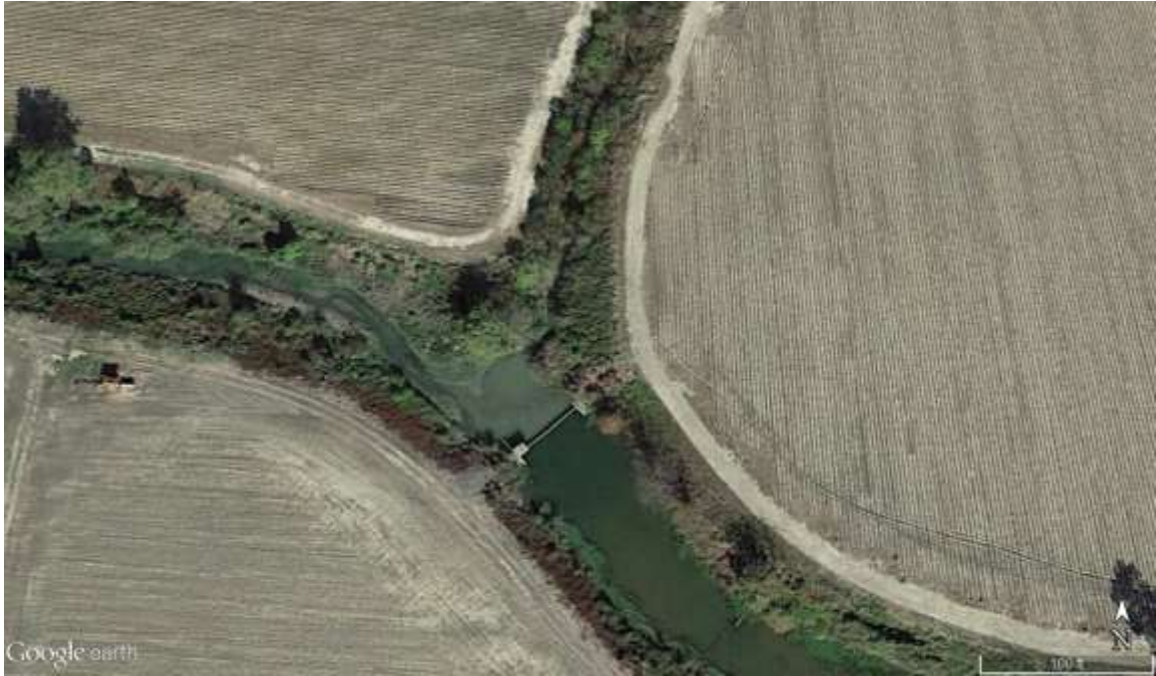
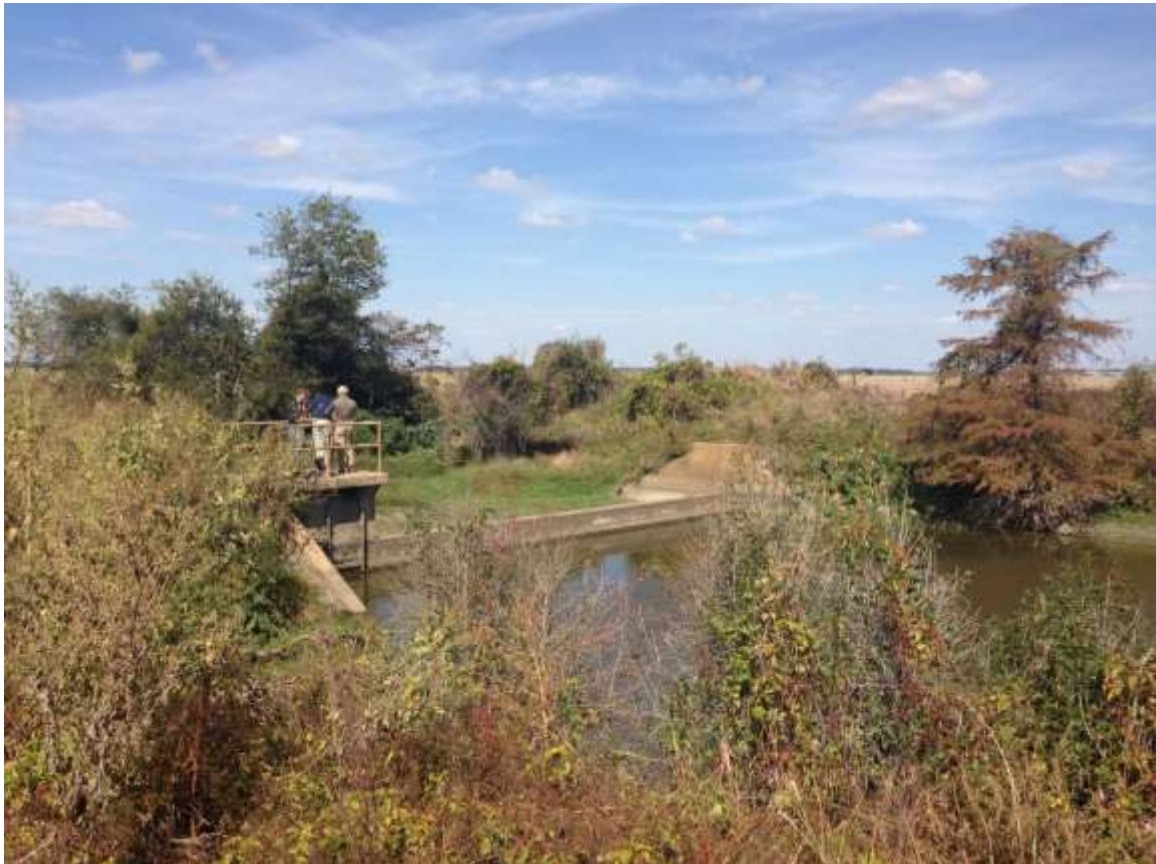
Figure 8: Baxter Bayou control structure.

Notes: The Google Earth™ photograph (top) was taken on 11/15/12; the profile view (bottom) of the structure on 10/21/15

The lake has two outlets equipped with structures (Appendix B), Tensas Bayou (Figure 7) and Baxter Bayou (Figure 8). Anecdotal information by local stakeholders suggests that the structure on Baxter Bayou only allows water to flow out of the lake at high stage, otherwise reverse flow can occur at time of unevenly distributed precipitation. Prior to 1923, Baxter Bayou discharged into the lake. In 1923, Baxter Bayou was dredged to reverse the flow direction; it now flows toward Caney Bayou. The structure on Tensas Bayou is a weir that had been redesigned in 1975, but never replaced (Appendix B). Neither structure allows for lake level manipulation, both are in disrepair and both are being bypassed at higher flow. The U.S. Geological Survey (USGS) data collected at Baxter Bayou shows that during their one and a half year study, flow reversed direction (negative discharge) approximately eleven times (Figure 9).

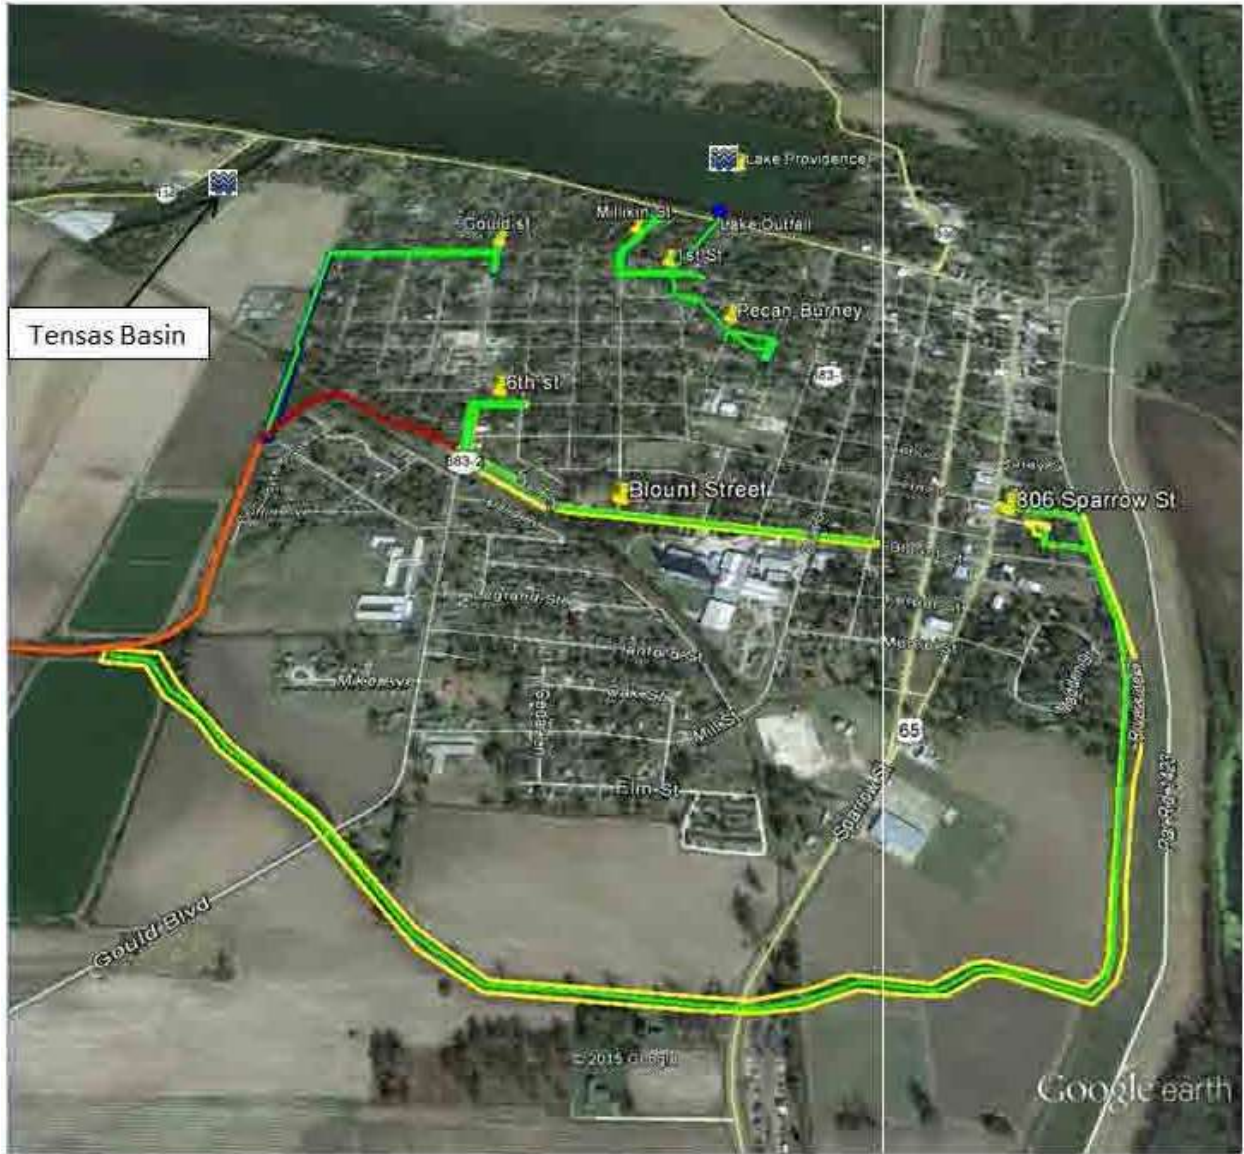
Figure 35: Proposed drainage improvements within and around the town of Lake Providence.
 Source: FEMA, 2015.

- Seven (7) Project Sites (📍)
- Drainage Improvements (—)
- FEMA Project Area (—)
- CDBG Project Area (—)
- DOTD L-25A Canal project area (—)
- DOTD project path to Hwy 3181 (—)

As the 2015 FEMA draft assessment indicates modifications to the control structure and drainage networks requires a scientific understanding of the hydrologic response of the watershed to storm event. Without this information it is difficult to develop a lake level management plan.

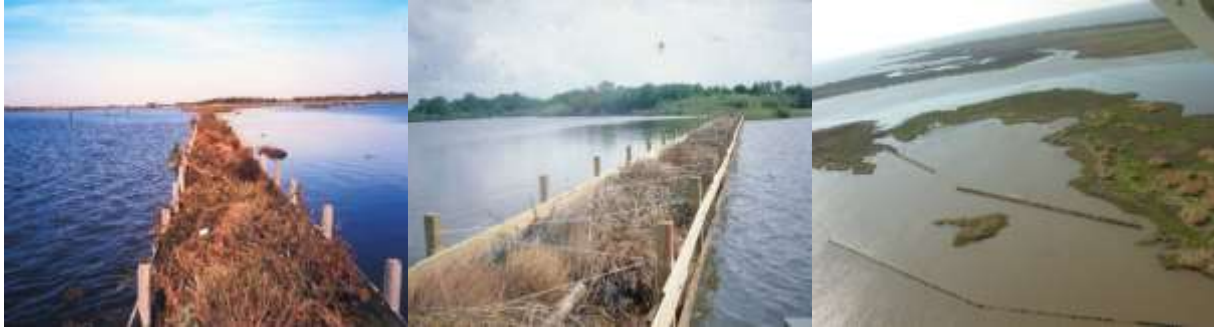
Figure 36: Examples of shoreline mitigation treatments

- (1) placement of a debris fence (commonly referred to as Christmas tree fences), these are easy and relatively inexpensive to construct and can be very effective in removing wave energy from the shoreline (Figure 36). These structures could be built seaward of the bulkhead, approximately 10-15 yards in front to remove the wave energy from the

bulkhead. They also have the potential to create a fish habitat that currently does not exist. These fences have been used for many years by coastal parishes in their coastal restoration efforts. The debris fences allow water to filter through while eliminating the wave energy.

Shoreline modifications are common along private shoreline, in the form of shoreline hardening and bulkheads. The vertical aspect of bulkheads causes erosion, turbidity and wave within the lake. Mitigation of wave energy from vertical bulkheads can be accomplished by multiple methods including the following treatments:
