PROJECT MEMORANDUM

PROJECT: LDNR – Abandoned Site – Hwy. 3015 (east of Smyrna Road) in DeSoto Parish, LA

SUBJECT: Hallwood Petroleum – Mason #1 (Serial Number 158546); Section 27; T13 North; R15 West
Project Entrance Coordinates: 32.090039; -93.885934

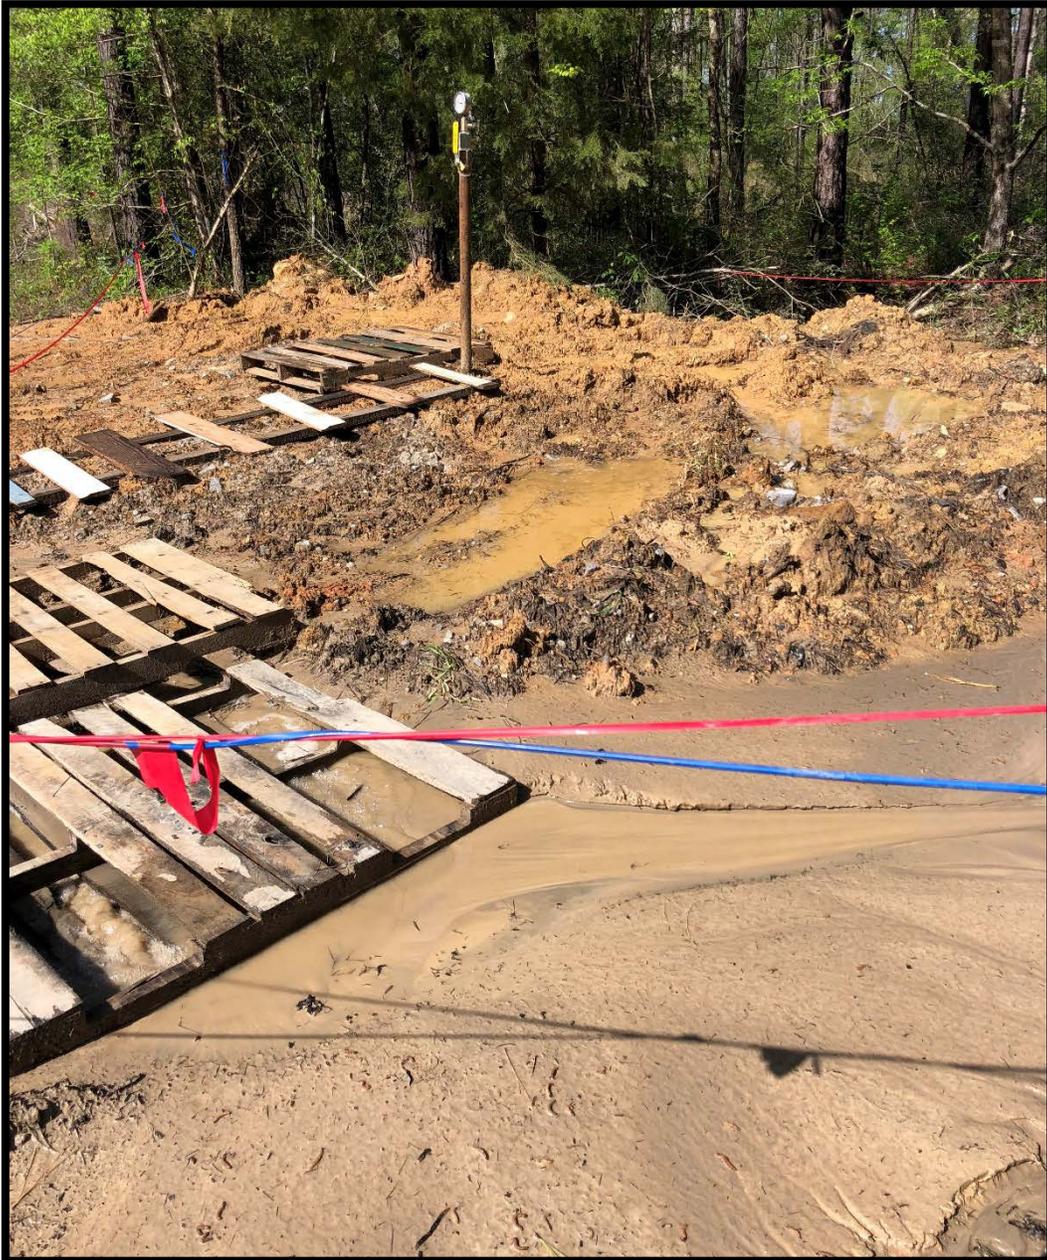
Photo #: 8374 – Photo Date: 3/29/2018 – Photo Time: 10:49am – Photo By: Mark S. Moore
GPS Points 207 – 211
Sample Points for: S1, W1 & A1
View Generally to the West
Surface Sediments from the Bubbling/Aeration Action
at/near Steel Well Riser for Abandoned Well (Serial Number 158546)

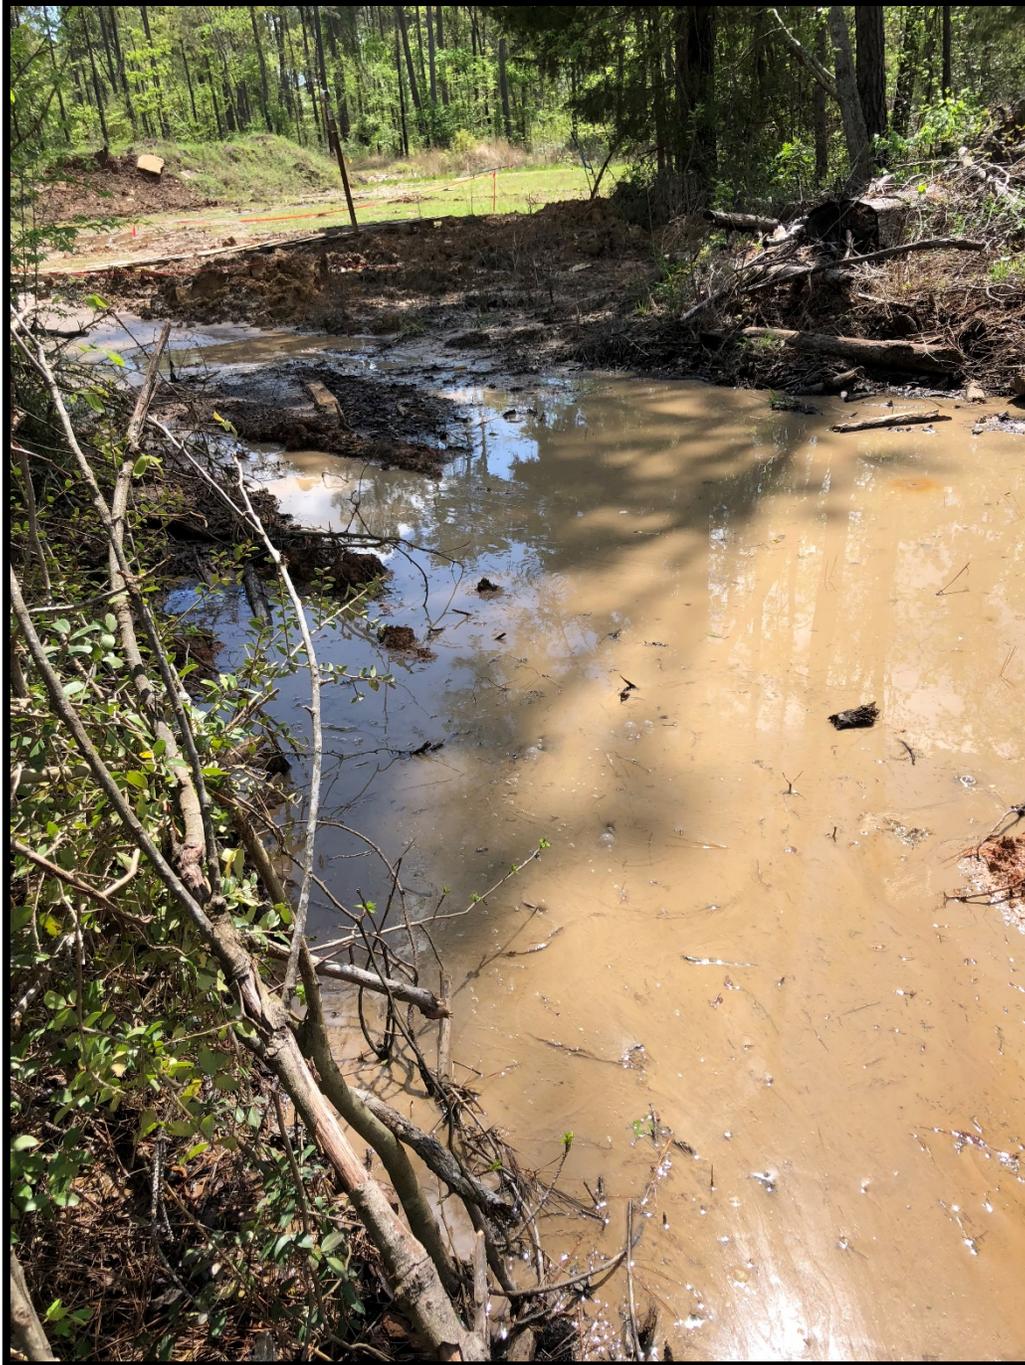
Photo #: 8394 – Photo Date: 3/29/2018 – Photo Time: 2:06 pm – Photo By: Mark S. Moore
Between GPS Points 211 & 212

View Generally to the Southeast from near GPS Point 212

Light Brown Surface Sediments from the Bubbling/Aeration Down-Gradient (topographically)
from GPS Points 207 & 208 at/near Steel Well Riser for Abandoned Well (Serial Number 158546)

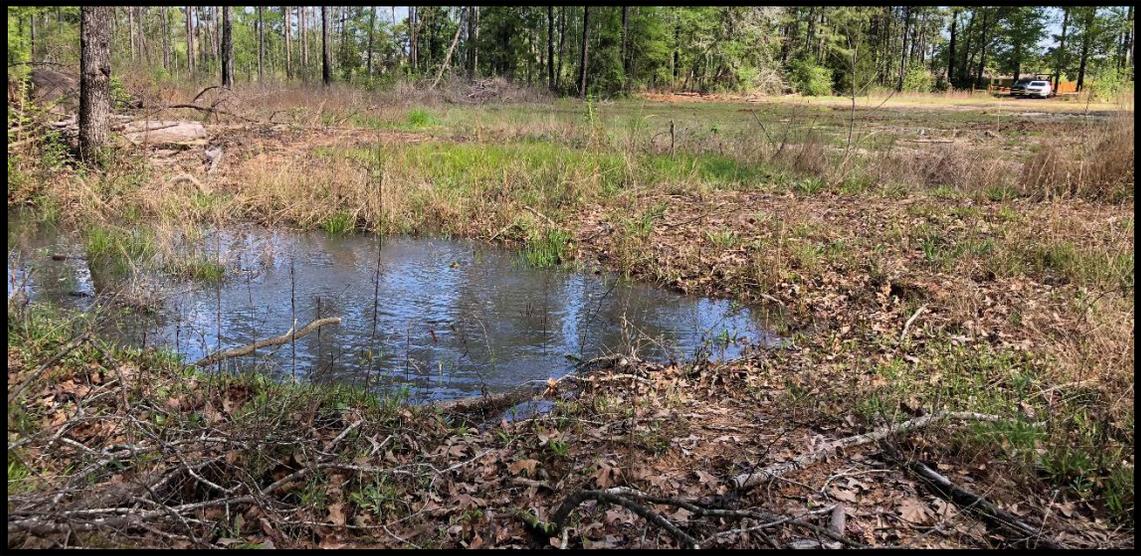
Photo Number 8378 – Photo Date: 3/29/2018 – Photo Time: 11:24 am – Photo By: Mark S. Moore
GPS Points 214, 216, 217, 238

Photos Shows Sample Point W2 and Surface Water with Bubbling Throughout
View Generally to the North-Northeast

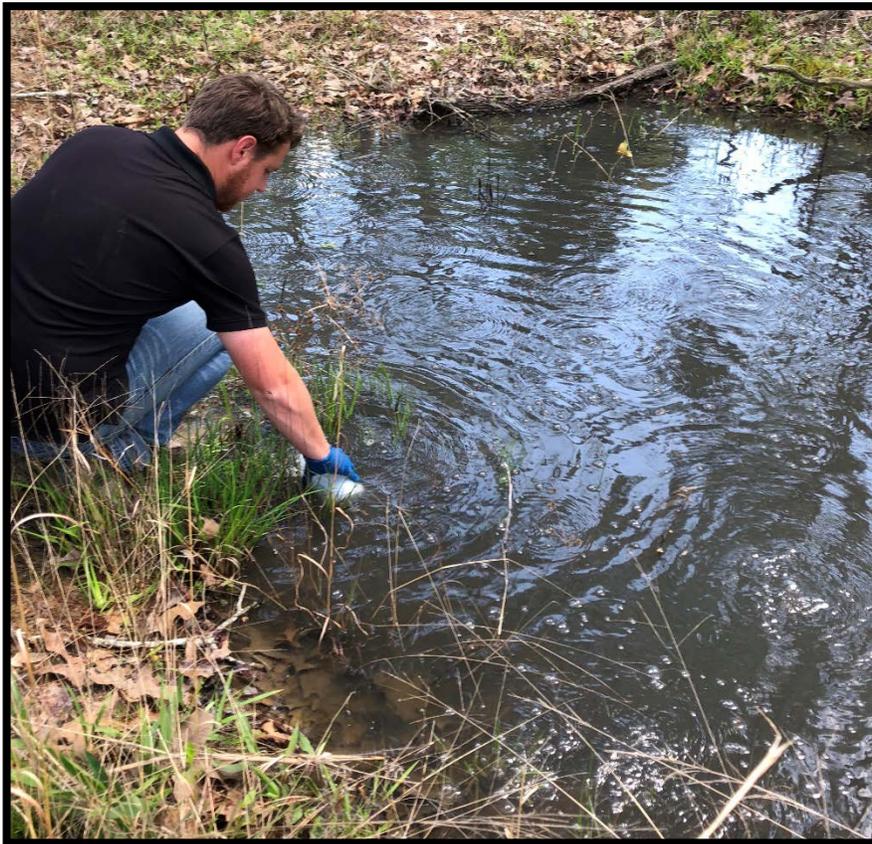
Photo #8403– Photo Date: 3/29/2018 – Photo Time: 2:40 pm – Photo By: Mark S. Moore
GPS Point 214

Photo Shows Sample Point W2 and Bubbling in the Surface Water
View Generally to the Southeast

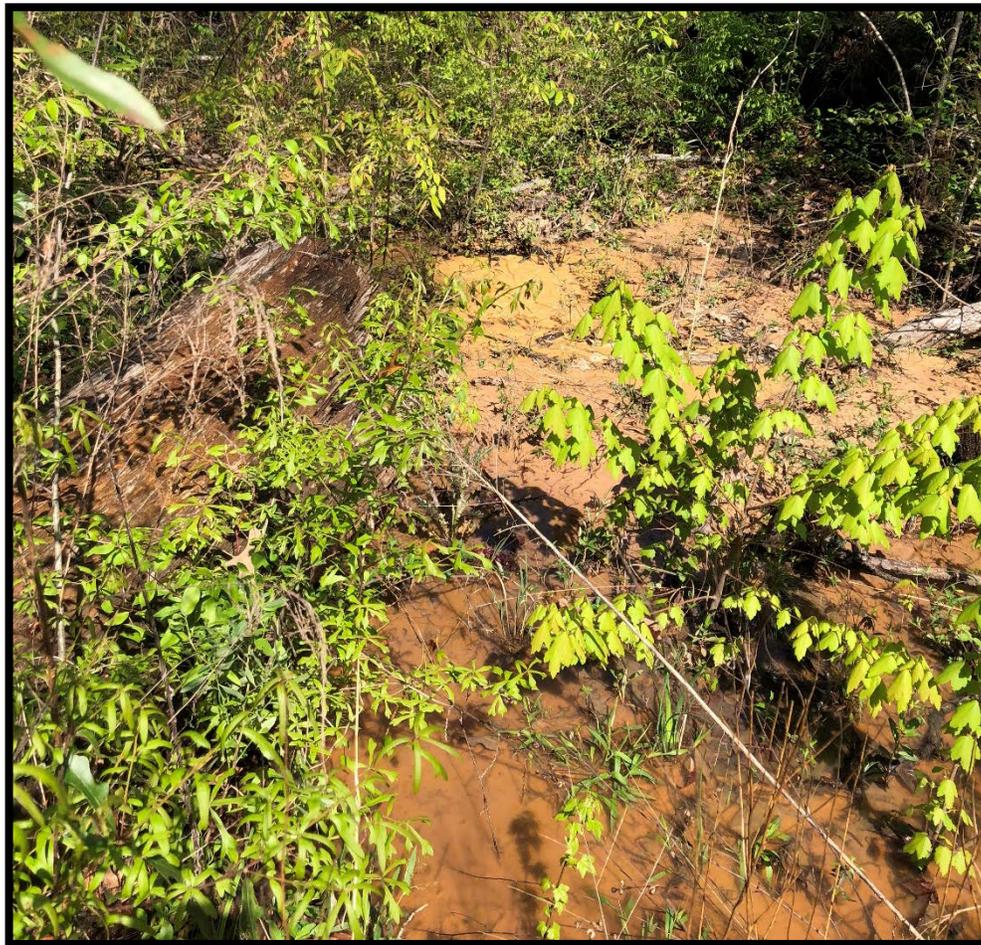
Photo #8380– Photo Date: 3/29/2018 – Photo Time: 11:25 am – Photo By: Mark S. Moore
Photo Shows GPS Point 215 & Sample Points S3, W3 & A2; Light Brown Sediments From the Bubbling Action

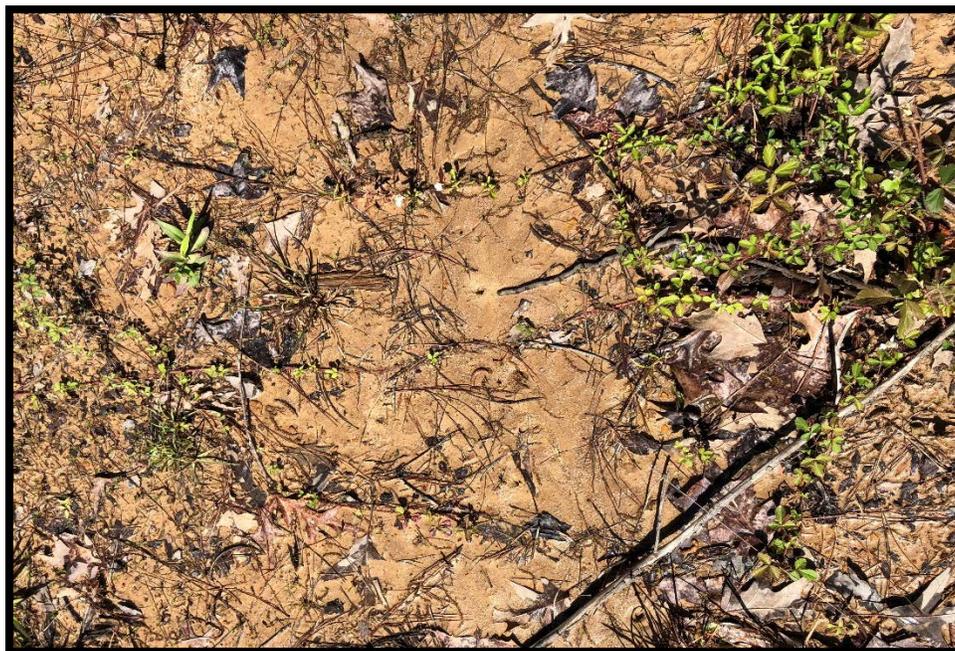
Photo #8383– Photo Date: 3/29/2018 – Photo Time: 11:31am – Photo By: Mark S. Moore
Photo Shows Bubble/Air Holes from the Bubbling Action Near GPS Points 223, 224 & 238

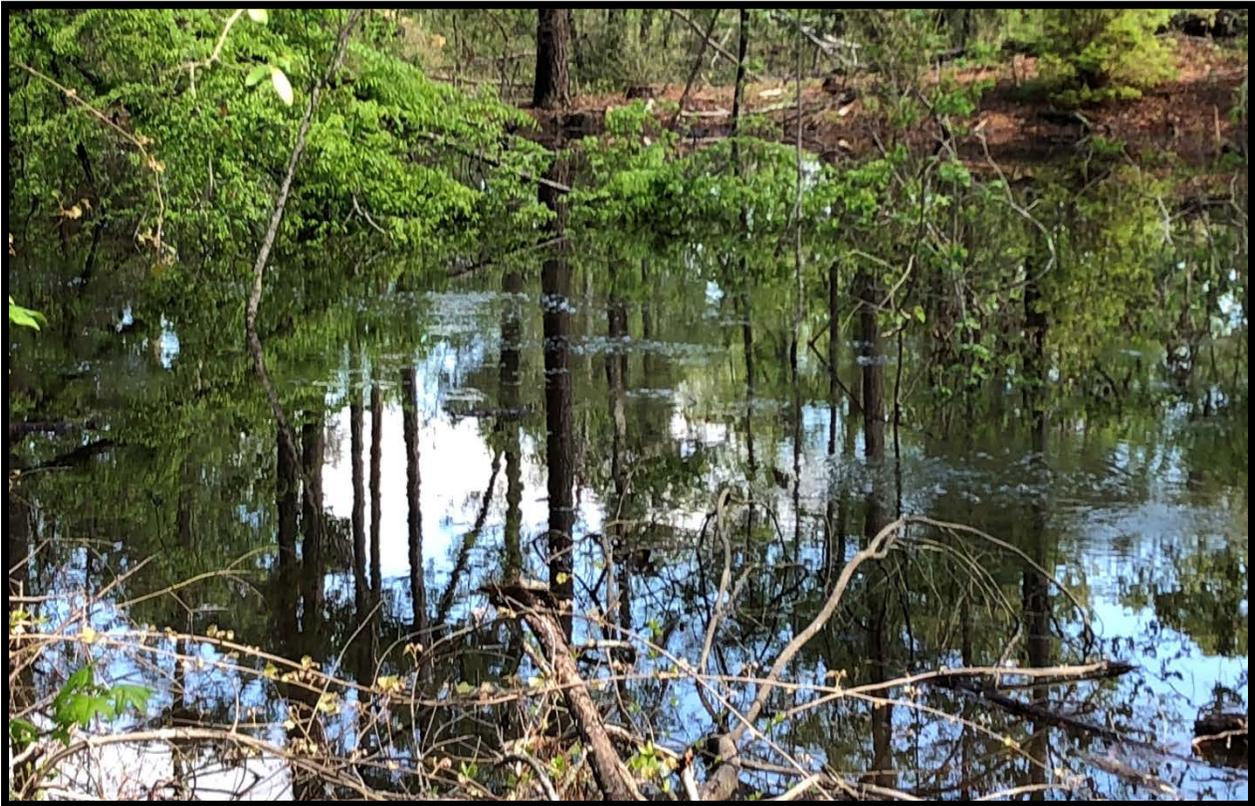
Photo #8375– Photo Date: 3/29/2018 – Photo Time: 11:10am – Photo By: Mark S. Moore
Photo Shows Gas/Air Holes in the Pond Approximately 240' Southeast of Water Sample W2 and GPS Point 214

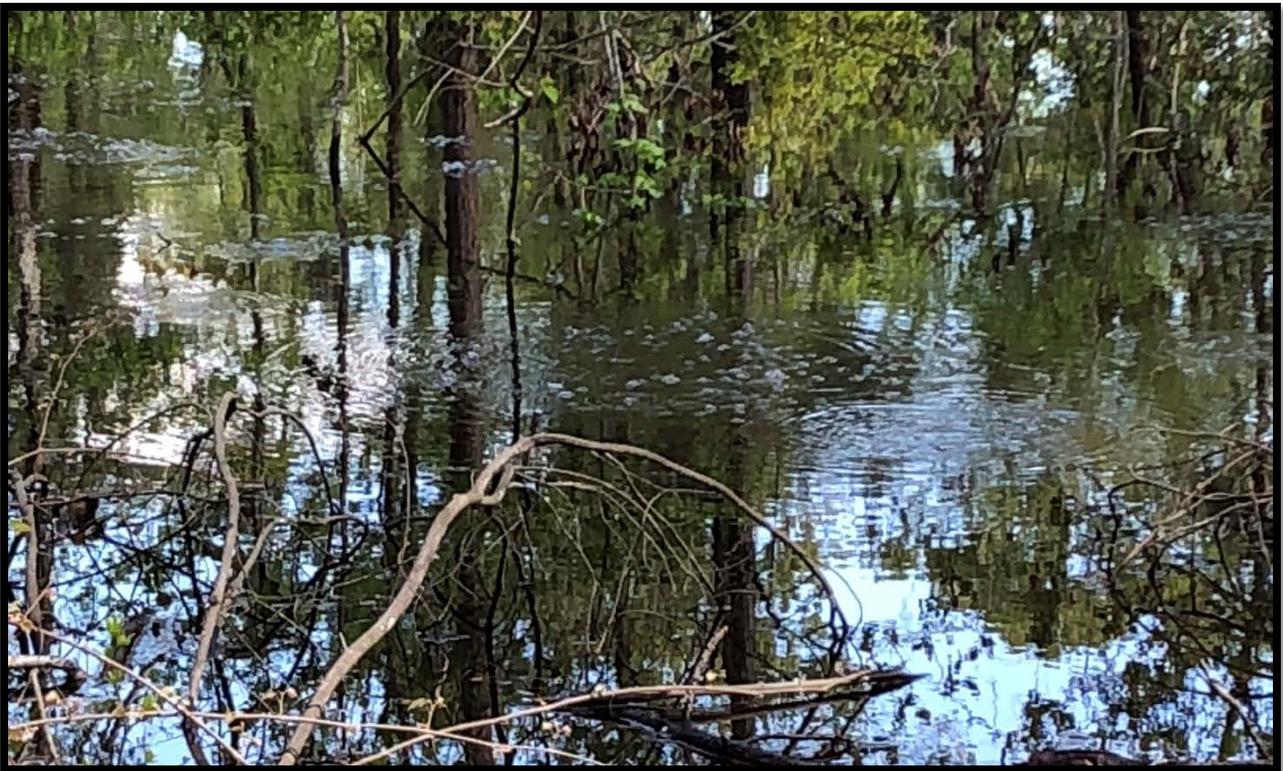
Photo #8376– Photo Date: 3/29/2018 – Photo Time: 11:10am – Photo By: Mark S. Moore
Photo Shows Gas/Air Holes in the Pond Approximately 250' Southeast of Water Sample W2 and GPS Point 214
