Lake Providence Watershed Council

MANAGING LAKE PROVIDENCE WATERSHED RESOURCES

2022 Update

An Annual Report to the Louisiana Legislature

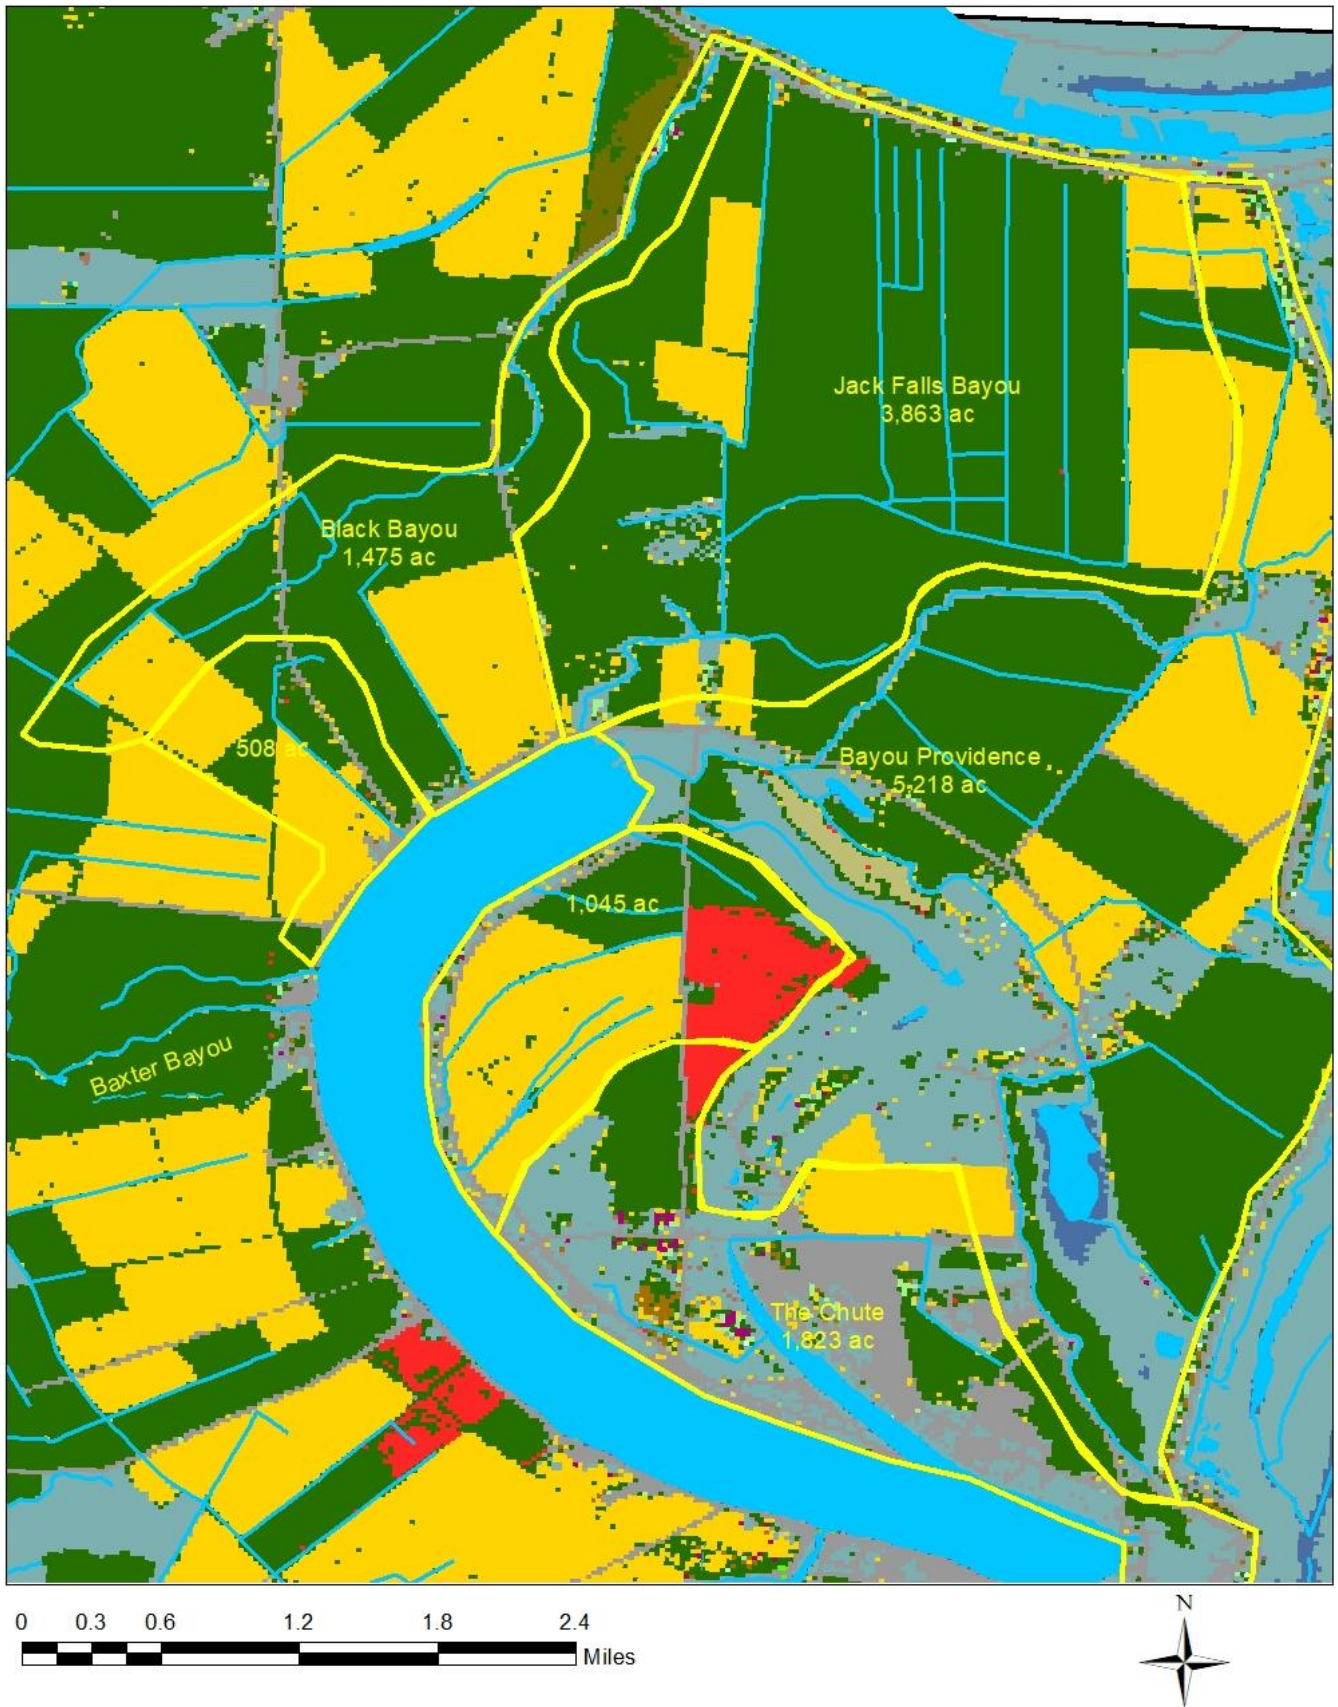
Figure 1: Lake Providence subbasin. Colored in yellow are field planted in 2021 in corn, in green soybeans, and in red cotton. All other areas represent undeveloped or developed land and open water (data: USDA CropScape)

In view of the series of high rainfall events during this past year, one of the most imminent threats to the viability of the lake is the massive intake of water at the north end from Jack Falls Bayou (Figure 1). Due to the fact that many acres of agricultural land drain through the lake from this source, silt is being deposited at an alarming rate. In 2021, for the first time substantial areas of silt bar were exposed for an extended period allowing for the germination of plants. LPWC also acknowledges that resolving this concern is costly and time consuming. However, it is vital if we are to continue enjoying the lake as we know it. Possible remedies that have been discussed are diversion to another flood plain, pumping into the Mississippi River, a sediment reservoir before entering the lake, and dredging of the lake.

Until the water drainage into the north end of Lake Providence is addressed there will be continued muddy waters entering the lake and siltation on the bottom of the lake. This occurring over an extended period of time will lead to a huge sand/mud bar covering many acres across the north end of Lake Providence.

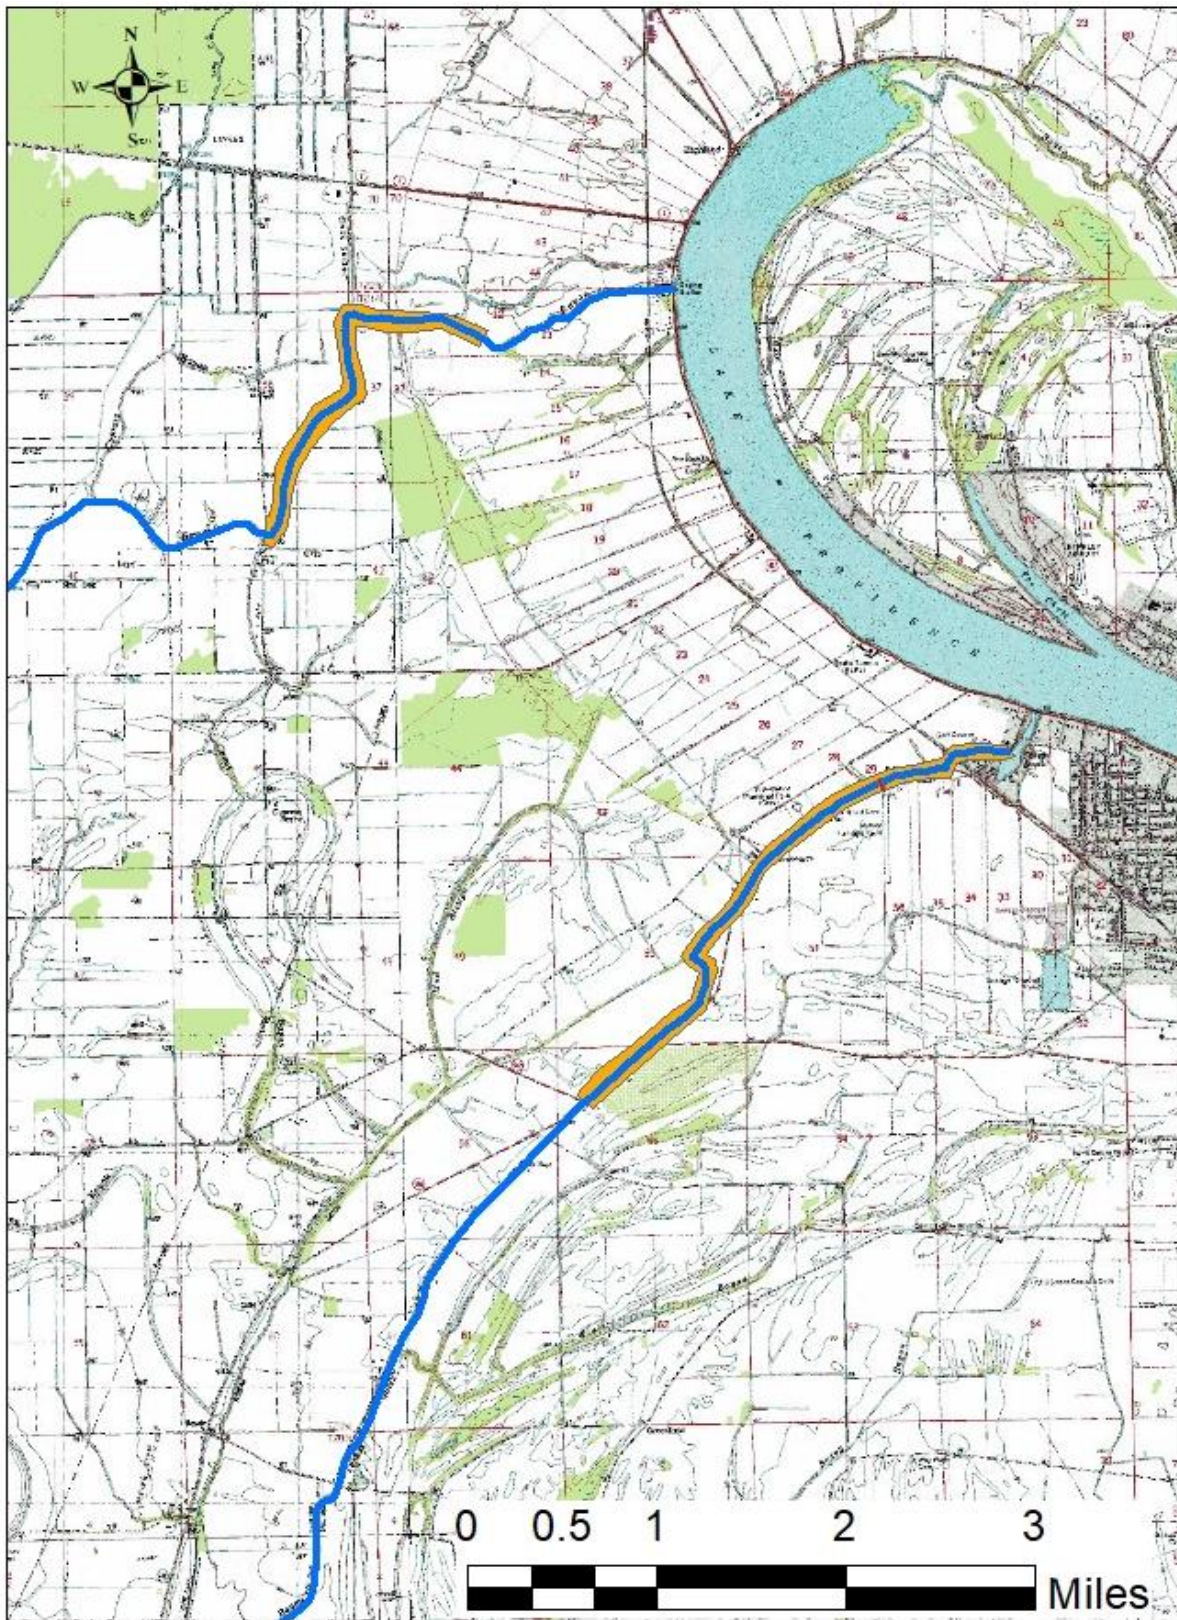
Figure 2: Areas of Baxter Bayou and Tensas Bayou that were cleared this past year (shaded in yellow along the bayous).

During the second half of September 2021, the East Carroll Police Jury hired a private contractor to clean out Baxter Bayou. They started at Cotton Club Road and headed back east toward the Baxter Bayou control structure (Figure 2 and see Appendix B for photographs). Once this was completed there was discussion at the Police Jury level to go back to Cotton Club Road and start cleaning the bayou westward. However, due to recent rainfall this has not happened yet. A total of 148 hours were spent clearing and snagging approximately 3.5 miles of Baxter Bayou.

The Fifth Levee District has the responsibility for maintenance of Bayou Tensas south of Hwy 582. The District sprays the trees and brush along the banks. East Carroll Parish Police Jury performs maintenance of Bayou Tensas from Hwy 582 to Lake Providence (Figure 2). This section of the river was cleared of brush and debris in 2021. Typical clearing and snagging methods include the use of large tracked vehicles (with a sawing blade at the end of a long arm) being placed in the stream channel, thus disturbing the sediment in the bed of the channel and leading to increased sediment loading in the channel. Both the removal of the vegetation and the movement of the equipment in the channel tend to lead to bank destabilization and erosion. Typically use of the sawing blade causes woody/vegetative debris and sawdust to be deposited in the channel. The resulting sediment, debris, and sawdust can then be deposited downstream, potentially leading to flow impediments and adverse impacts to water quality including increased total suspended solids, low dissolved oxygen, increased nutrients, higher temperature, and increased fecal coliform concentrations. For reasons stated above, clearing and snagging activities are expected to adversely impact water quality including increased total suspended solids, low dissolved oxygen, increased nutrients, higher temperature, and increased fecal coliform concentrations.

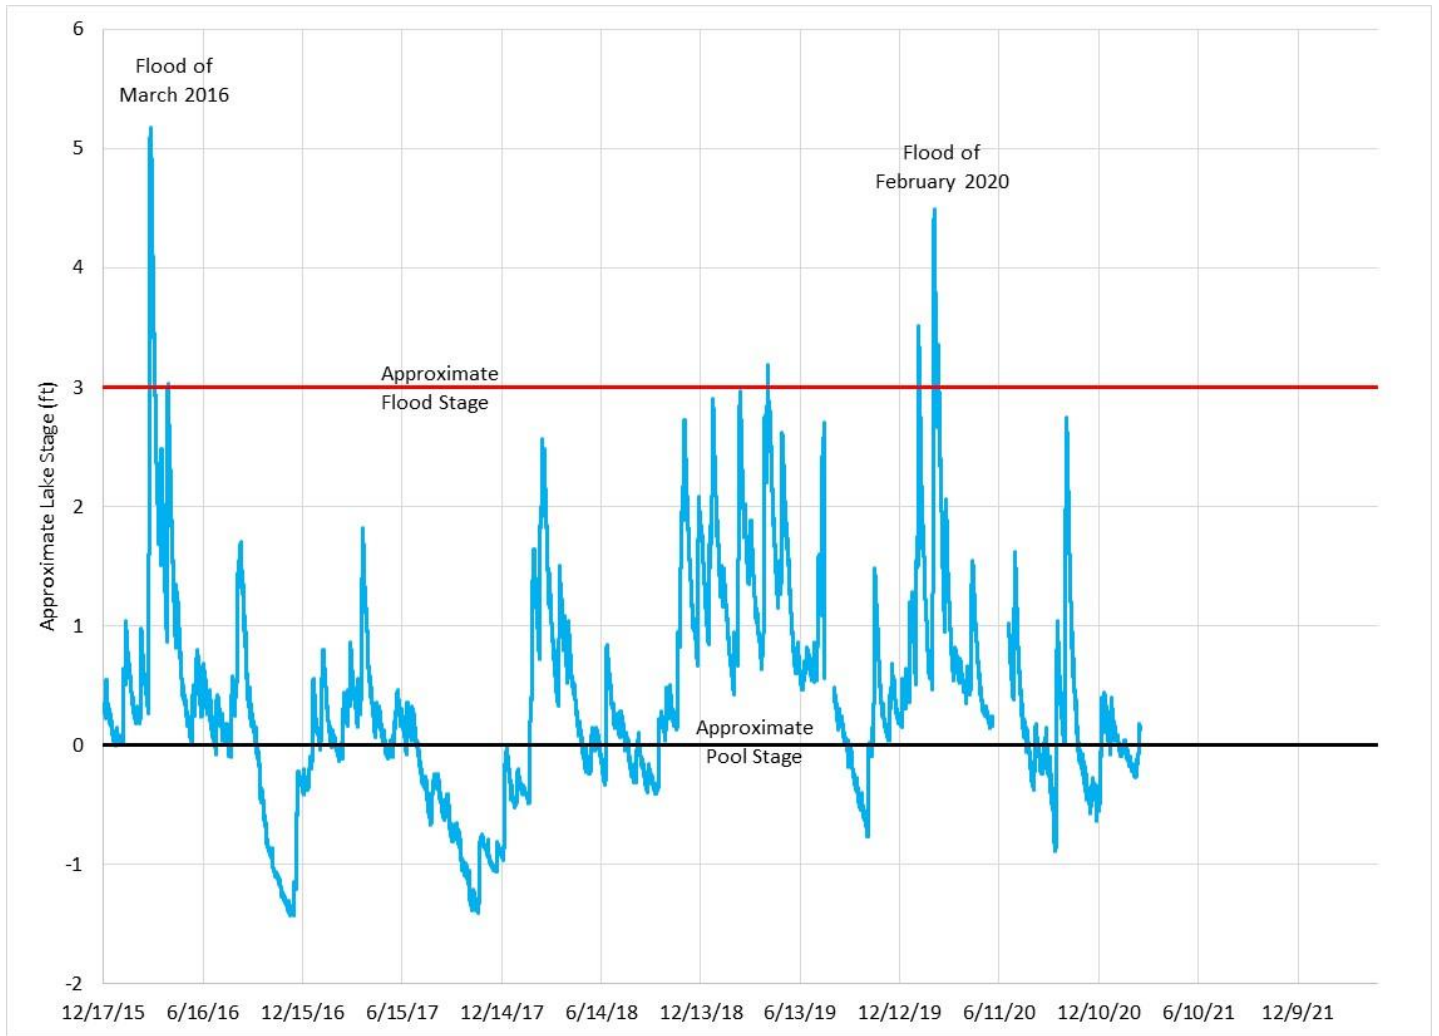
Figure 3: Recorded lake stage in feet above approximated pool stage (~90 ft.NAVD29).

The lake monitoring gage installed at the former swimming pier by the Louisiana Geological Survey was moved to a new location in September 2021 after a portion of the pier received damaged (e.g. collapse) during the June 2021 flood resulting in the gage no longer being able to be accessed from shore. The new location of the gage is on a private pier owned by the East Carroll Parish sheriff. Due to the pandemic restrictions and because the gage was not accessible for an extended period of time, some data (most of 2021) was lost, including that for the flood on June 2021 (Figure 3).

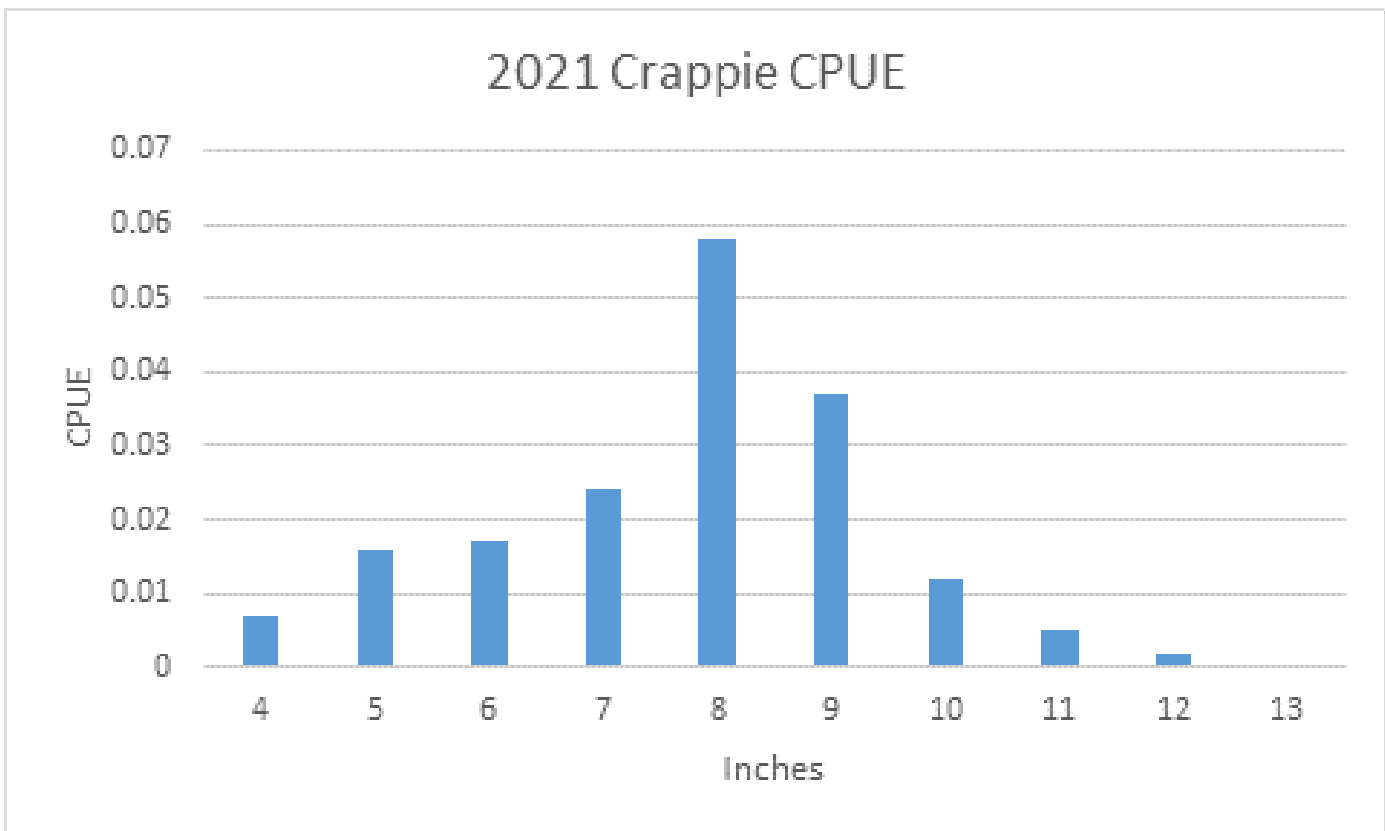
Figure 4: Catch Per Unit Effort (CPUE) rate for crappie in 2021.

In 2021, the Louisiana Department of Wildlife and Fisheries conducted gill net samples for evaluation of commercial species and lead net samples for crappie and sunfish. Gill net samples appeared normal with an abundance of buffalo fish and channel catfish. The length distribution of the crappie sample is shown in Figure 4. Overall, abundance was down slightly, though the population has a perfect size distribution. An interesting finding is that 76% of the crappie were black crappie, whereas in 2017 and 2018, they only comprised 8% and 11%, respectively. Black crappie prefer clearer (less turbid) conditions than white crappie. So, this could possibly be an indicator of less turbid conditions in the lake over past couple years, but definitely not conclusive. No fish samples are scheduled for 2022.

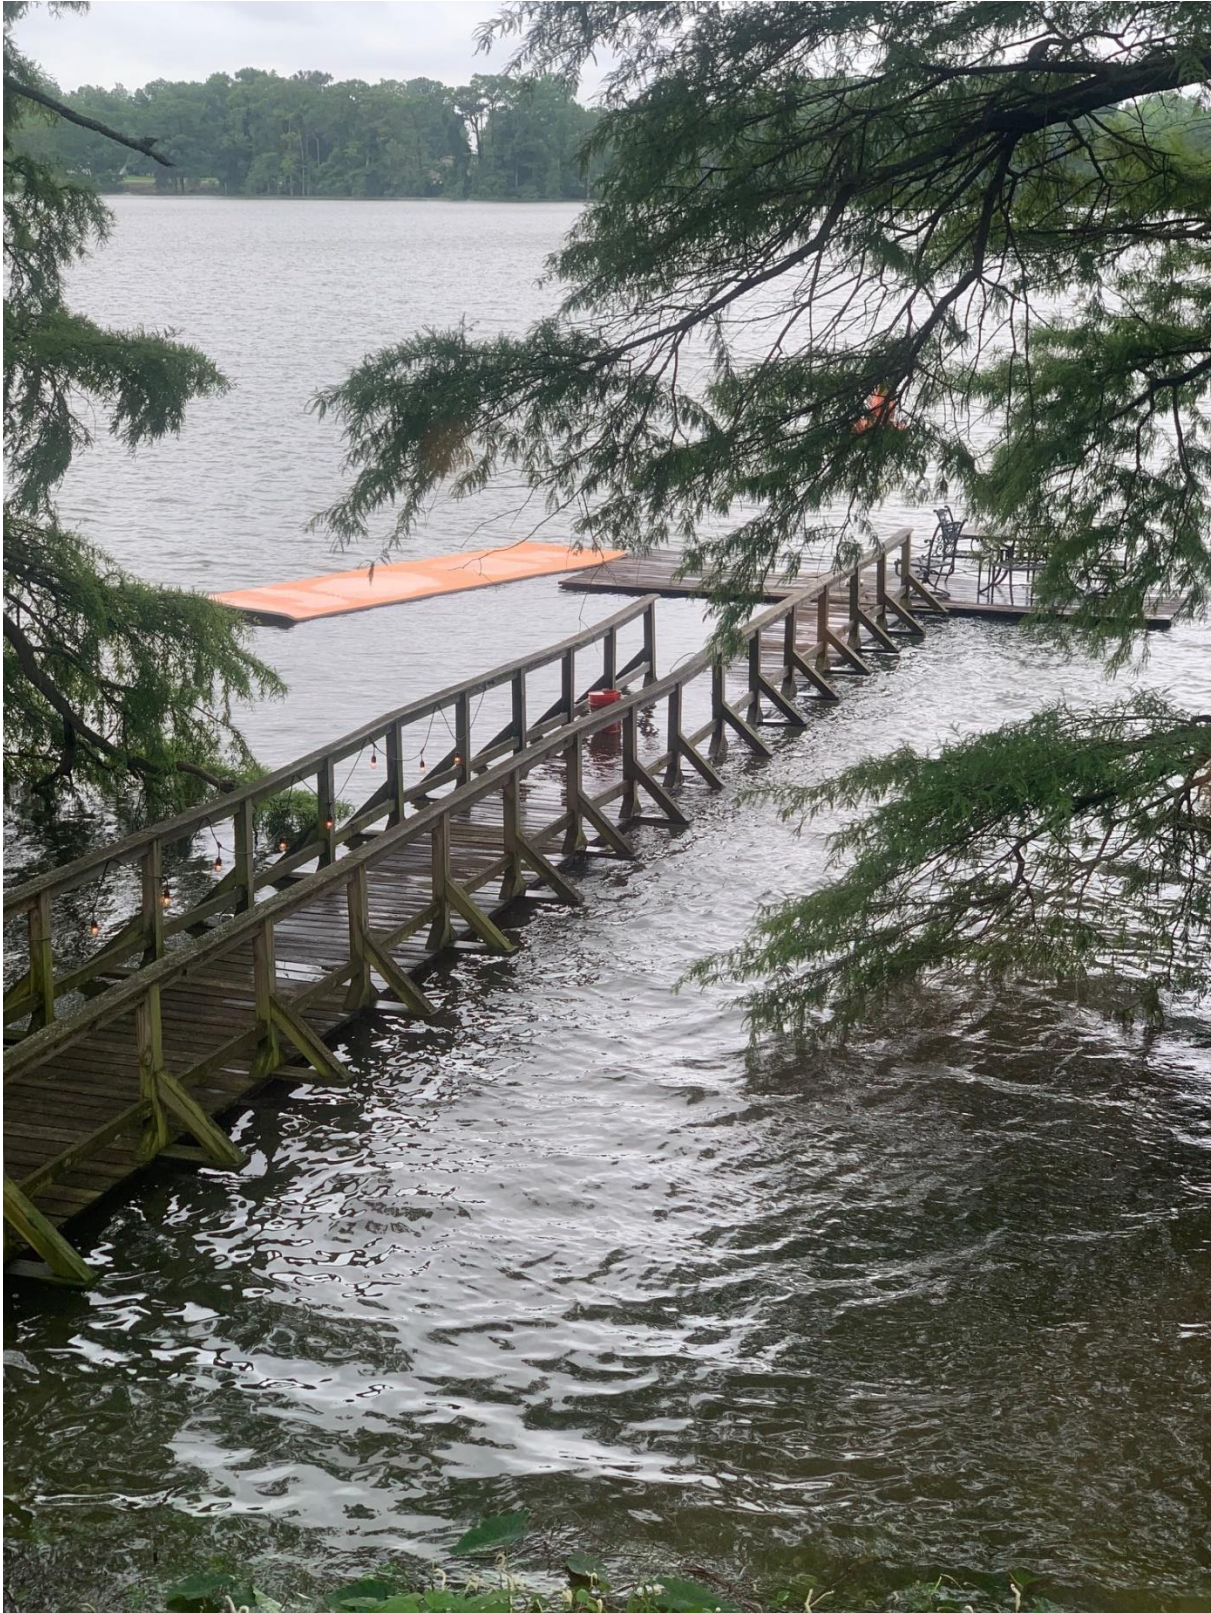
Photo A1: Pier located on 2180 Island Point Dr which is the south end of lake directly across from The Dock restaurant on Hwy 65. Photo taken 6/12/2021 by Jim Lensing

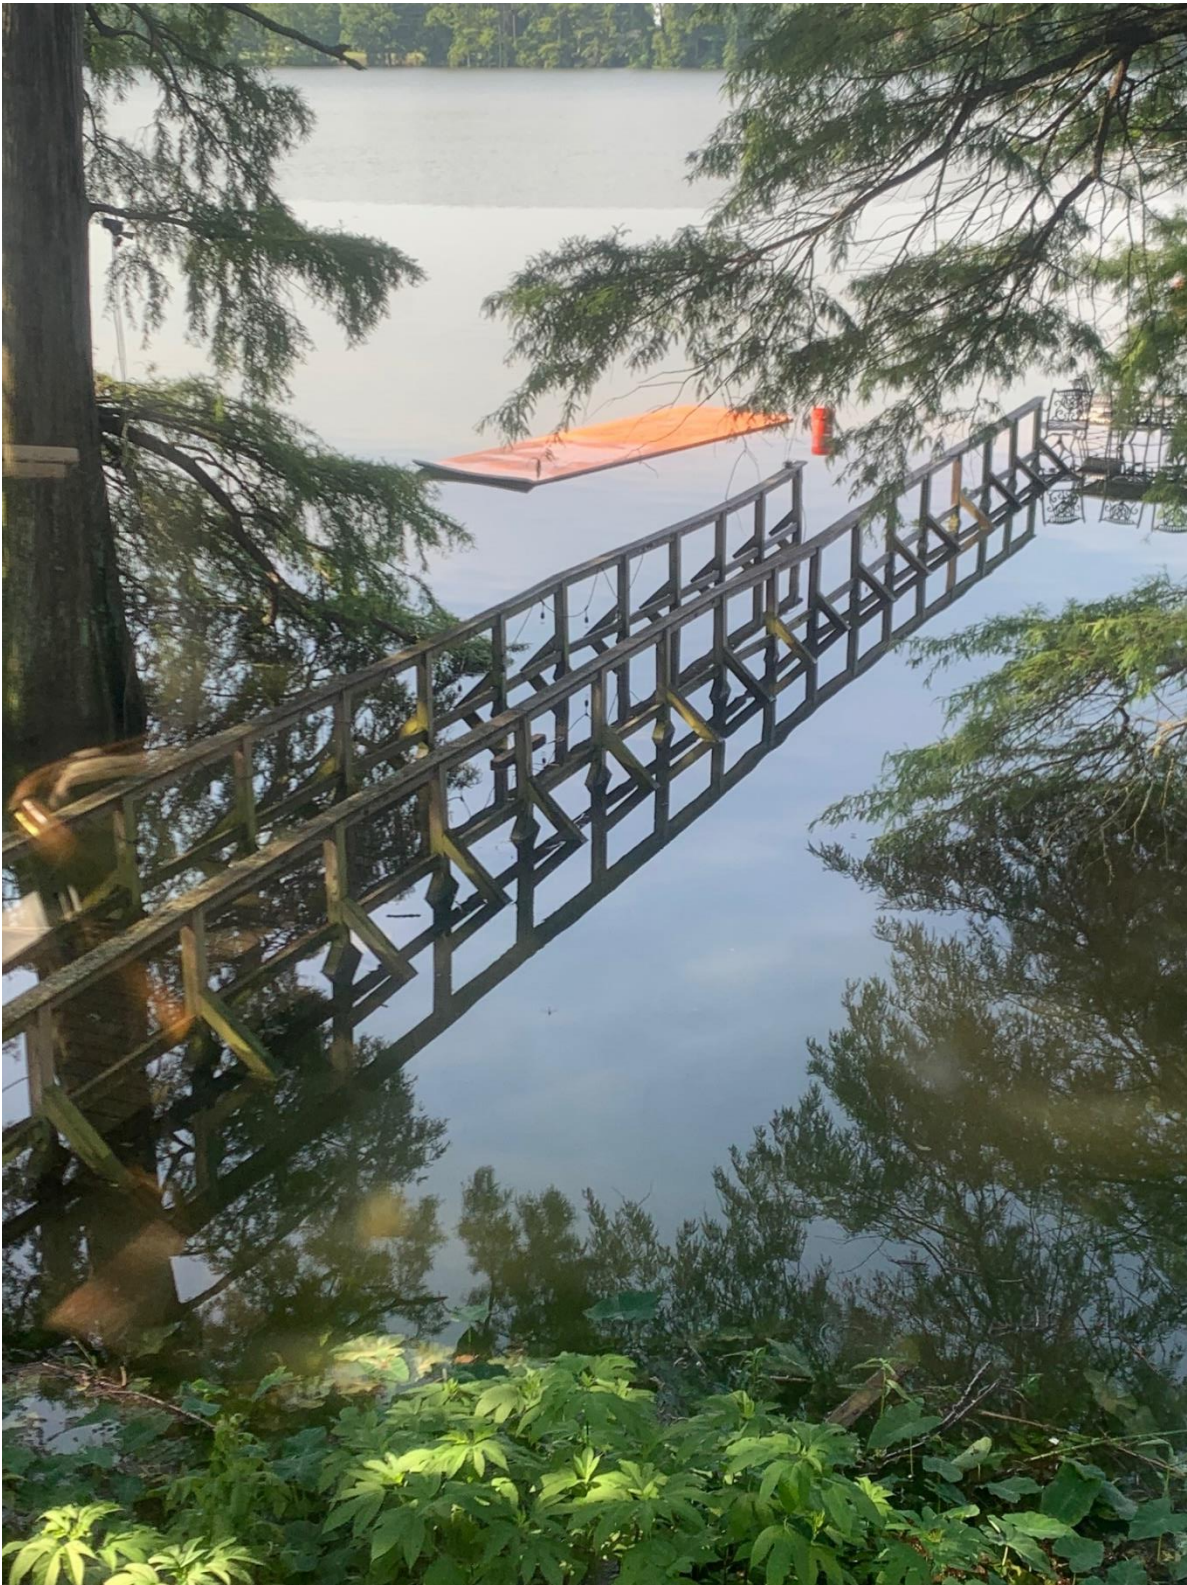
Photo A2: Same Pier as pictured before a couple hours later. Photo taken 6/12/2021 by Jim Lensing

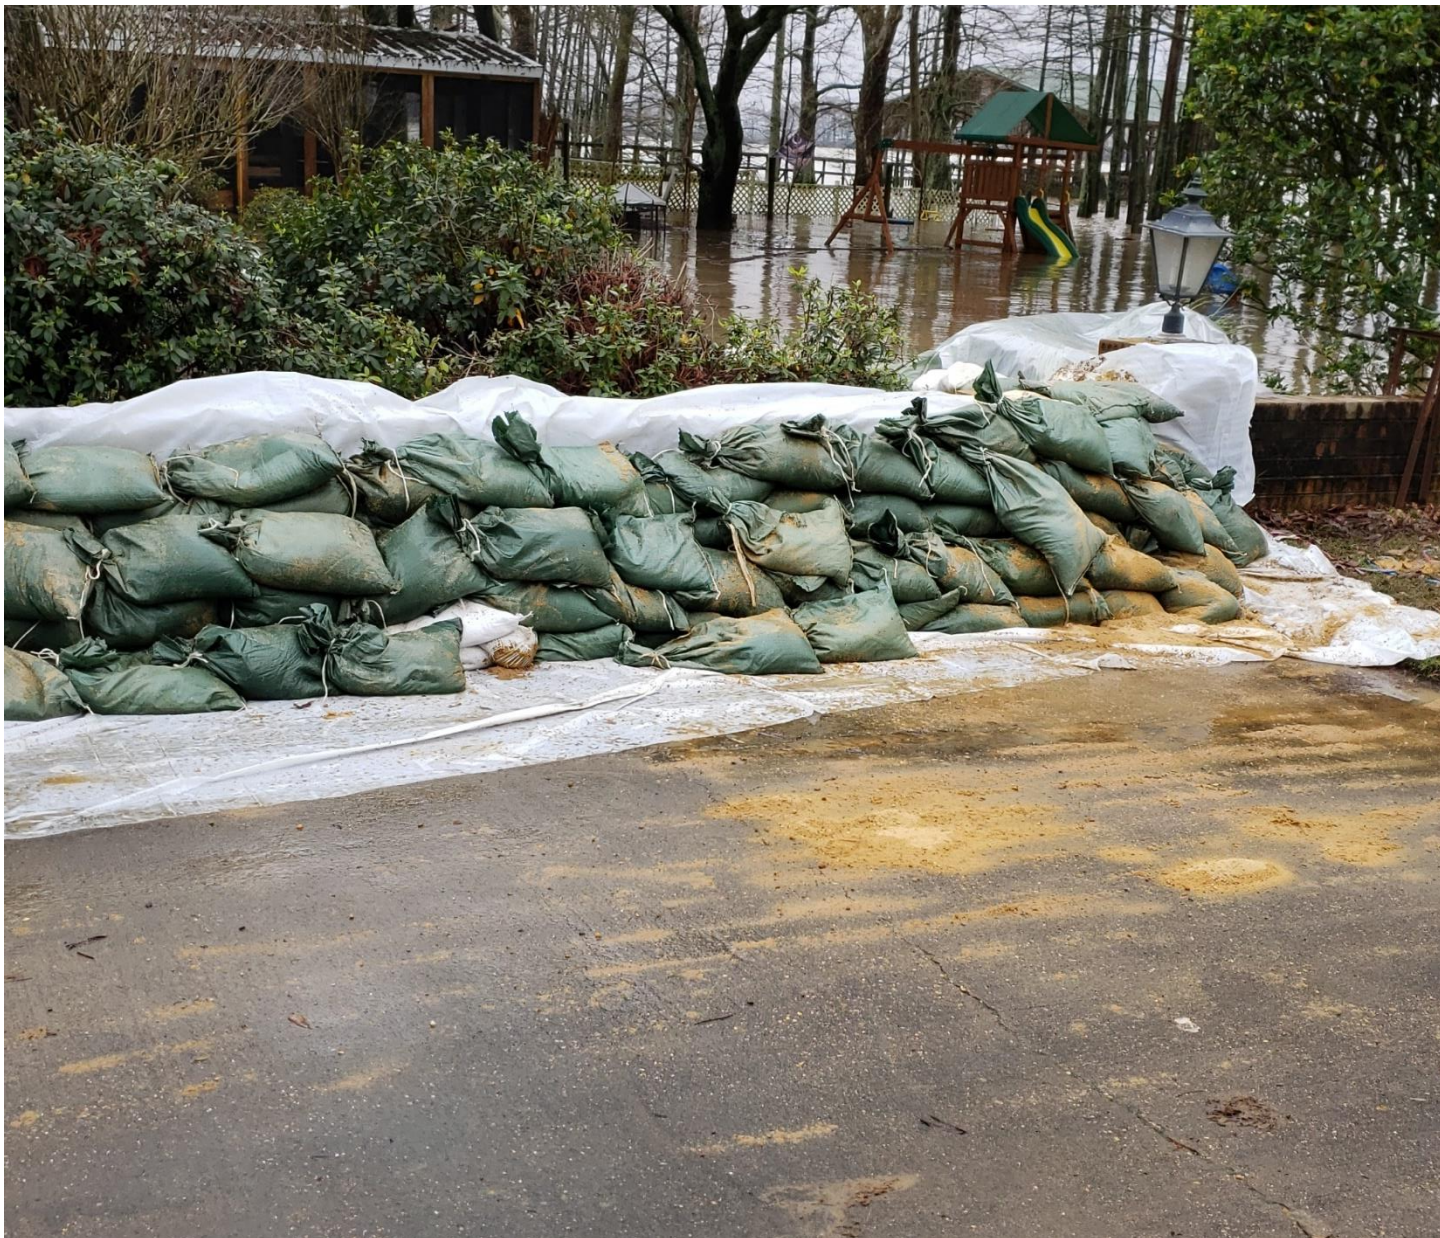
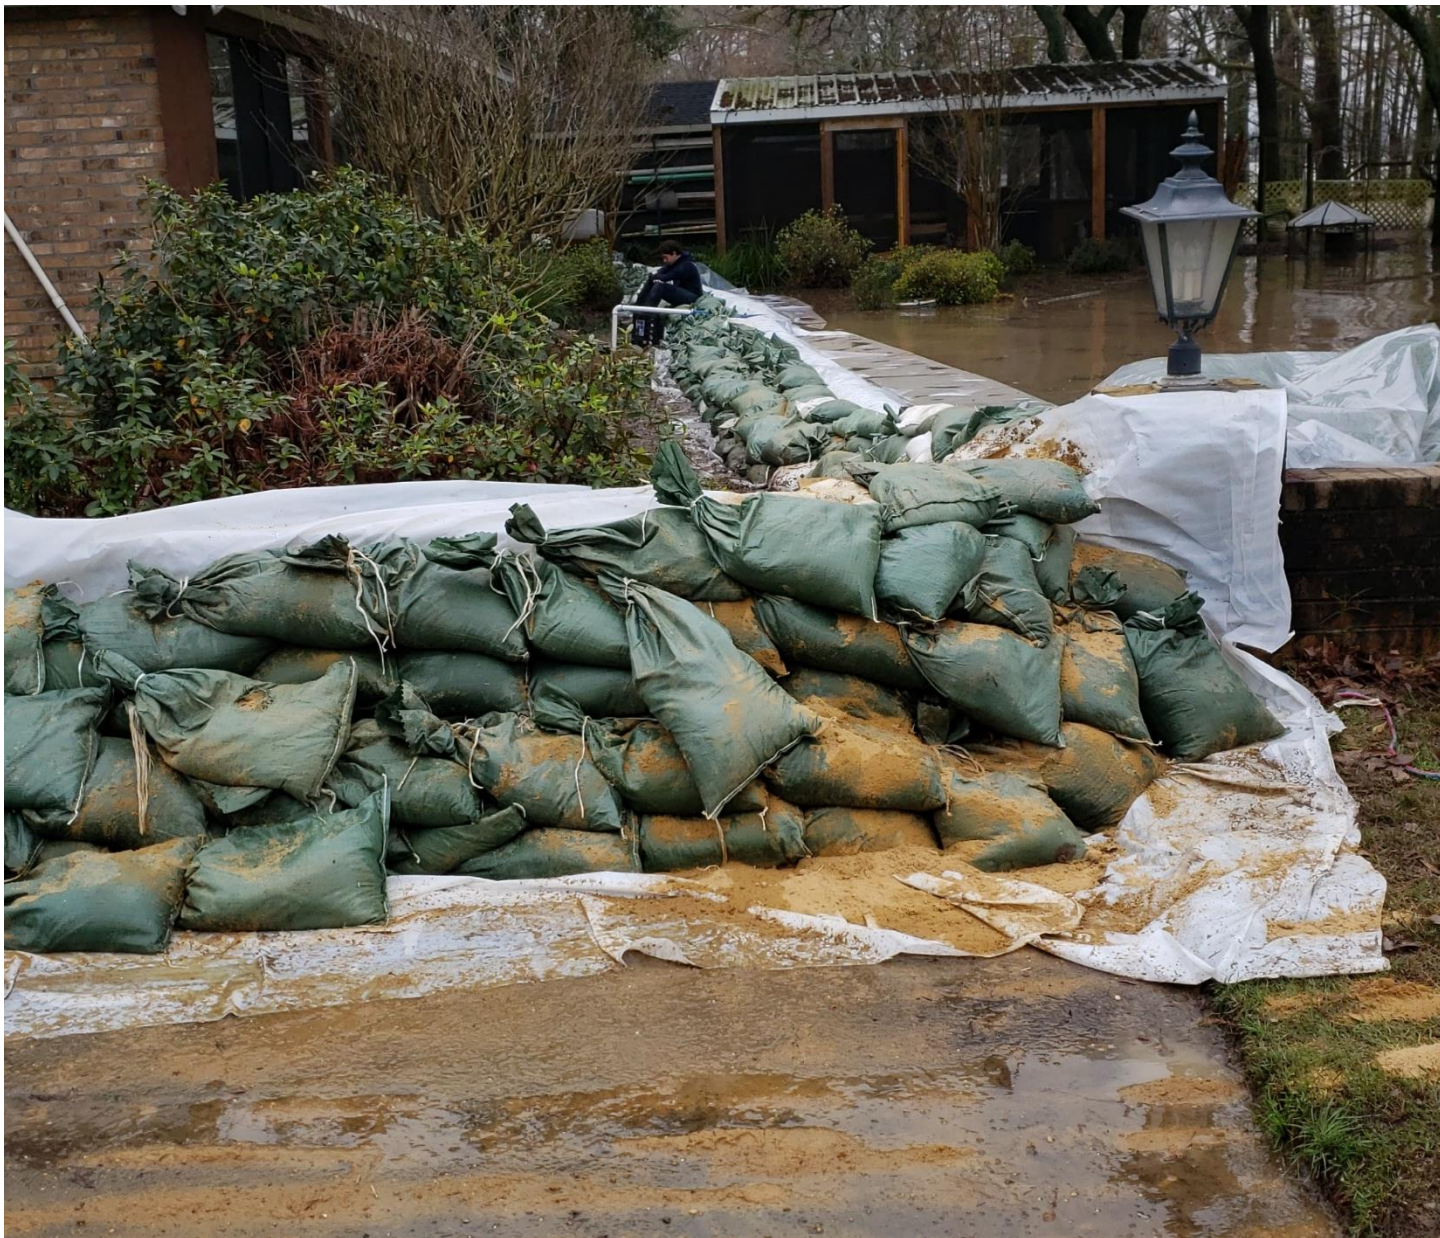
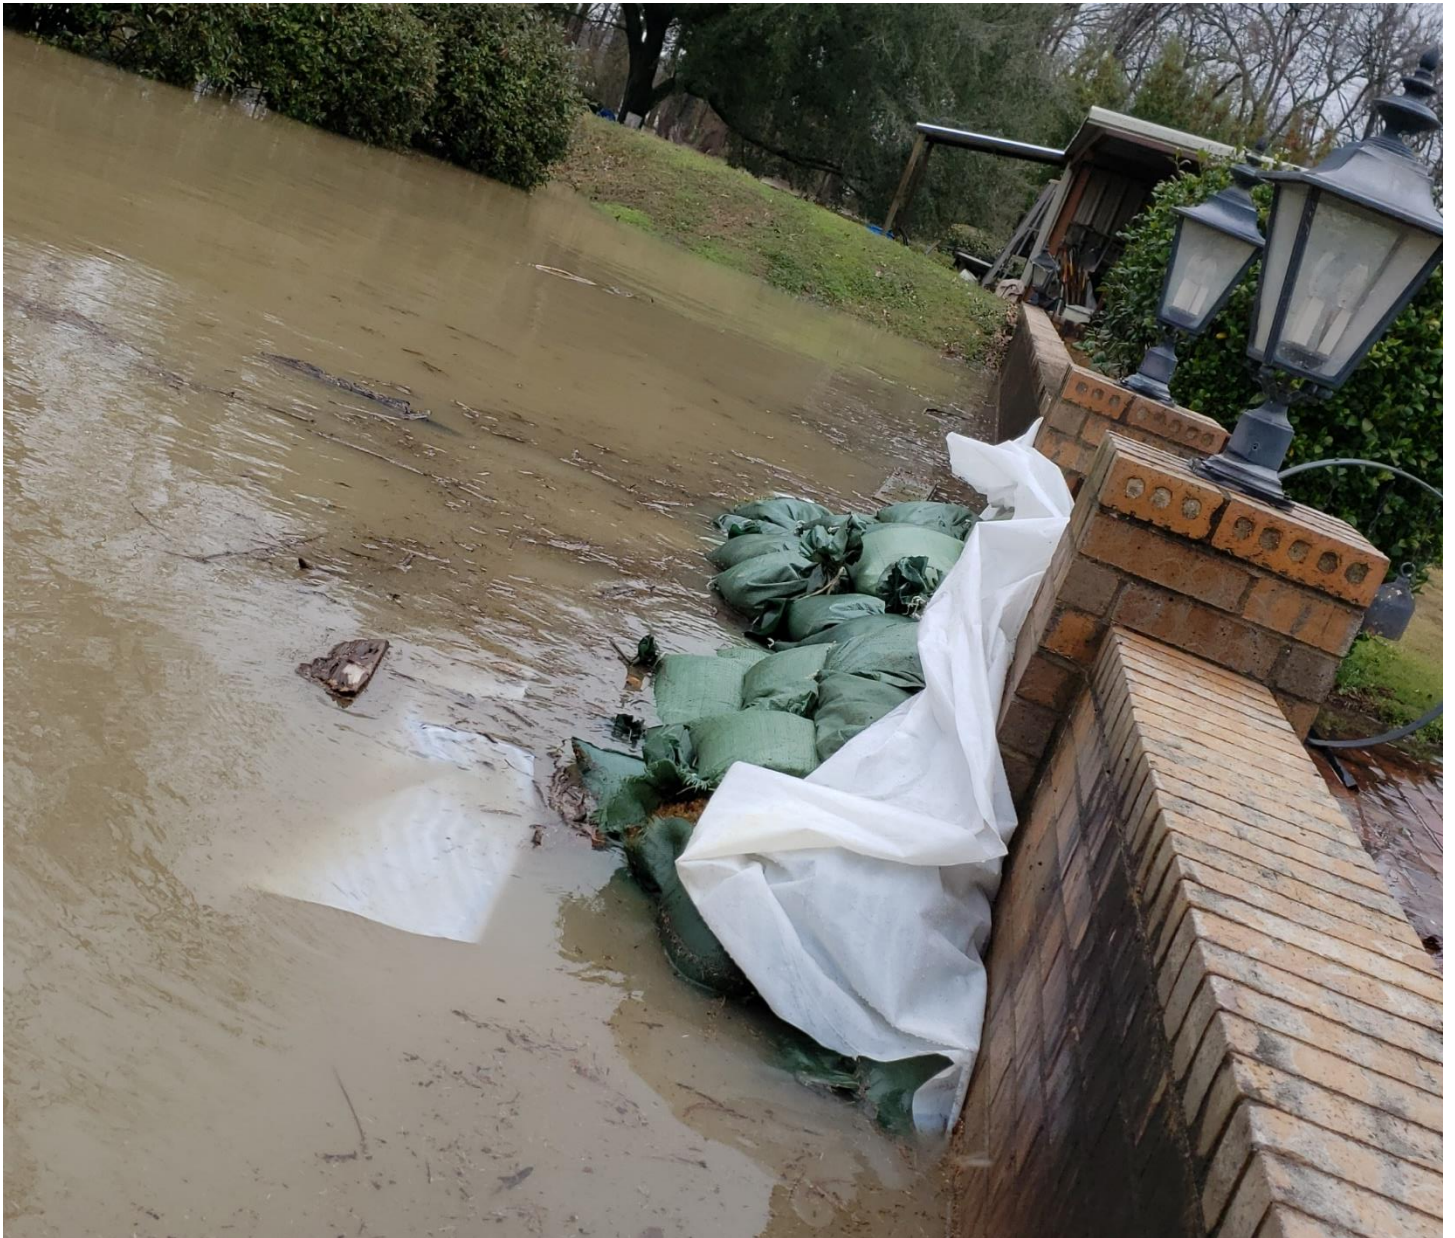
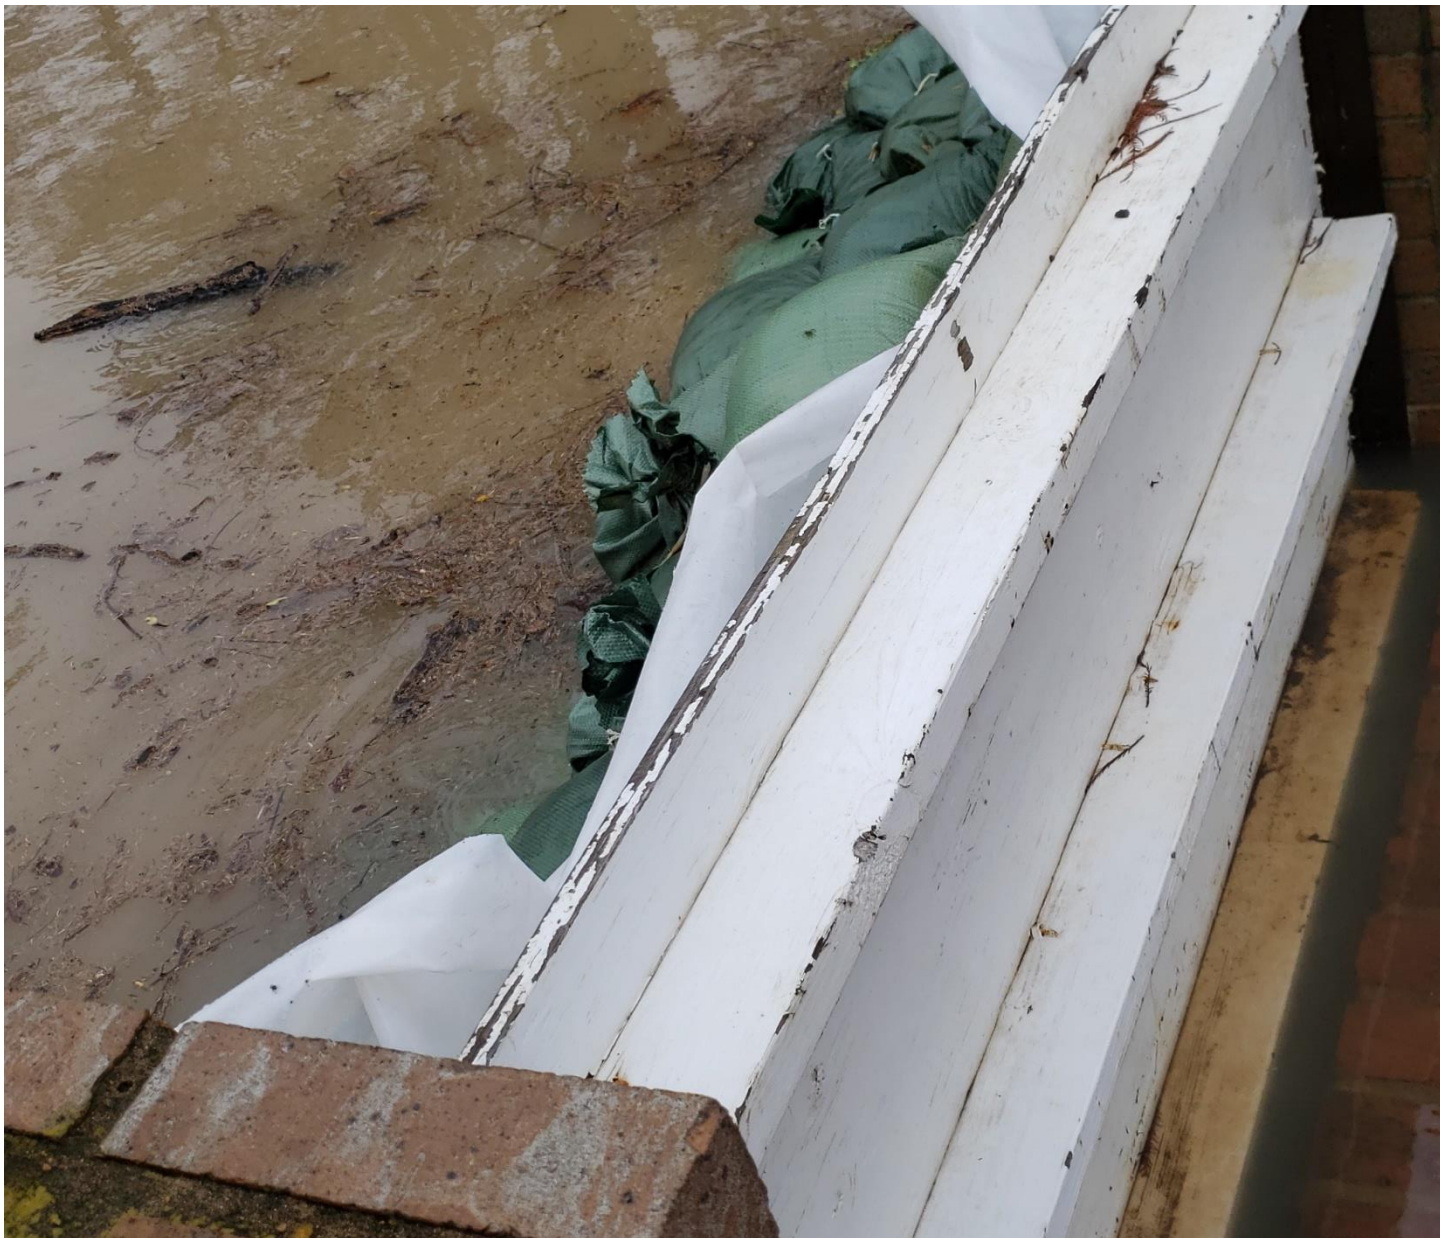
Photo A3: Sandbagging at the residence of 506 Island Point Dr which is the north end of Lake Providence. Photo taken 6/12/2021 by Reynold Minsky.

Photo A4: Sandbagging at the residence of 506 Island Point Dr which is the north end of Lake Providence. Photo taken 6/12/2021 by Reynold Minsky.

Photo A7: Sandbagging at the residence of 506 Island Point Dr which is the north end of Lake Providence. Photo taken 6/12/2021 by Reynold Minsky.

Photo A8: Sandbagging at the residence of 506 Island Point Dr which is the north end of Lake Providence. Photo taken 6/12/2021 by Reynold Minsky.
