Lake Providence Watershed Council

MANAGING LAKE PROVIDENCE WATERSHED RESOURCES

2022 Update

An Annual Report to the Louisiana Legislature

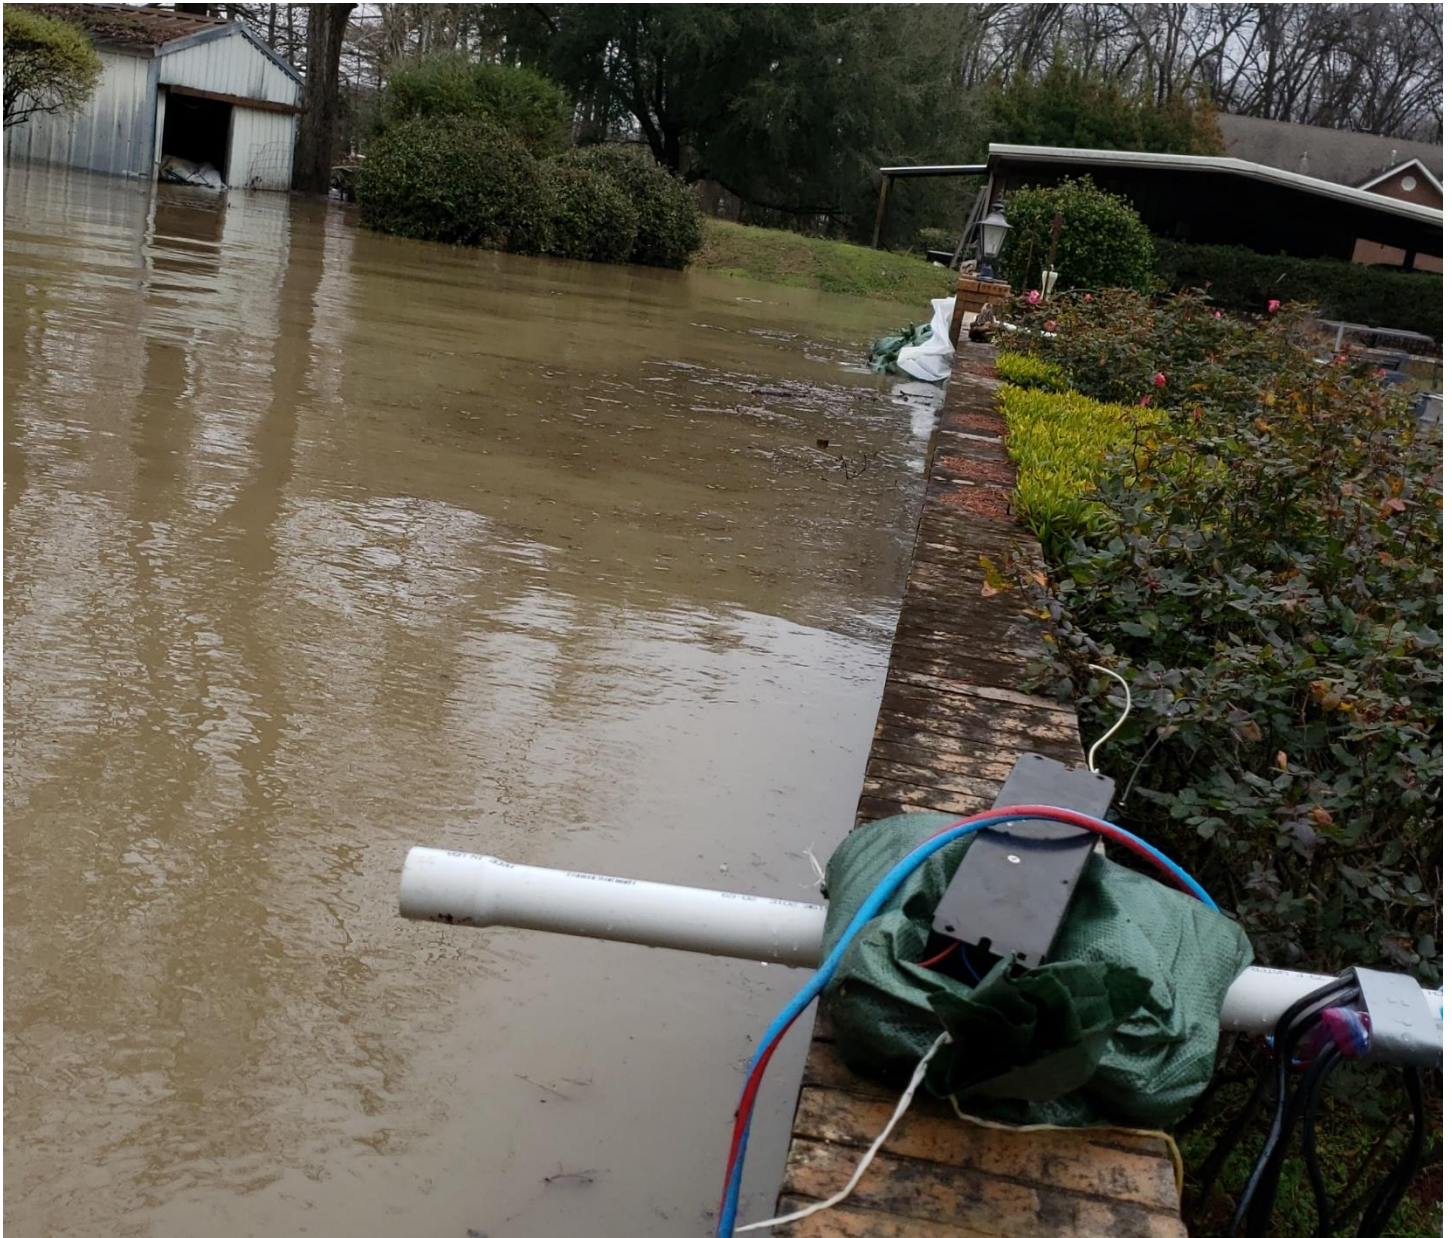
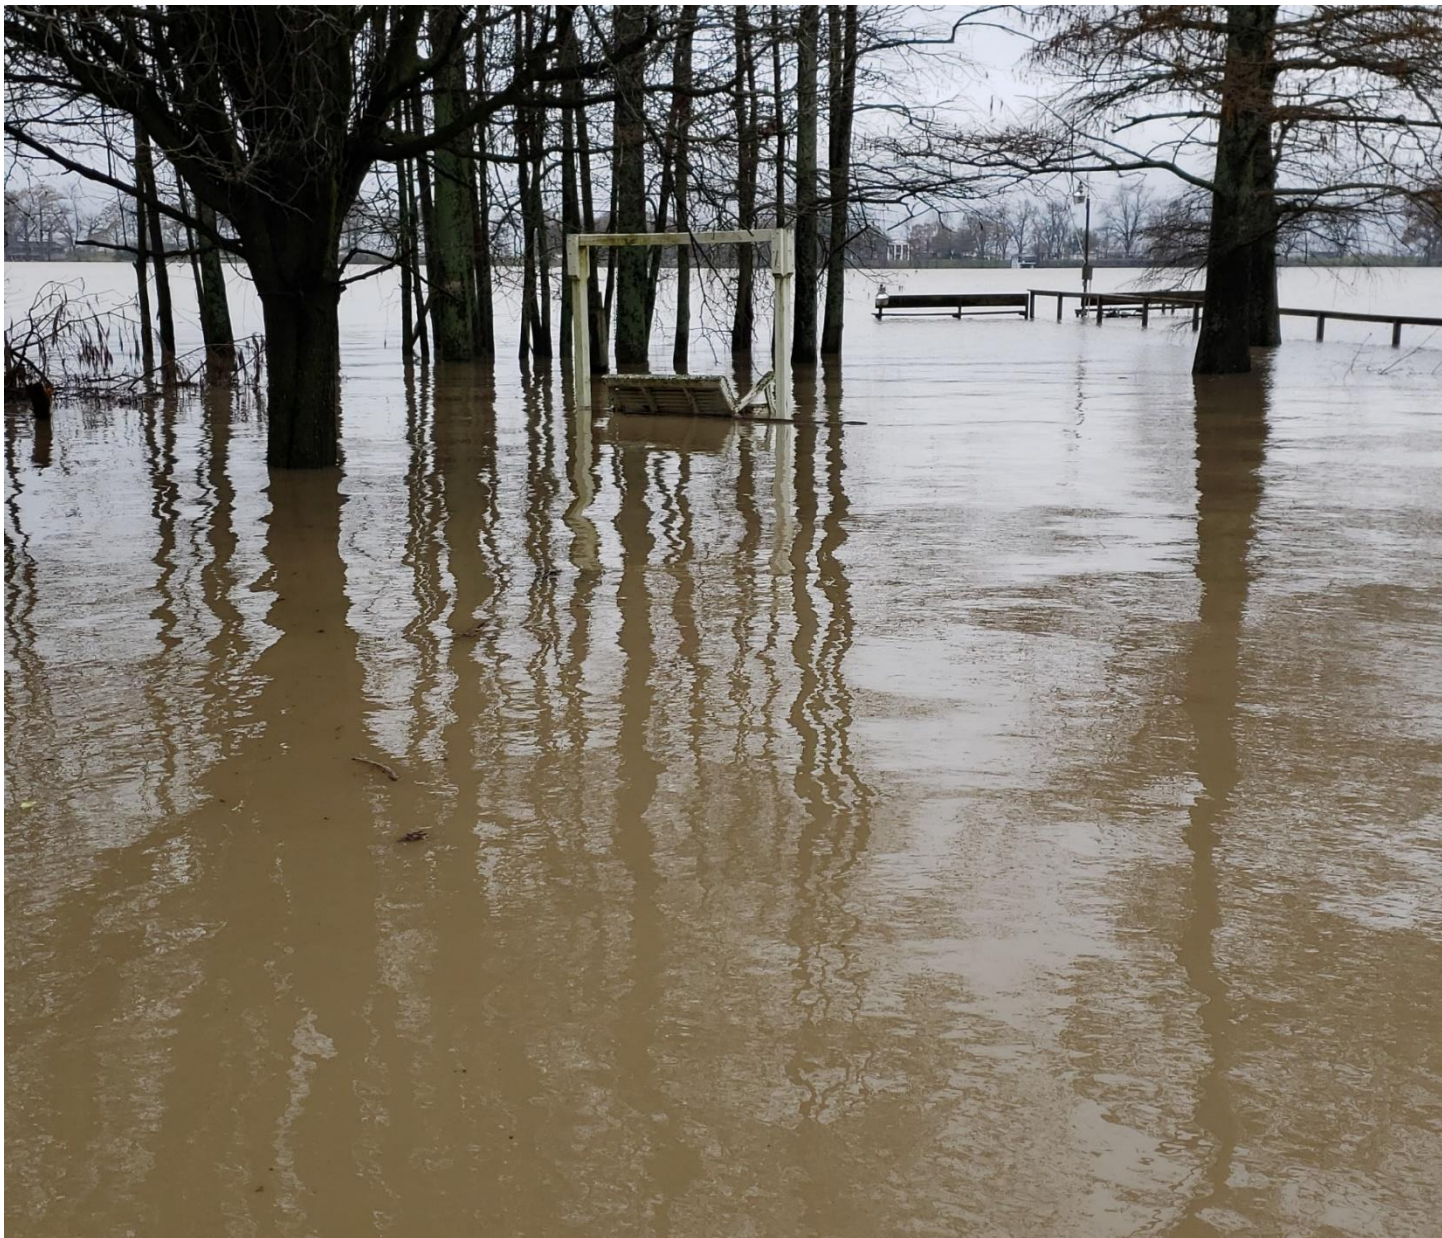
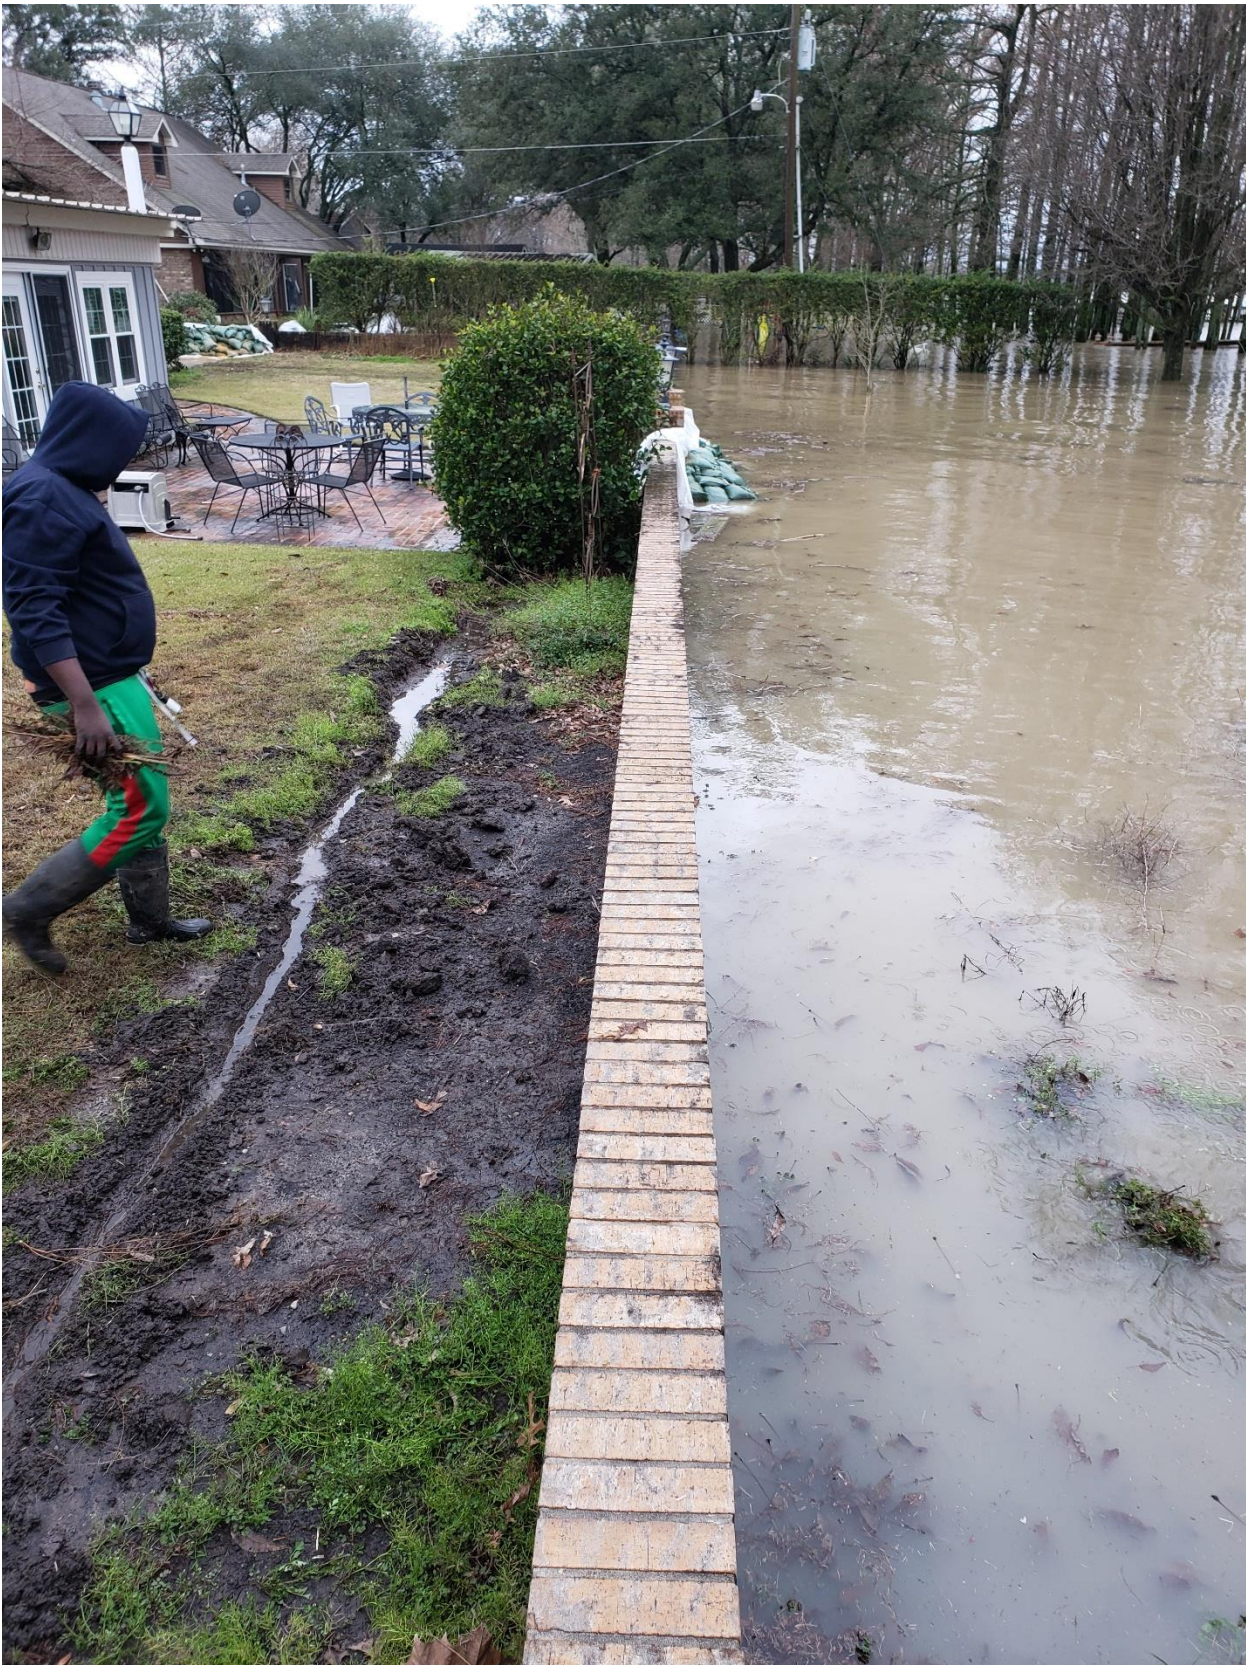
Photo A5: The residence of 506 Island Point Dr which is the north end of Lake Providence. Photo taken 6/12/2021 by Reynold Minsky.

Photo A6: The residence of 506 Island Point Dr which is the north end of Lake Providence. Photo taken 6/12/2021 by Reynold Minsky.

Photo A9: The residence of 506 Island Point Dr which is the north end of Lake Providence. Photo taken 6/12/2021 by Reynold Minsky.

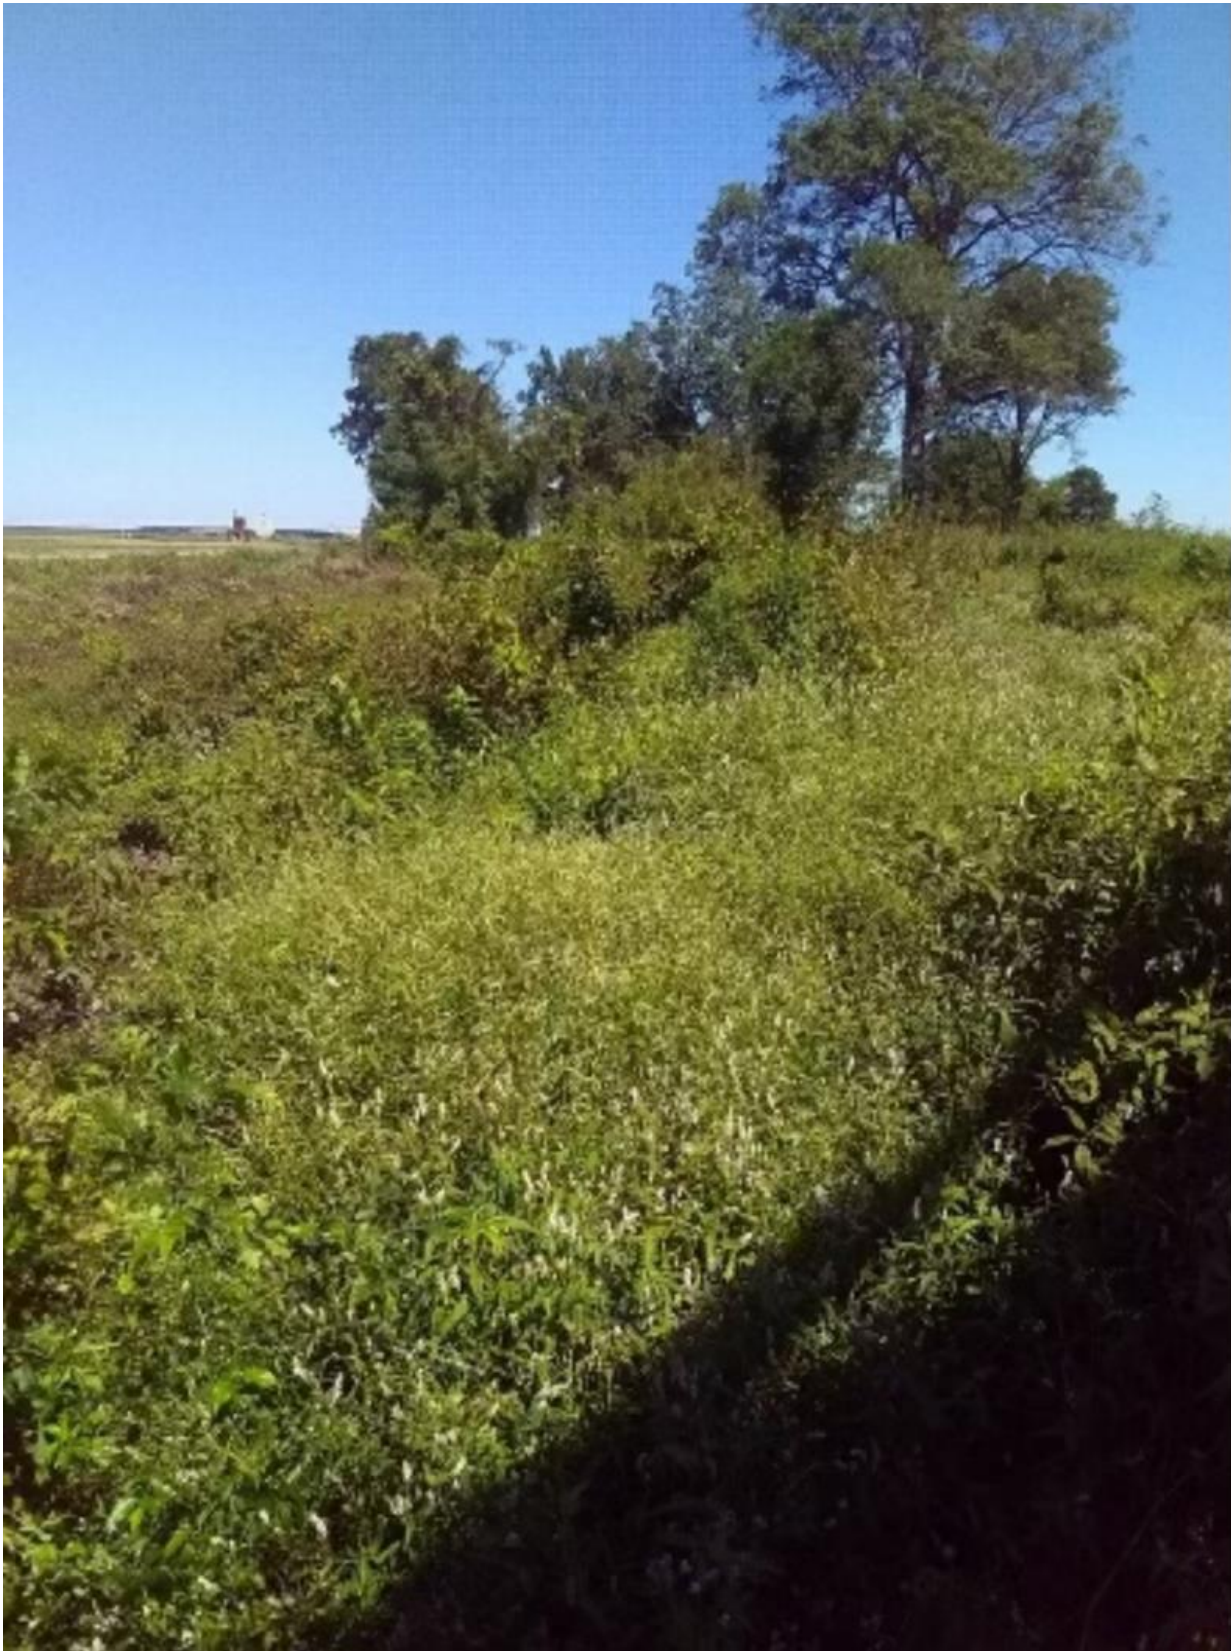
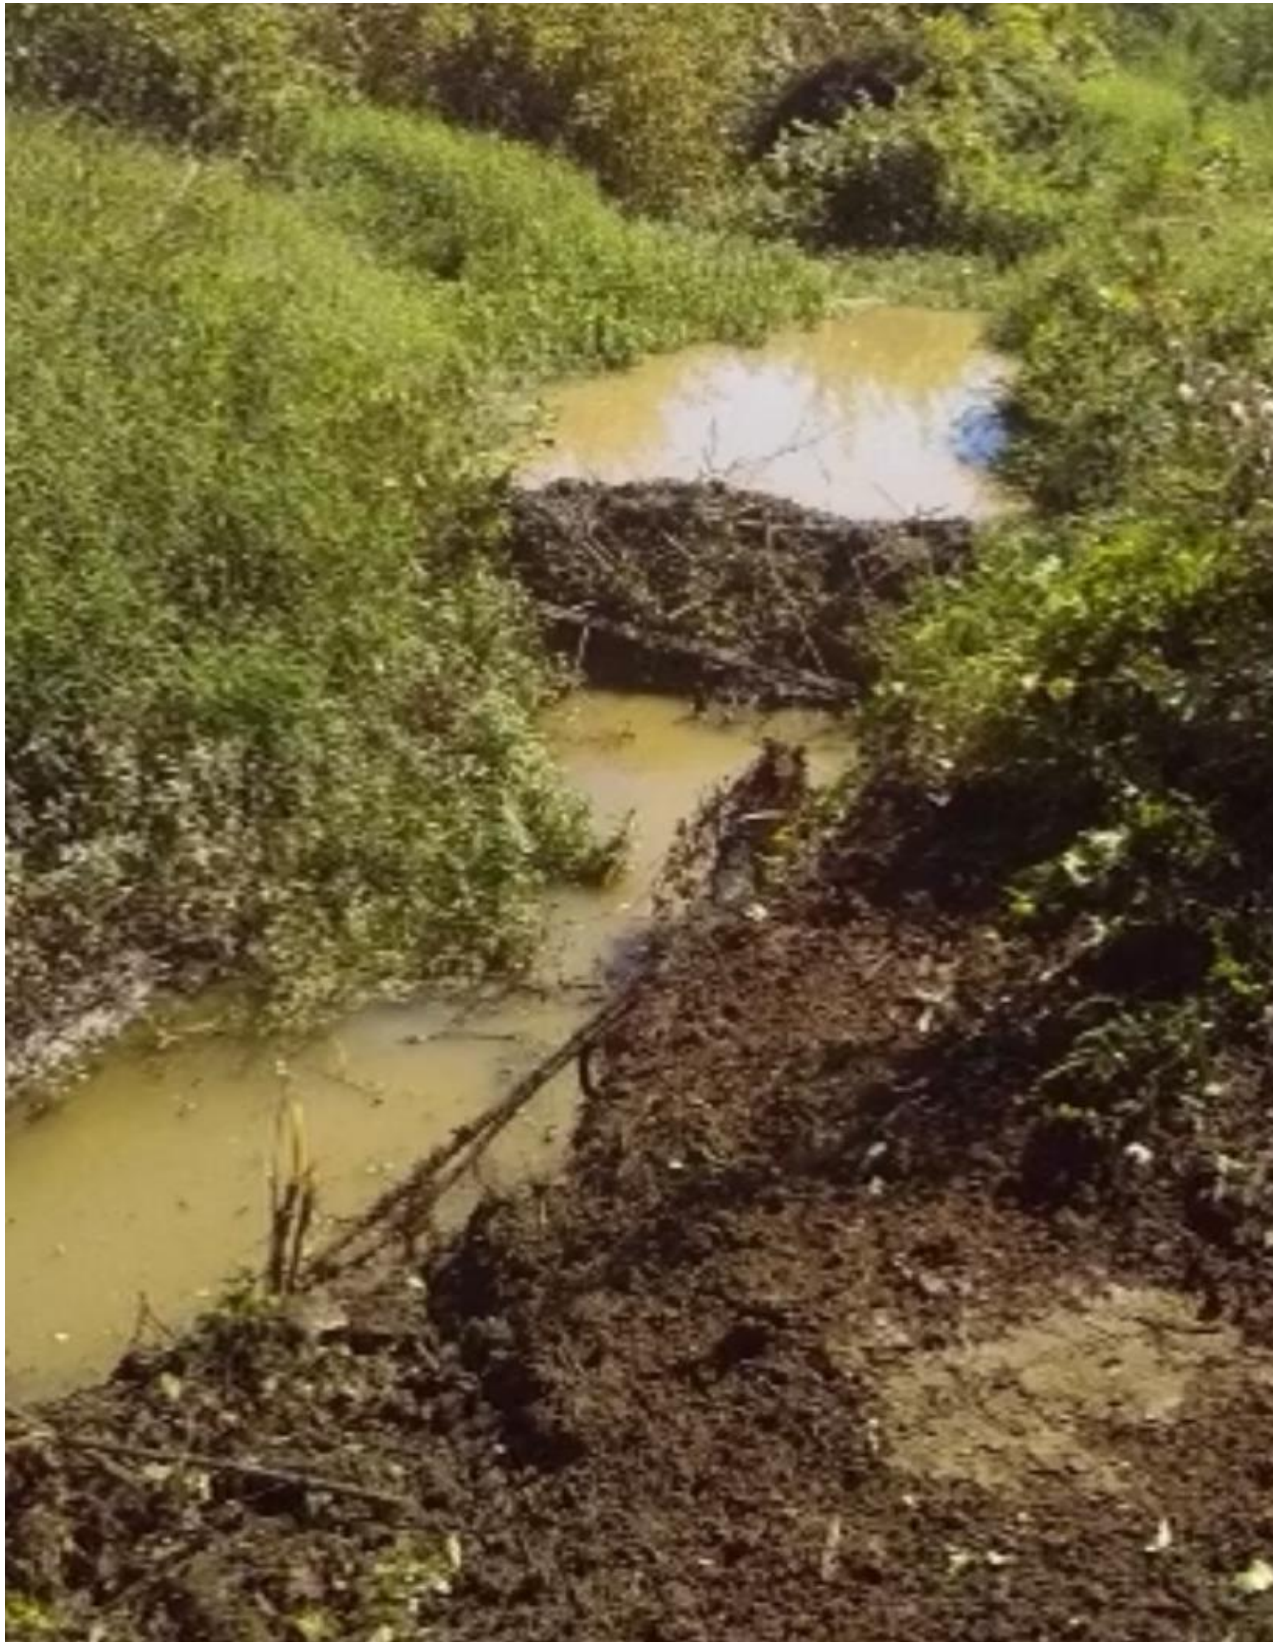
Photo B1: Before picture of Baxter Bayou taken on 9/5/21 by Bo Holt which is the date work began near Cotton Club Rd.

Photo B2: Before picture of Baxter Bayou taken on 9/5/21 by Bo Holt which is the date work began near Cotton Club Rd.

During the second half of September 2021, the East Carroll Police Jury hired a private contractor to clean out Baxter Bayou. They started at Cotton Club Road and headed back east toward the Baxter Bayou control structure (Figure 2 and see Appendix B for photographs). Once this was completed there was discussion at the Police Jury level to go back to Cotton Club Road and start cleaning the bayou westward. However, due to recent rainfall this has not happened yet. A total of 148 hours were spent clearing and snagging approximately 3.5 miles of Baxter Bayou.

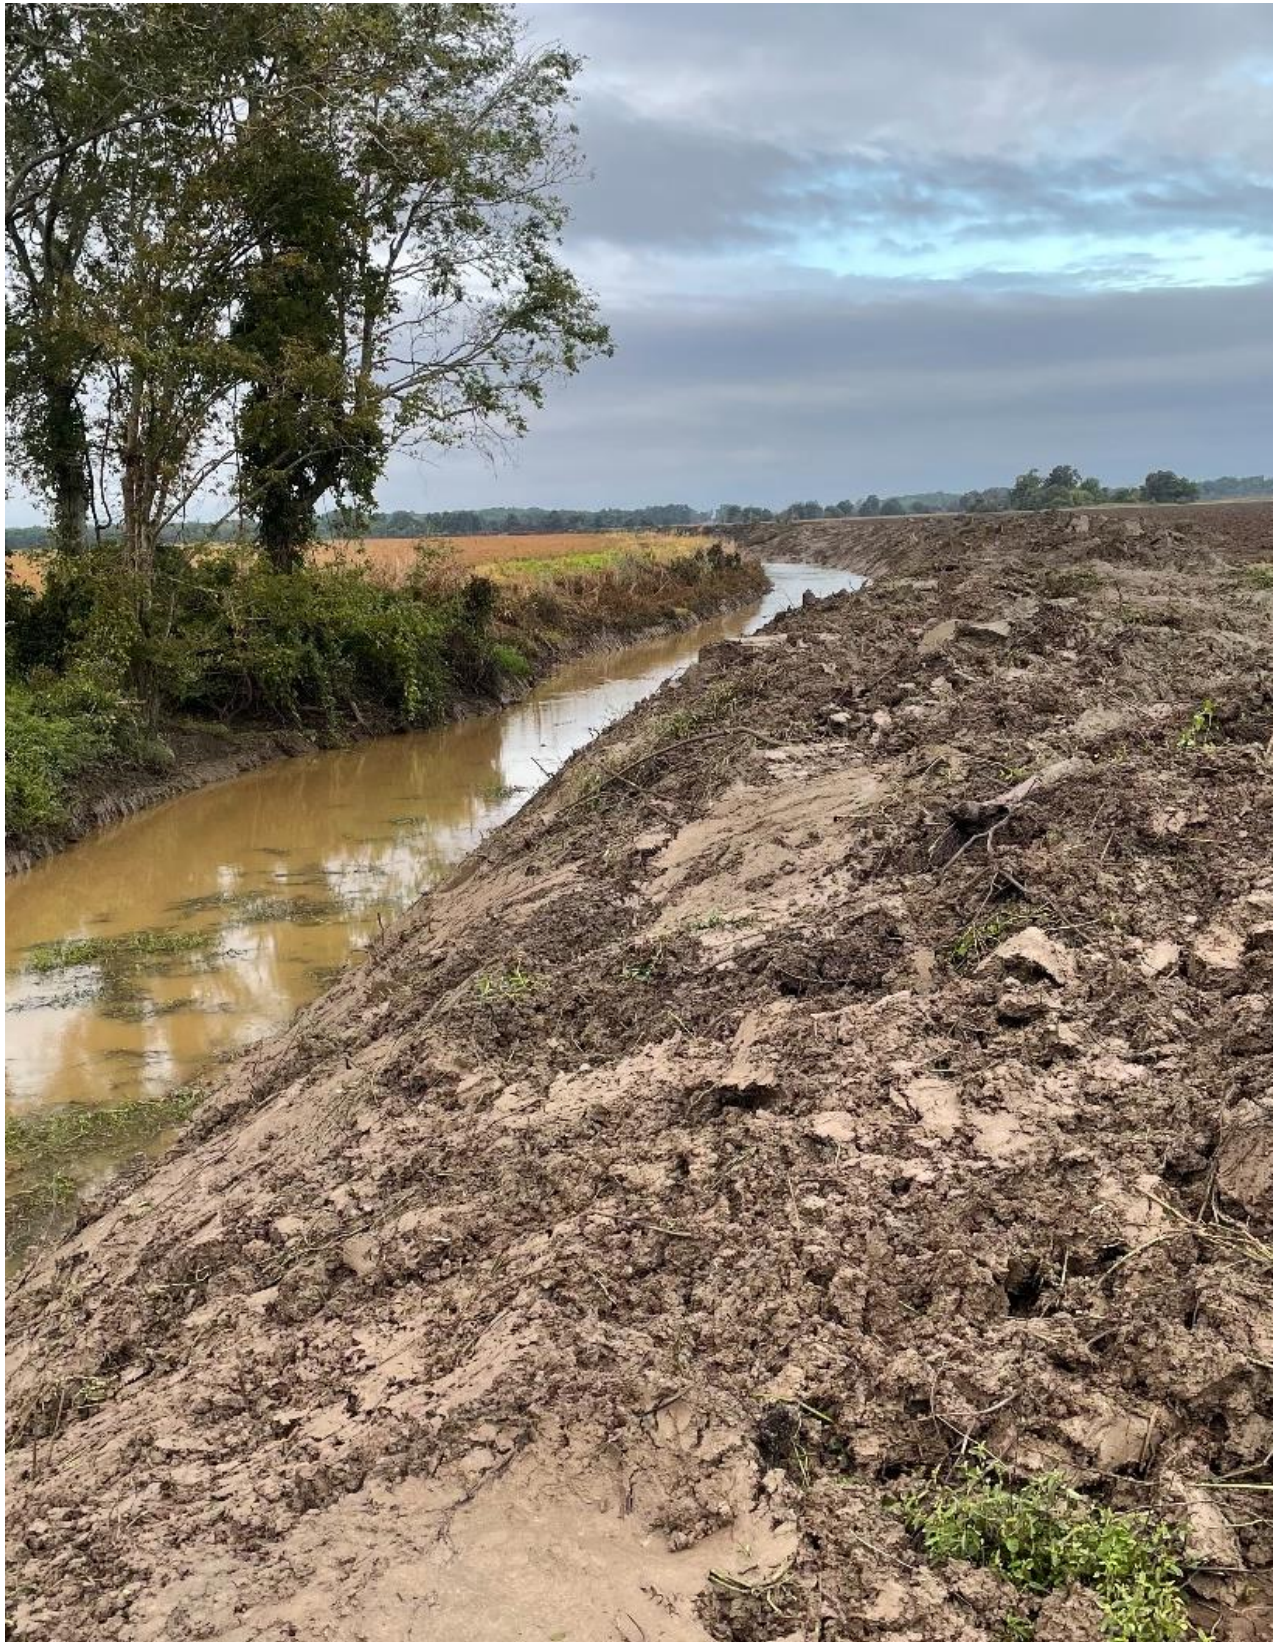
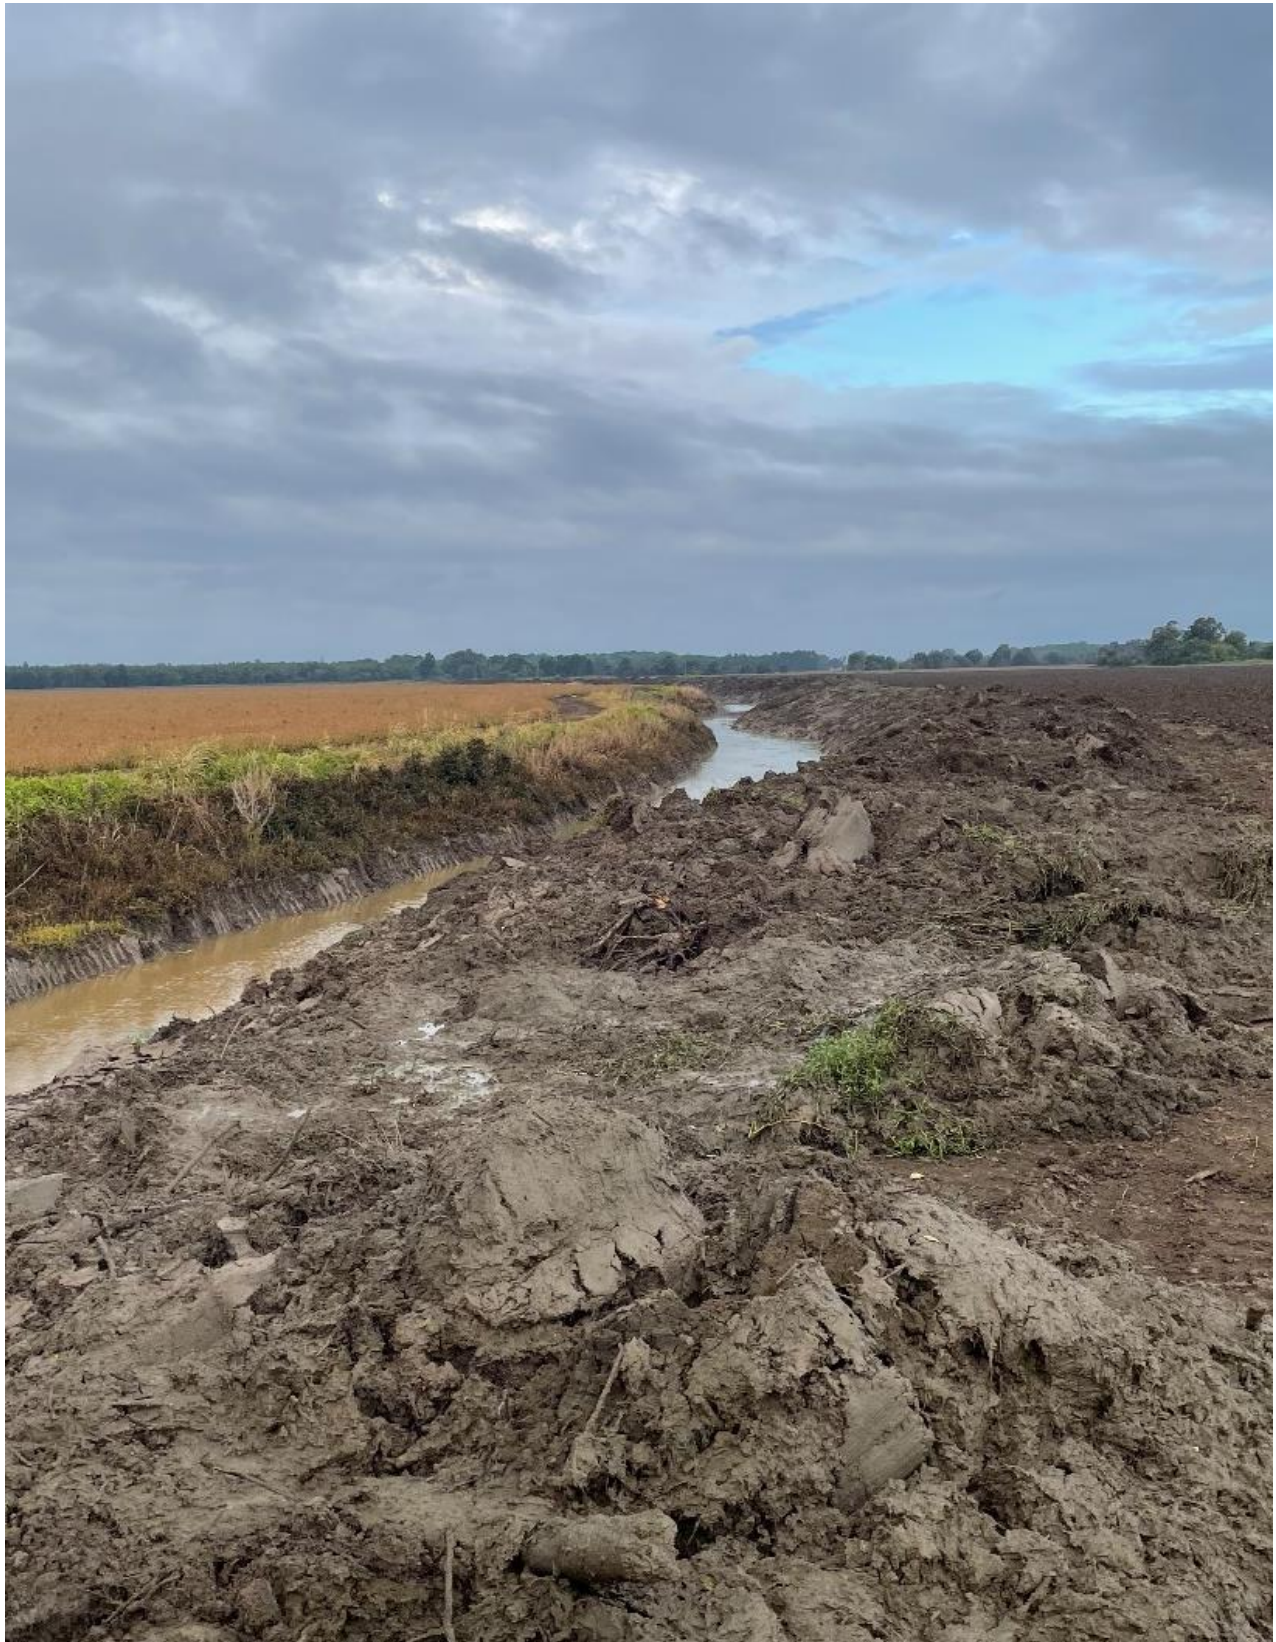
Photo B3: After picture taken on September 10th following a 3-in rain. This photo is showing areas cleared on Baxter Bayou facing towards the structure. Photo taken on 9/10/21 by Bo Holt.

Photo B4: After picture taken on September 10th following a 3-in rain. This photo is showing areas cleared on Baxter Bayou facing towards the structure. Photo taken on 9/10/21 by Bo Holt.

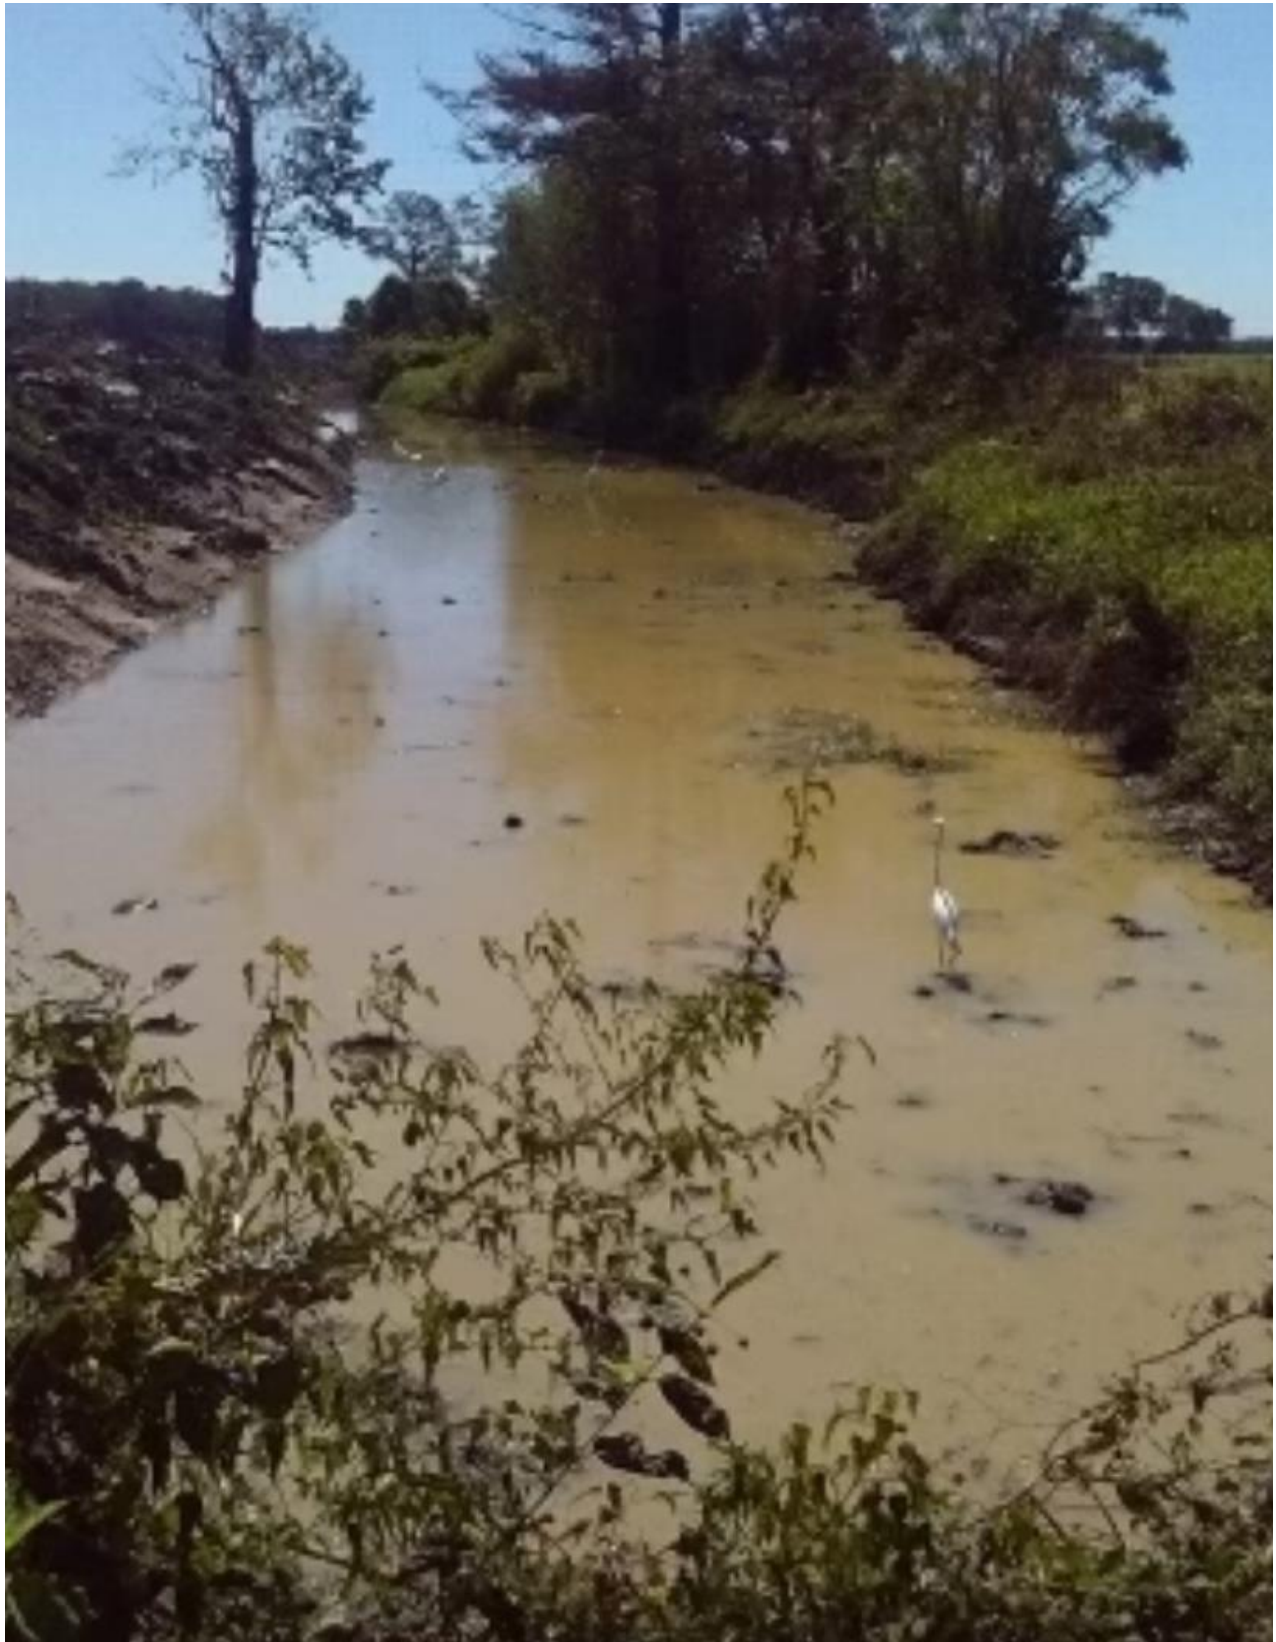
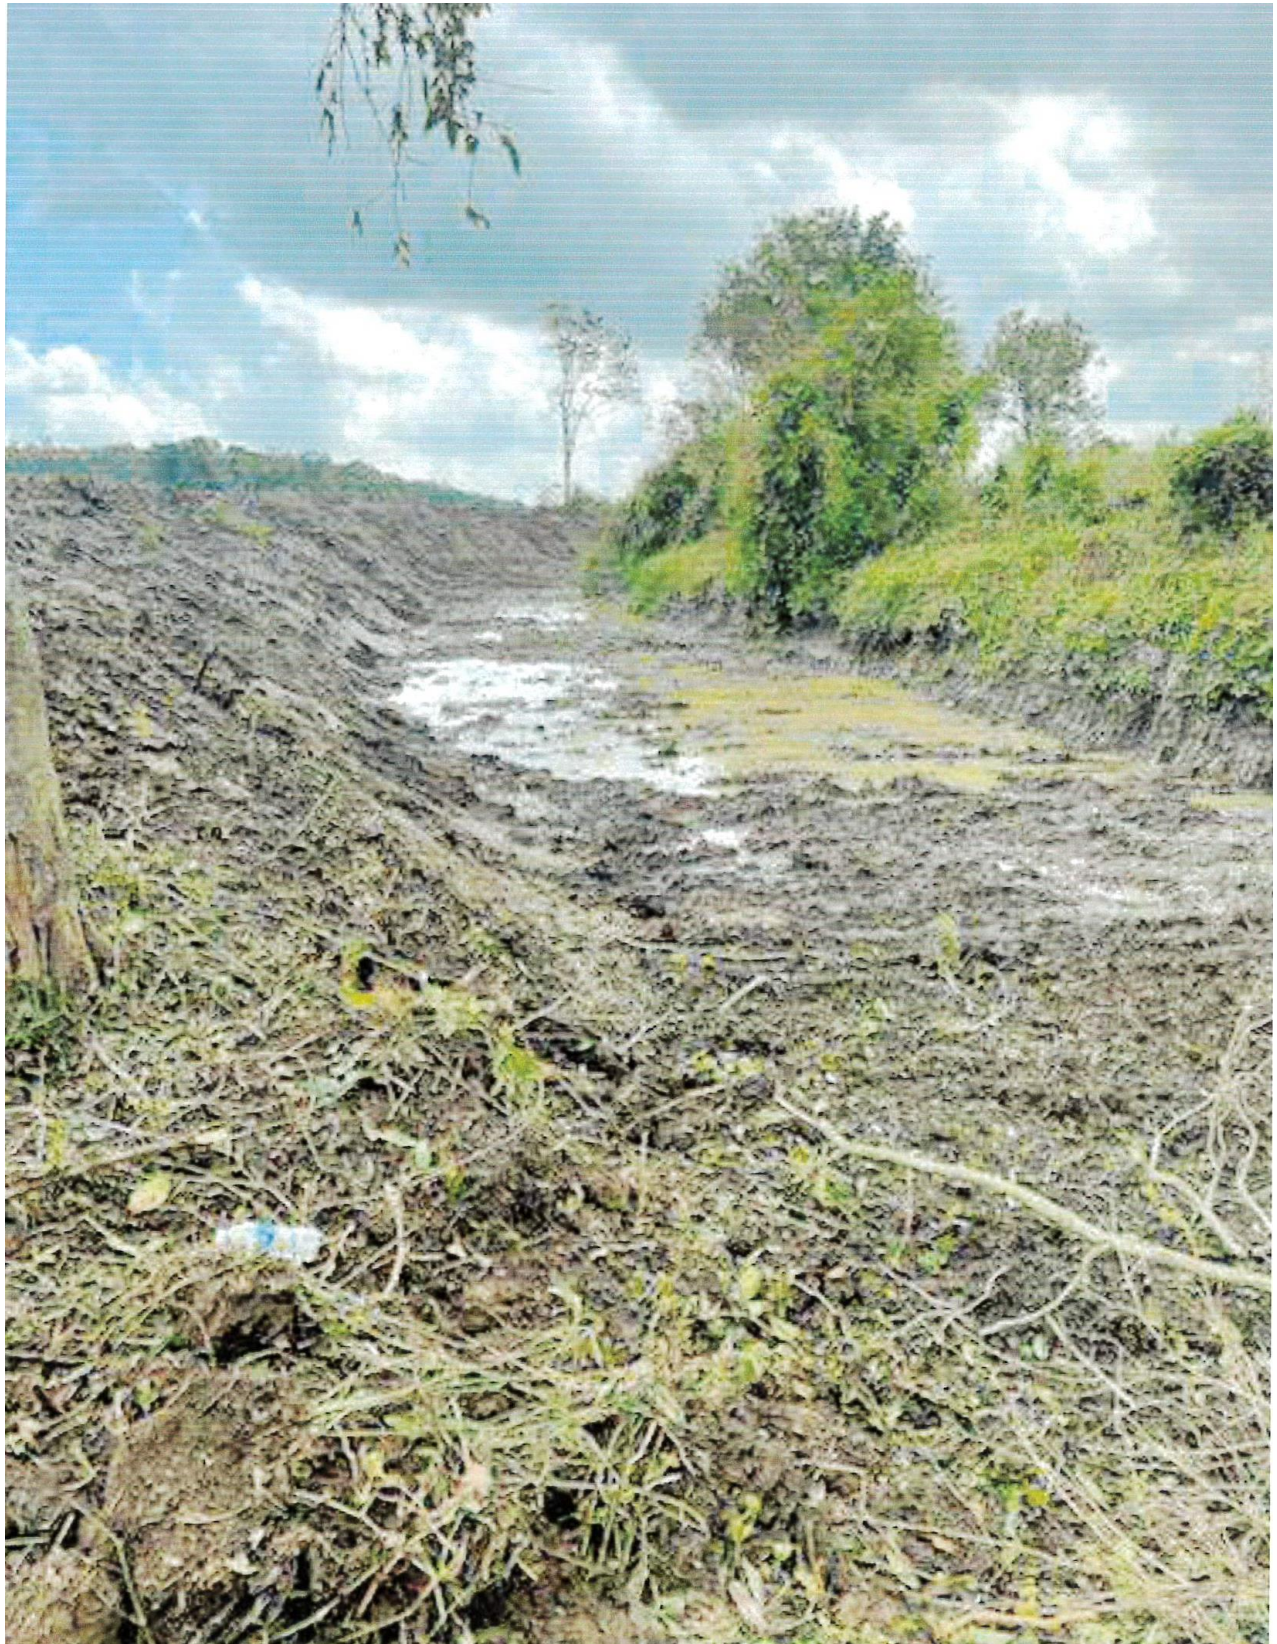
Photo B5: Area near Baxter Bayou structure on September 18th. Photo taken on 9/18/21 by Bo Holt.

Photo B6: Area near Baxter Bayou structure on September 18th. Photo taken on 9/18/21 by Bo Holt.
