Lake Providence Watershed Council

MANAGING LAKE PROVIDENCE WATERSHED RESOURCES

2022 Update

An Annual Report to the Louisiana Legislature

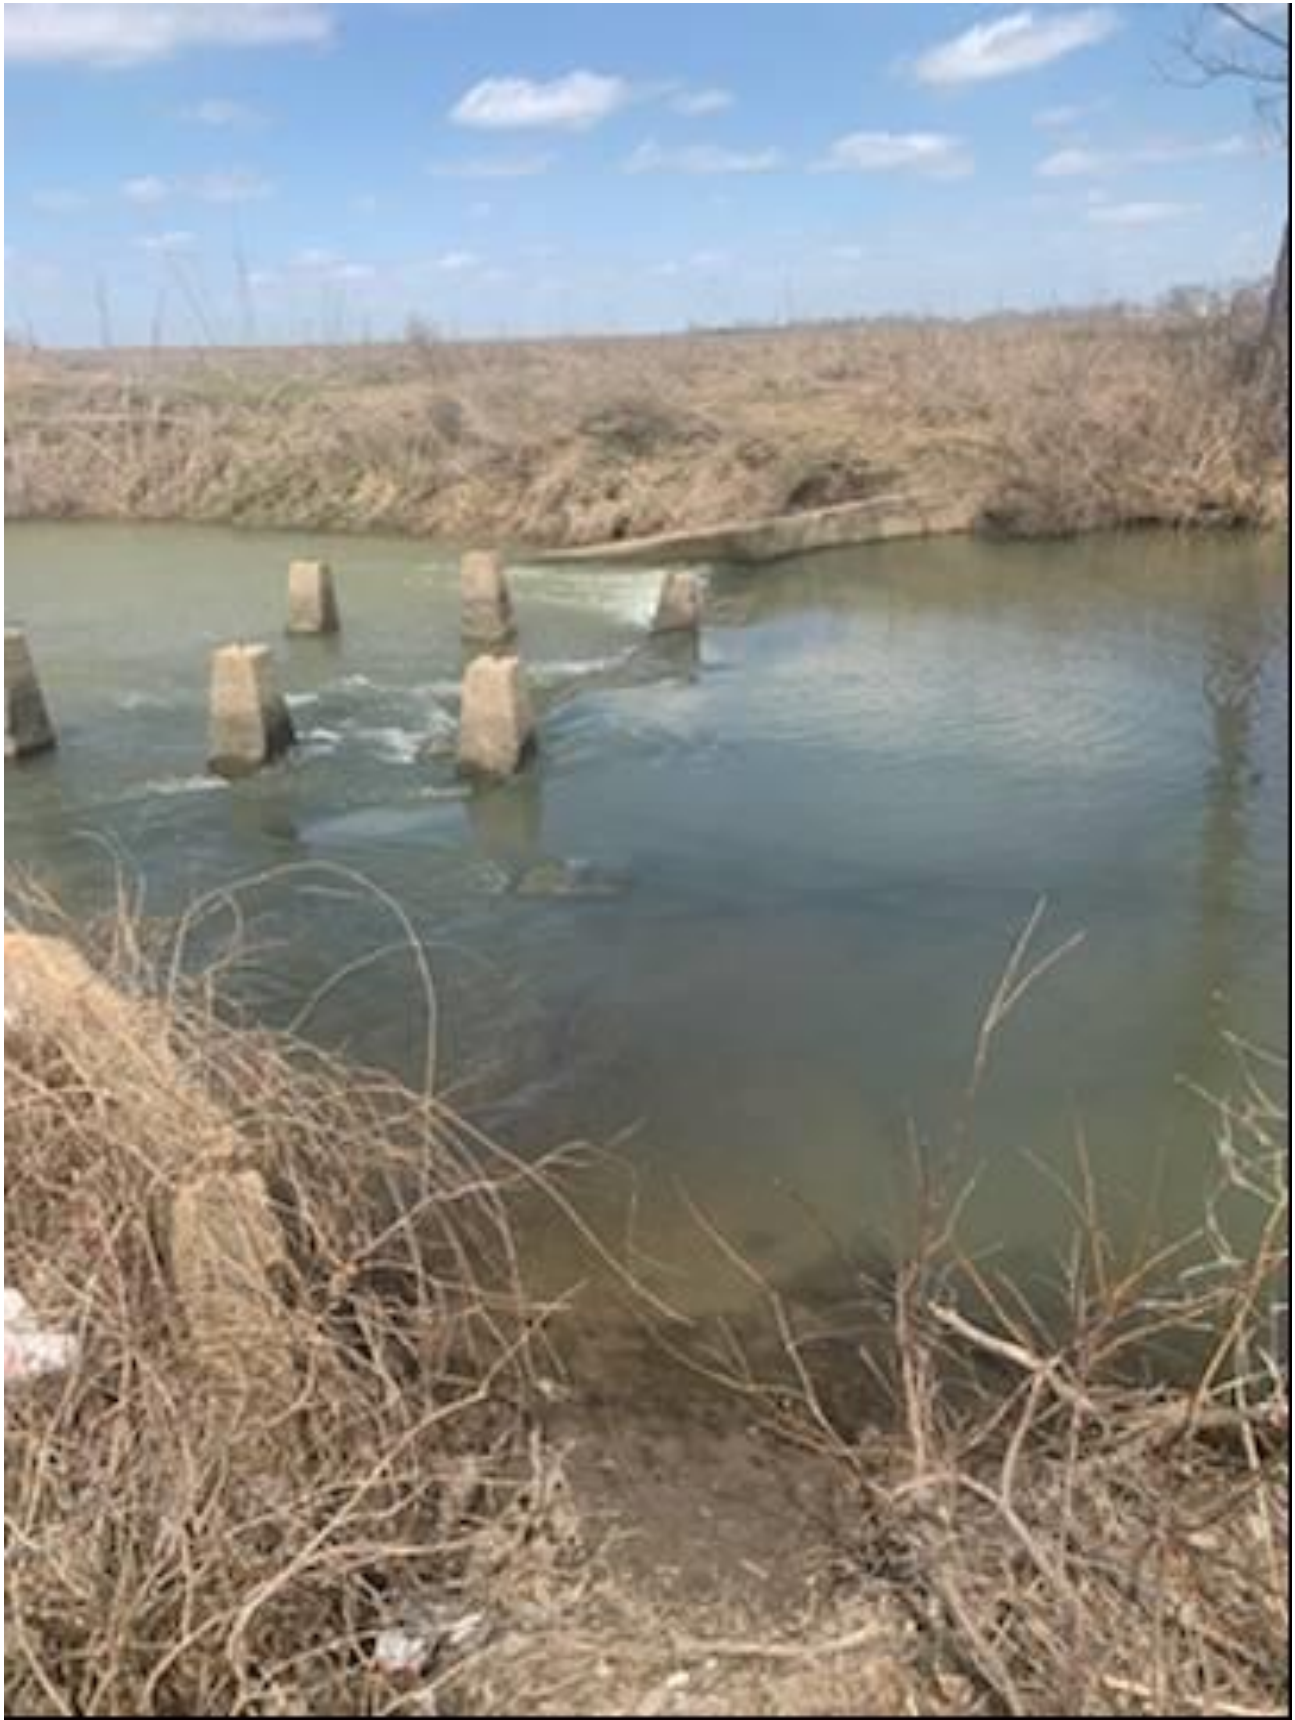
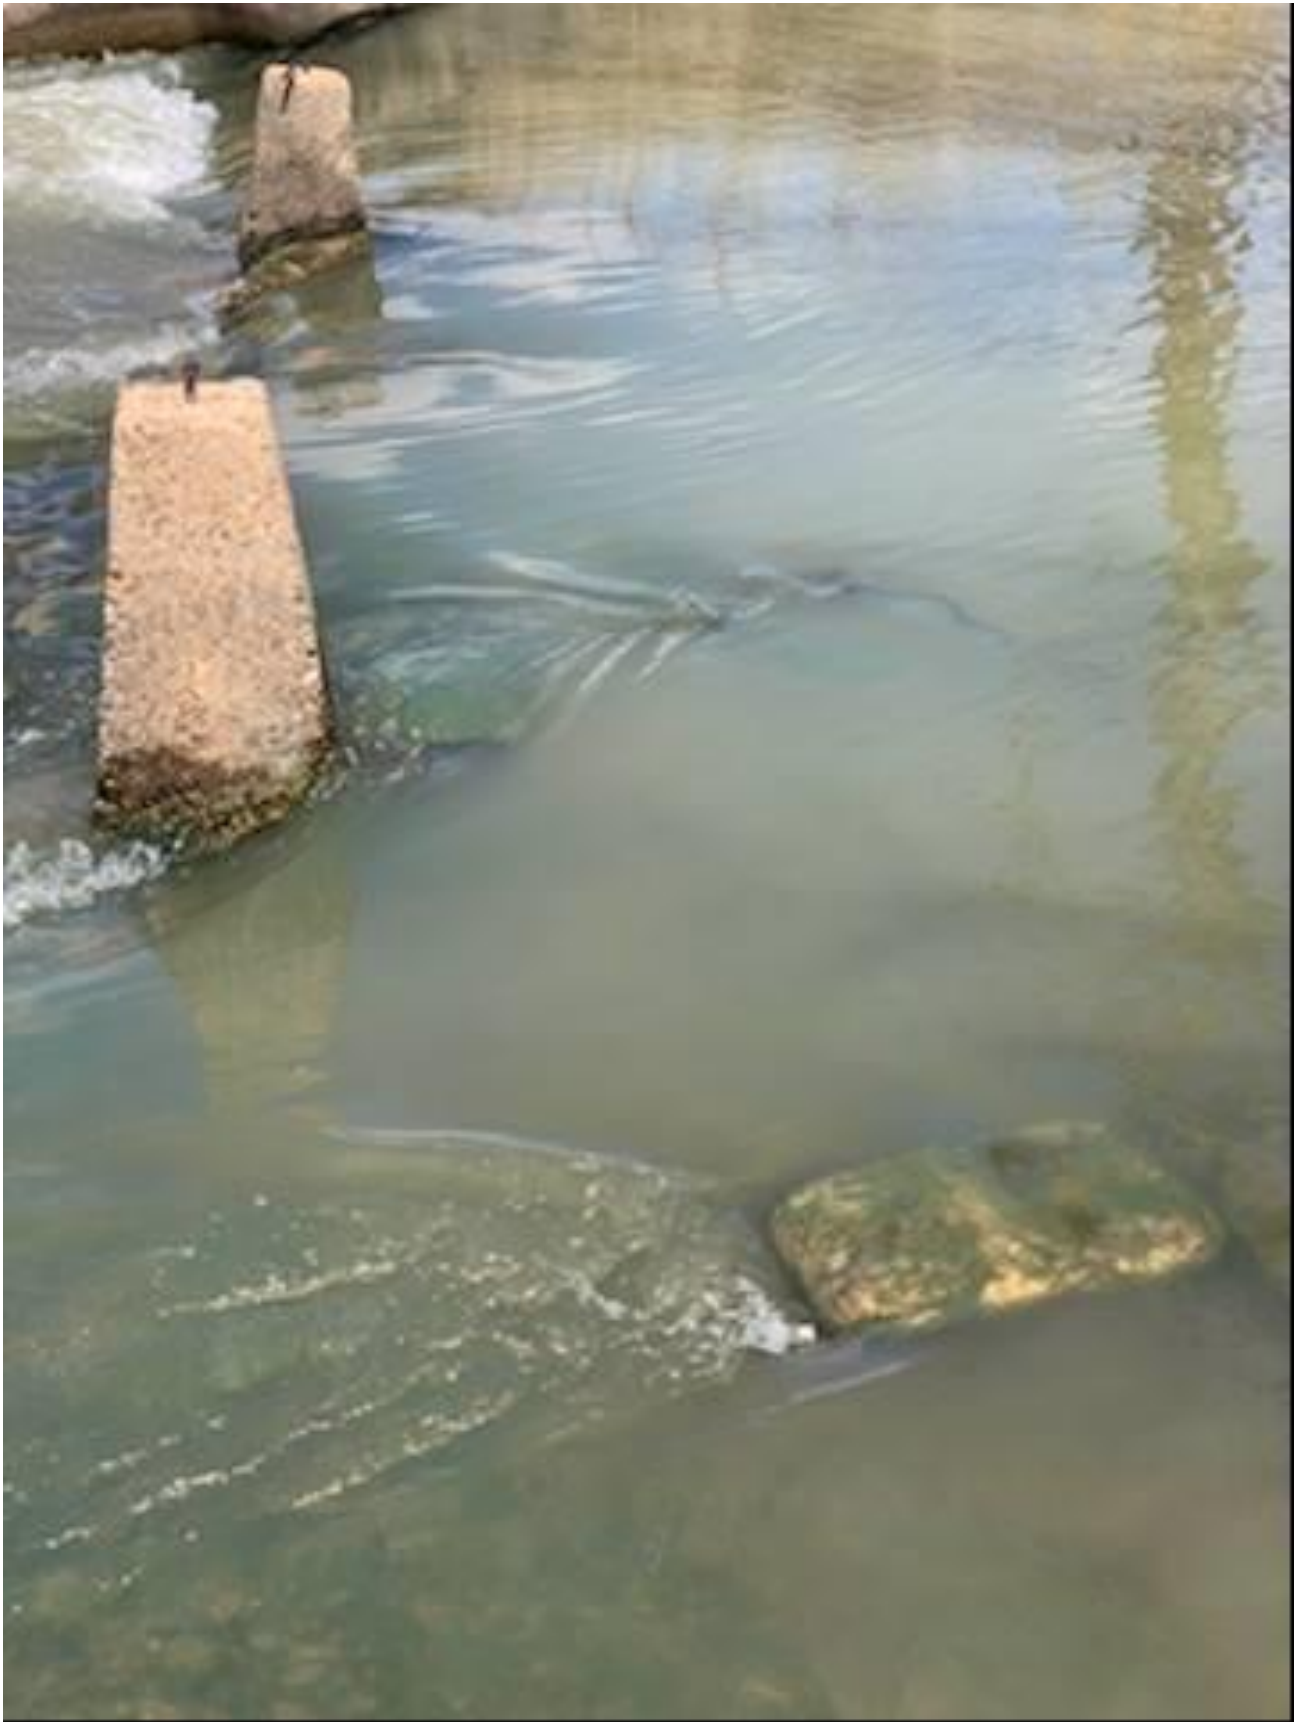
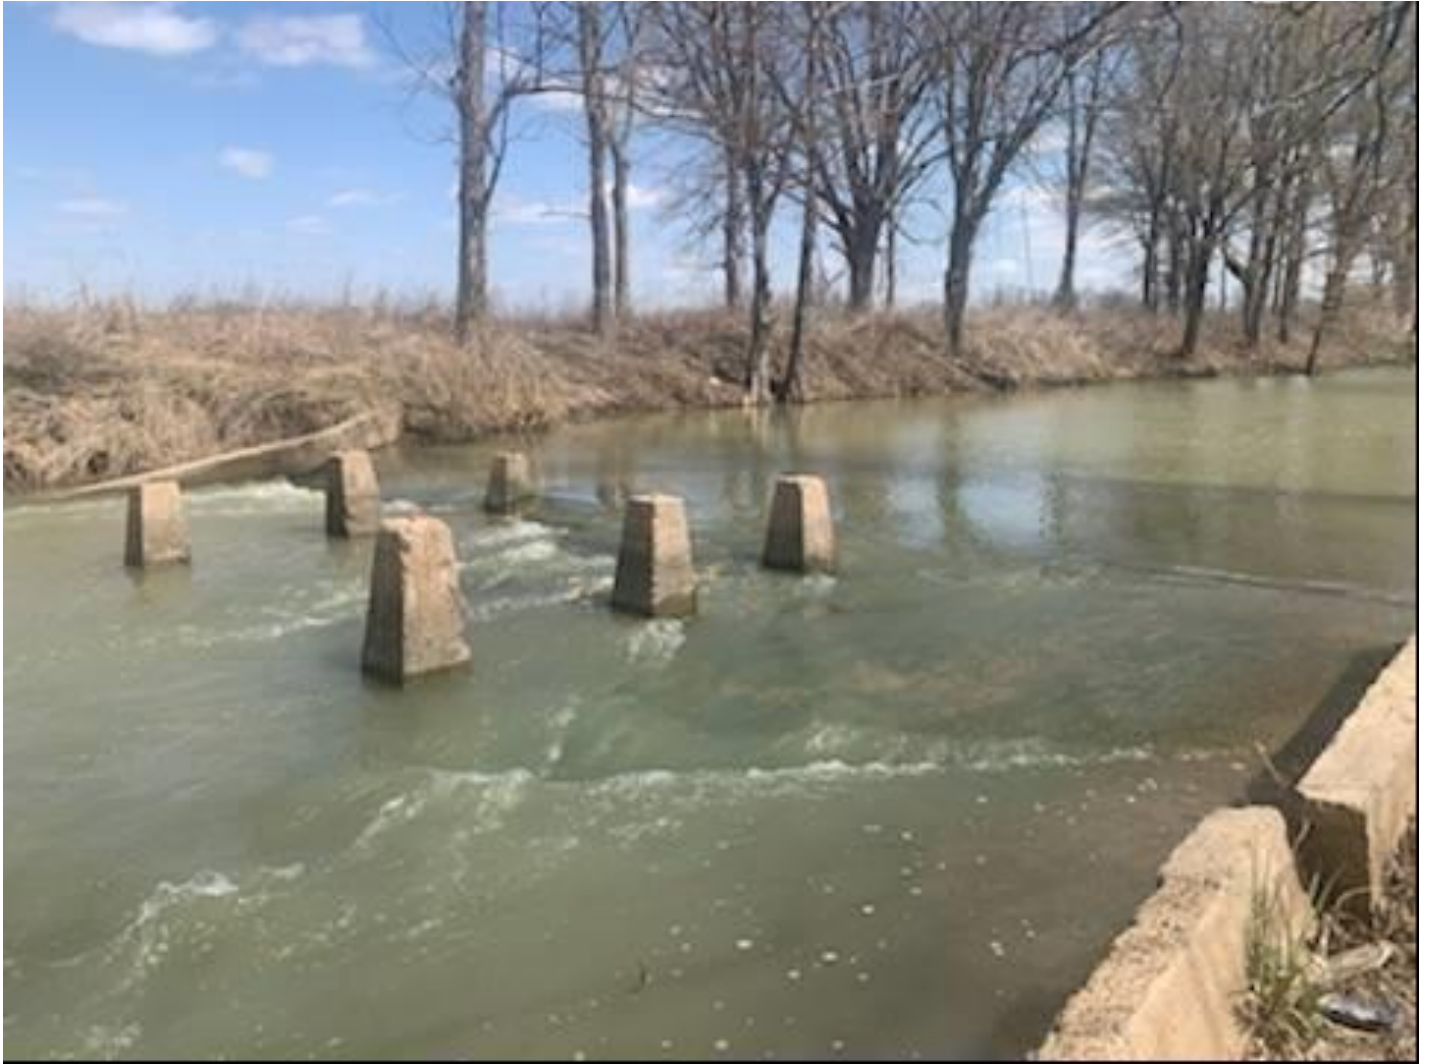
This older weir, which is the primary drain for the lake, does not allow for lake level manipulation (Appendix C). It is in disrepair and being bypassed along its side (see news article in Appendix D). The East Carroll Parish Police Jury has placed cement bags on the structure to maintain its integrity. The East Carroll Parish Police Jury has been in contact with the LDOTD and has hired an engineer to prepare plans to replace the weir. Current estimates suggest that the work will begin in 2023.

Photograph C1: View north across the Tensas Bayou Weir (taken by Roger Clement on 3/29/22).

Photograph C2: View north across the Tensas Bayou Weir (taken by Roger Clement on 3/29/22).

Photograph C3: View north across the Tensas Bayou Weir (taken by Roger Clement on 3/29/22).

As reported recently in an article printed in the Providence Journal (Appendix C), the East Carroll Parish Police Jury has been working for the past several years with the Louisiana Department of Transportation and Development to replace the weir on the Tensas Bayou. As reported in previous report, the weir built prior to 1970 to maintain the lake pool level, is in disrepair and currently being partially bypassed. Current estimates suggest that the work will begin in 2023. East Carroll Parish Police Jury submitted an \$800,000 request through capital outlay for the weir and drainage for FY22-23.

A crucial piece of East Carroll Parish infrastructure built before 1970 is currently undergoing a redesign and will be replaced in 2023. The weir in the Tensas Bayou, along Highway 134, that helps to control the elevation of the lake, is, as police juror Randy Walters puts it, “still functioning, but it’s only a matter of time before a weather event happens and it blows out.”

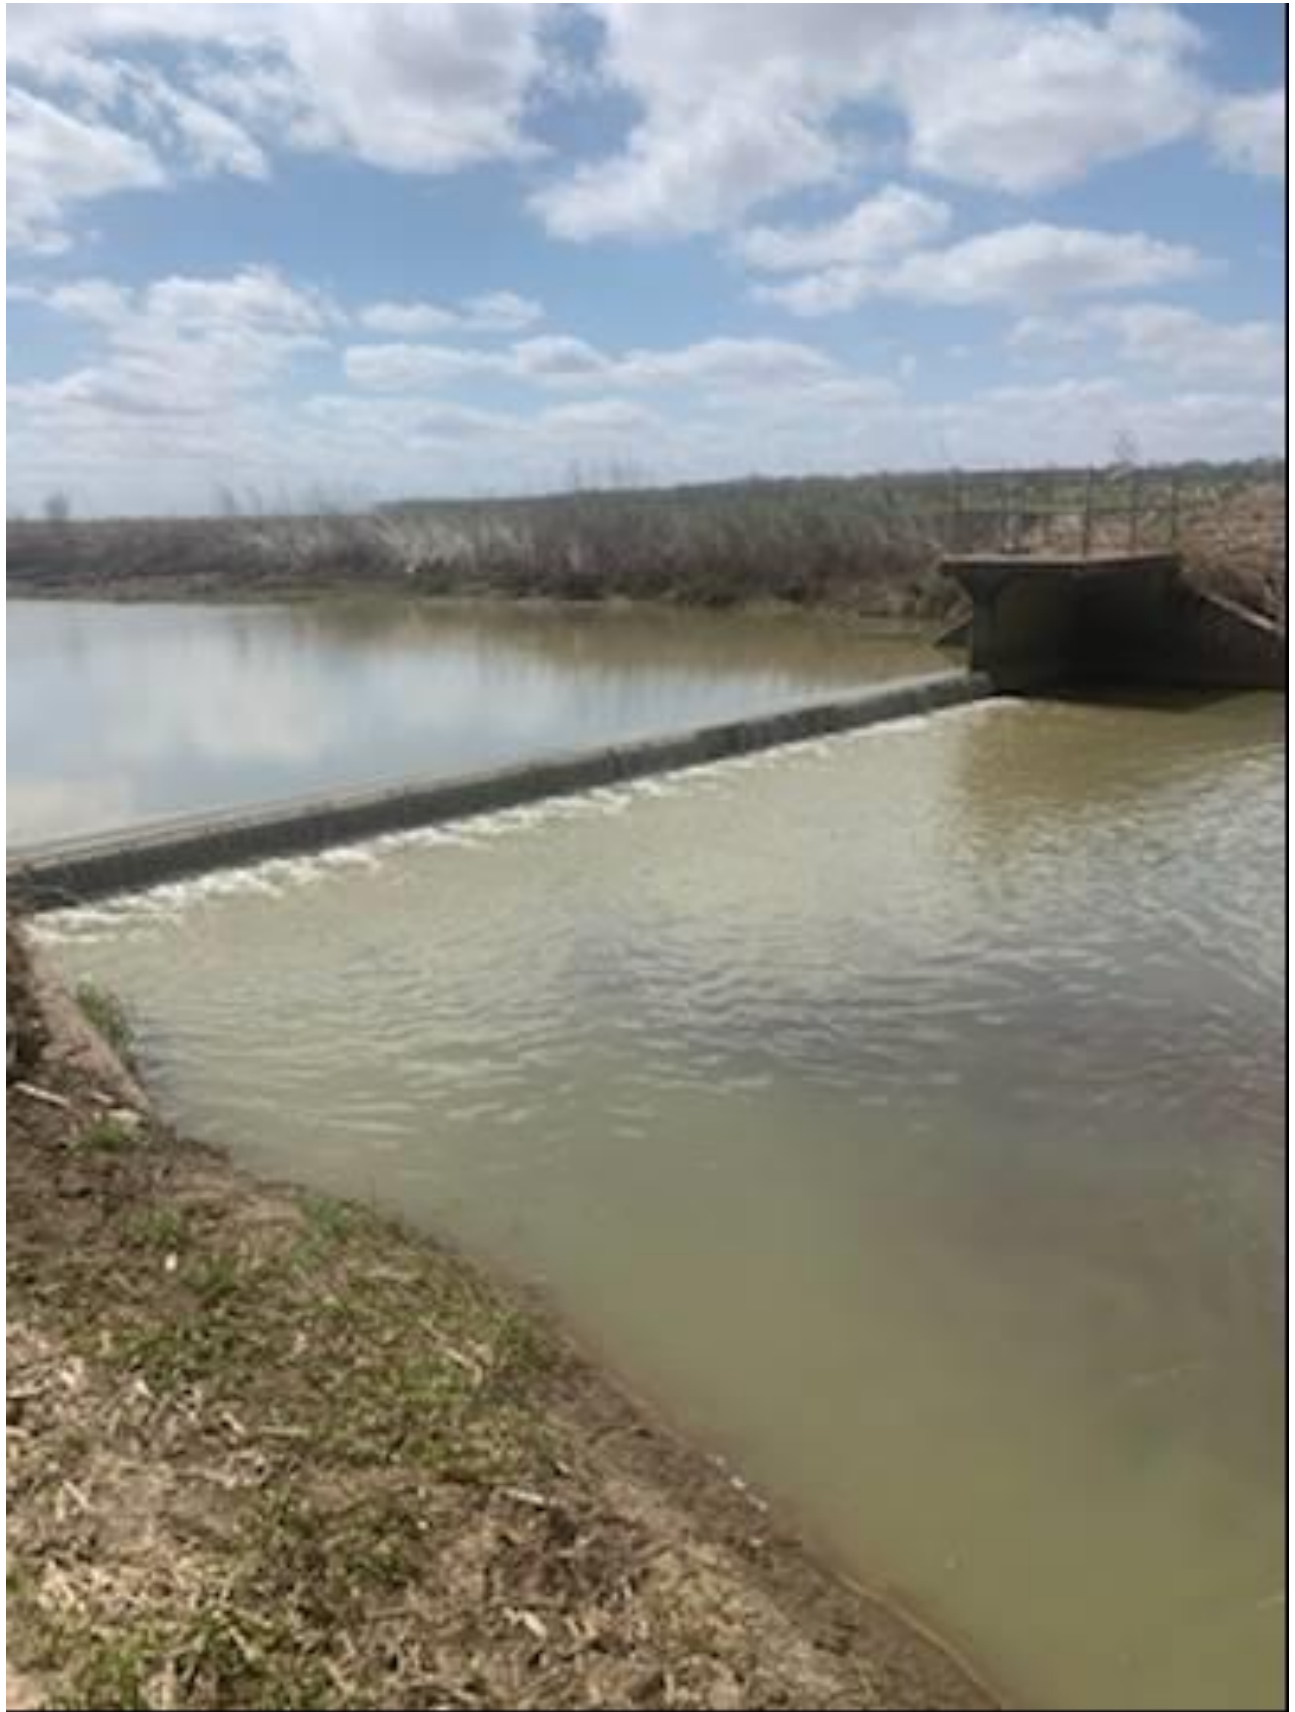
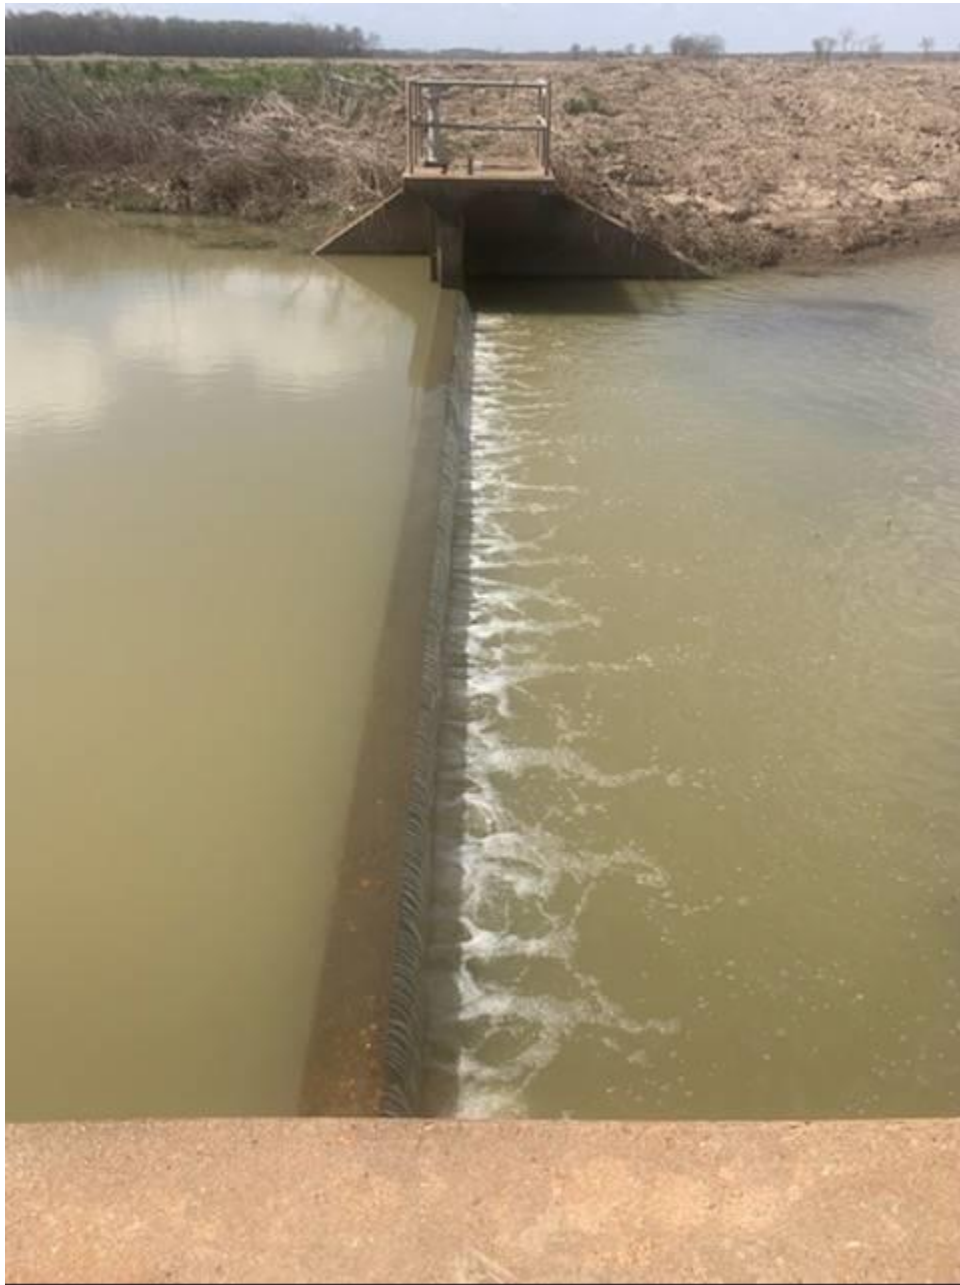
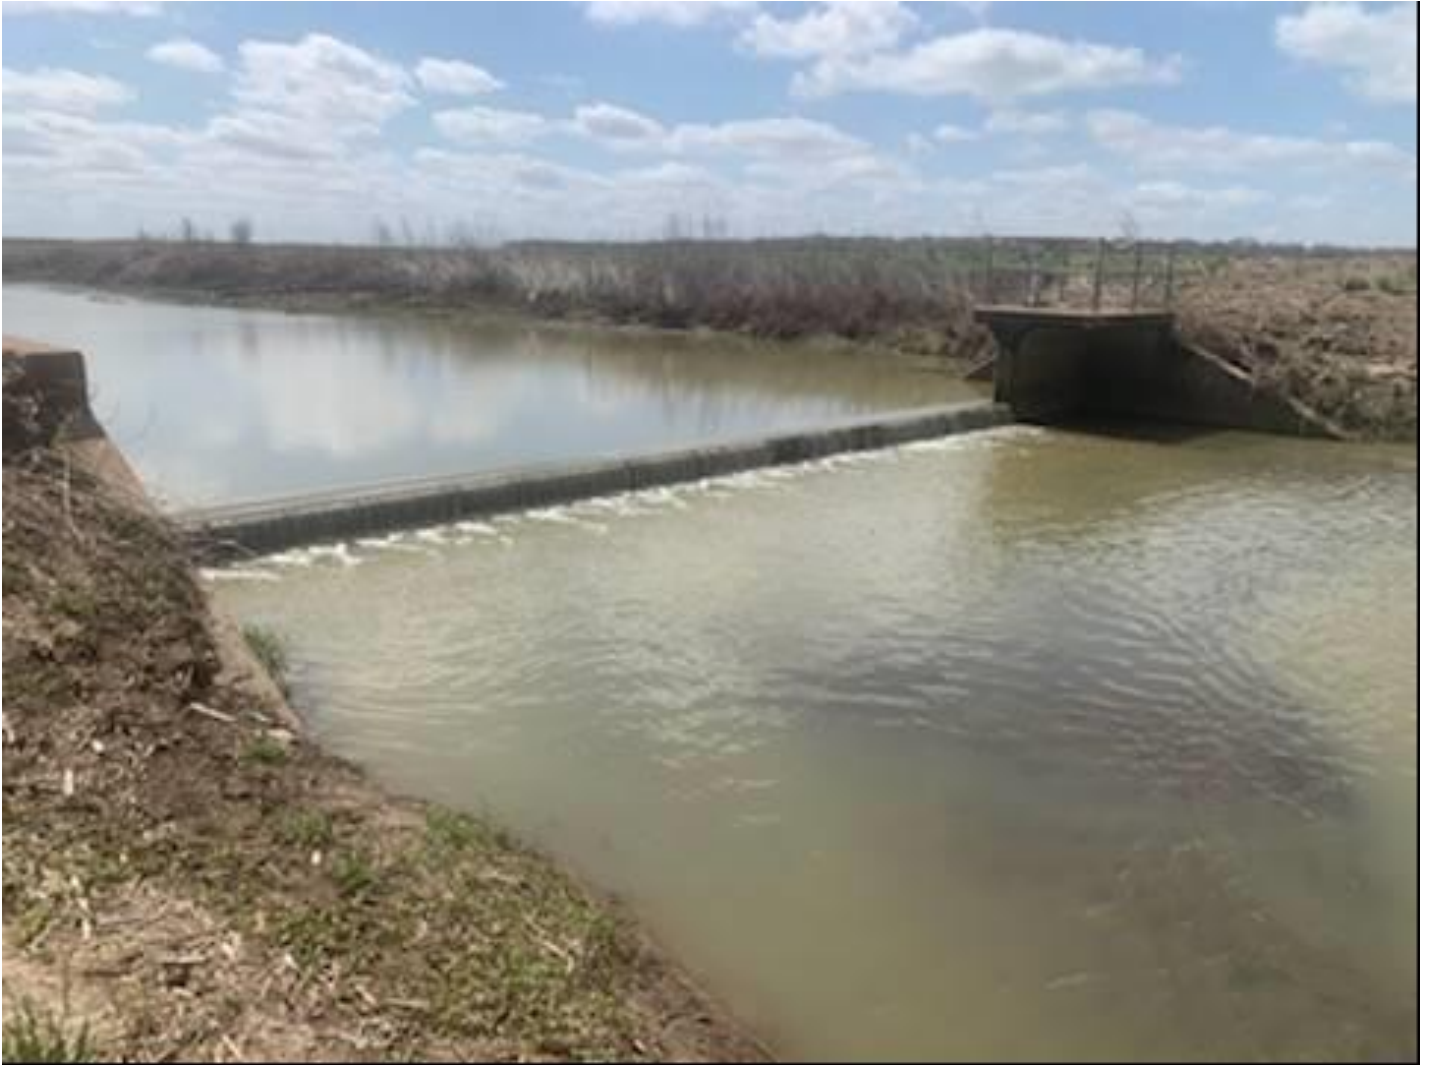
Baxter Bayou only allows water to flow out of the lake at high stage, otherwise reverse flow can occur at time of unevenly distributed precipitation. Currently, the structure does not allow for lake level manipulation as the gate valve is in disrepair and can no longer be operated. In addition, the structure is bypassed by the flowing water, both along the side and beneath the structure. The recent clean out work of Baxter Bayou appears to be a success by judging the movement of water in a rain event that was approximately 3 inches in a short period of time (Appendix E).

Photograph E1: View southeast across the Baxter Bayou Control Structure (taken by Roger Clement on 3/29/22).

Photograph E2: View south across the Baxter Bayou Control Structure (taken by Roger Clement on 3/29/22).

Photograph E3: View southeast across the Baxter Bayou Control Structure (taken by Roger Clement on 3/29/22).
