Four Bayou Pass Oil Spill 1999

Gina Muhs Saizan
Louisiana Oil Spill Coordinator's Office/DPS
Chevron NRDA Training

Four Bayou Pass Oil Spill

- November 24, 1999
- Pressure drop on a 20" crude oil pipeline
- ~850 bbls of crude oil was released
- MARS blend sour crude

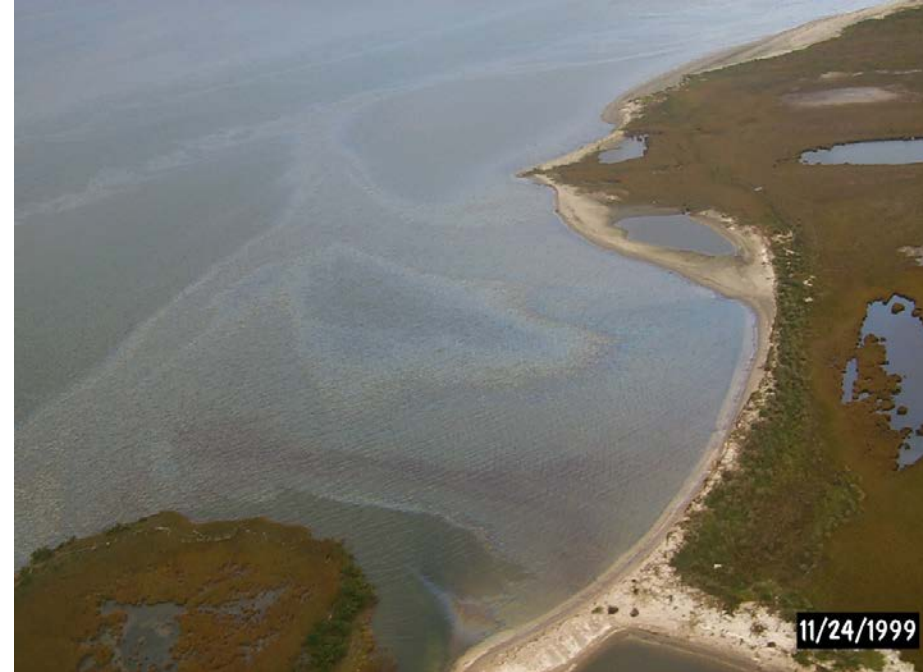
Oiled Beach

- Black oil streamers and rainbow sheens on Gulf, in passes, and bay for several days = Aquatic Injuries

- Black oil on beaches and marshes of barrier islands (Elmer's Island, Grand Isle, Grand Terre, and East Grand Terre) = Habitat Injuries
- Birds Oiled = Wildlife Injuries
- State Park and boat launch closures = Recreational Use Injuries

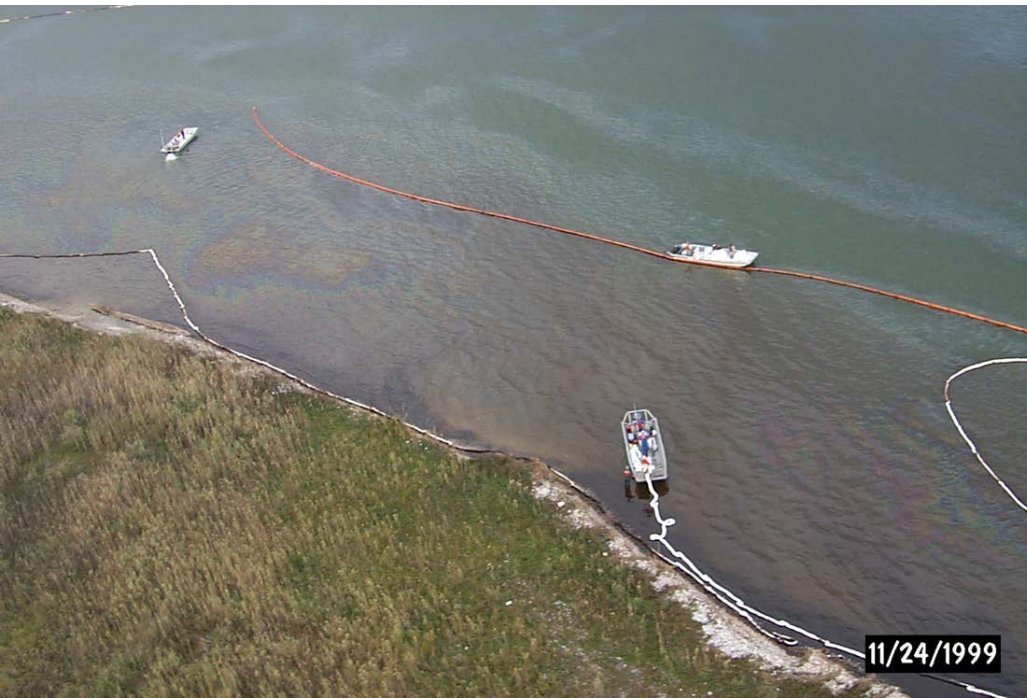
Oiled Marsh

A photograph of a marsh area heavily contaminated with oil. The water is dark and reflective, showing the surrounding tall, yellowish-brown grasses. The grasses are partially submerged and appear to be coated in a dark, viscous substance. The overall scene depicts a significant environmental impact.

- ~ 4.5 acres of marsh habitat was exposed to black oil
