DAMAGE ASSESSMENT AND RESTORATION PLAN

for 2014 Mid-Valley Pipeline Oil Spill

NRDA CASE FILE #LA2014 1013 1210

June 2022

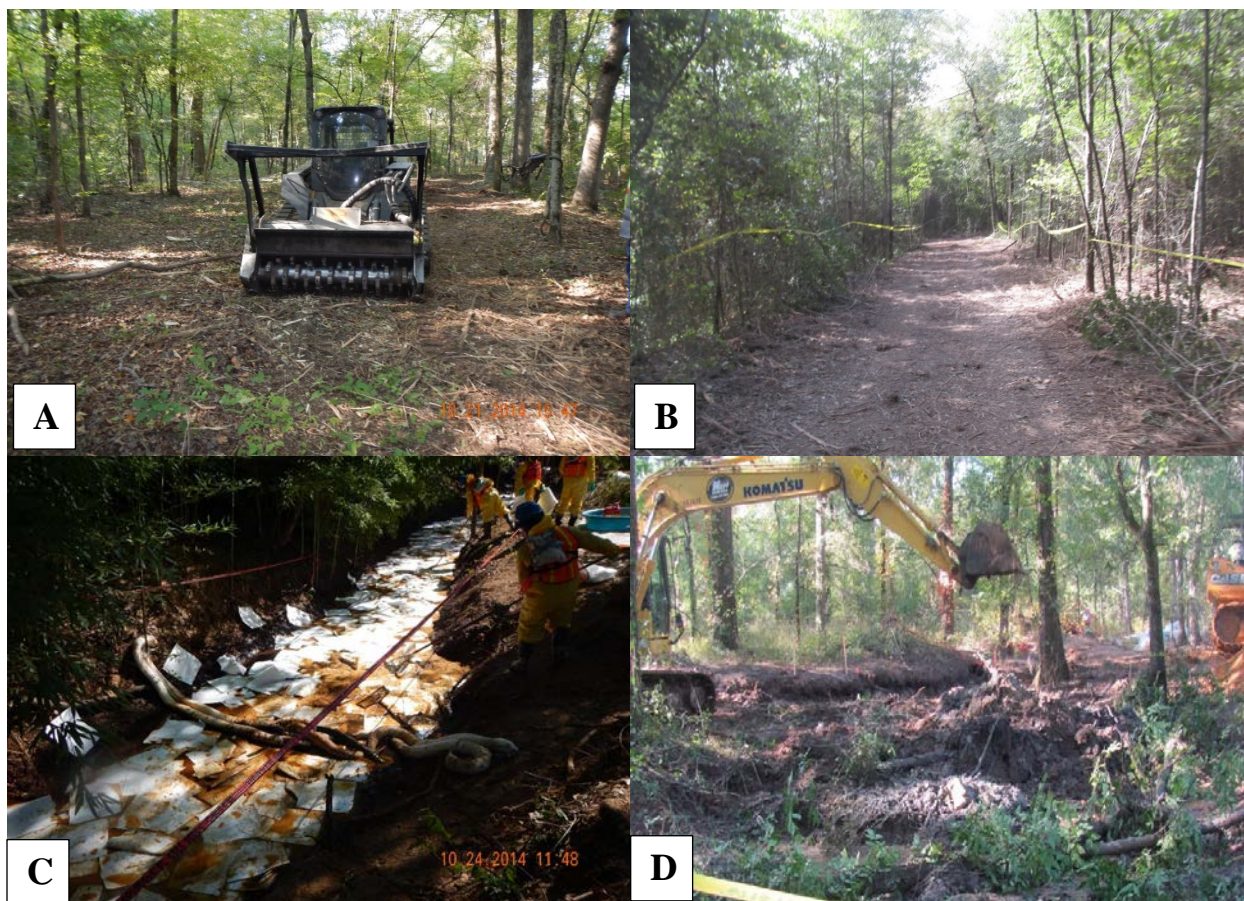
Figure 3.2 Photos documenting terrestrial habitat impacts caused response activities. A) Machinery used to clear-cut response paths, B) Portion of a clear-cut response path, C) Response personnel during clean-up, D) Disturbance along the Tete Bayou and mixed forest habitat during the response

Portions of the mixed forest habitat were clear-cut in order to create a series of pathways or trails to access and clean-up oil in and along Tete Bayou and nearby waterways during the response. These paths were clear-cut using a John Deere Doggett 333E with a chipper/shredding attachment. Additional response related injuries to mixed forest habitat included trampled or denuded vegetation caused by the foot traffic of approximately 400 clean-up personnel and use of heavy equipment and Utility Terrain Vehicle's. Figure 3.2 shows examples of the terrestrial habitat impacts caused by the response actions.
