US DOT PHMSA AID Situational Awareness for Employees: SAFE Bulletin¹ Internal Corrosion – Crude Oil

49 C.F.R. Part 195 Transportation of Hazardous Liquids by Pipeline

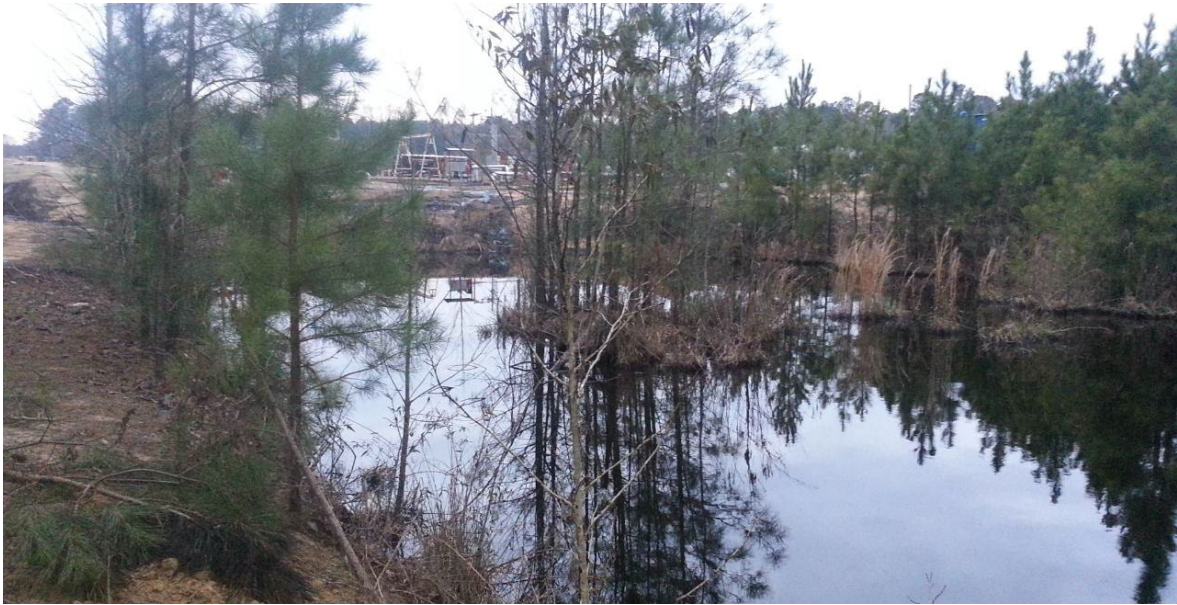
The strainer was part of the original 1940 construction. The strainer failure was caused by extreme, localized internal corrosion. The internal corrosion was caused by an acidic environment, most probably naphthenic acid (normal in crude oil). There was no evidence of MIC. [Failure Investigation Report](#)

Figure 10. Retention pond was designed to capture released oil. Photo from EPA website¹⁷.
