US DOT PHMSA AID Situational Awareness for Employees: SAFE Bulletin¹

Side-Entry Tank Mixer Product Releases from Crude Oil Breakout Tanks Due to Hinge Assembly Disengagement and Other Causes

49 C.F.R. Part 195 Transportation of Hazardous Liquids by Pipeline

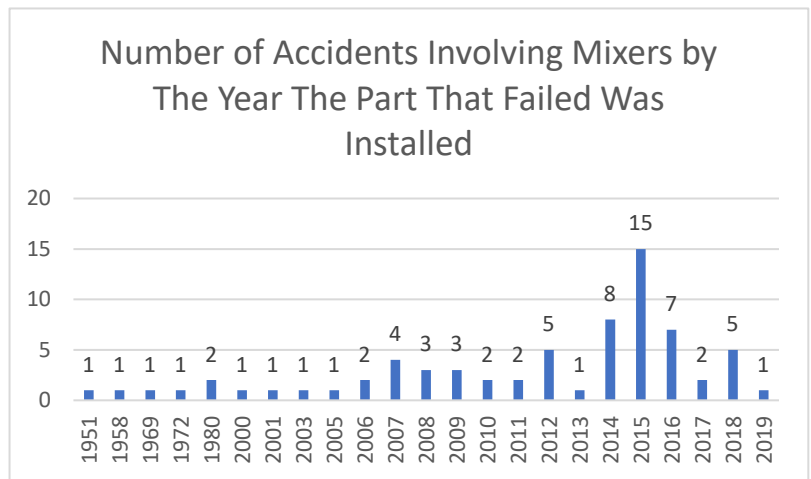
- 99 of 4,001 hazardous liquid (HL) accident reports involved a tank mixer (~2.5% of all HL accidents).
- 30,828 barrels of crude oil were unintentionally released. Product was totally contained on operator-controlled property in 97 of the 99 accidents.

- 4 hinge assembly events on crude oil tanks resulting in the unintended release of 29,163 barrels.
- 81 ‘seal or packing’ leaks
- No fatalities, injuries, or evacuations. Pipeline operations were shut down 20 times.

- 1 ignition which involved a bearing event that led to a mechanical seal leak.
- 1 ignition/explosion occurred during the replacement of the tank mixer when flammable vapors reached a source of ignition.

- 79 accidents were identified by local operating personnel, 4 by ground/air patrol, and 1 by Controller and 1 by CPM/SCADA.
- The highest number of reportable accidents involved a mixer where the part that failed was installed between 2014-2016.
