#### INCIDENT ACTION PLAN

Location	Control Level	Operational Period	
Bayou Corne Sink Hole	Company Supervisory	From 10/9/12	To 10/10/12

RE: In-Place Inclinometer and Tiltmeter Monitoring System, Napoleonville Dome Weekly Report: September 29 Through October 5, 2012

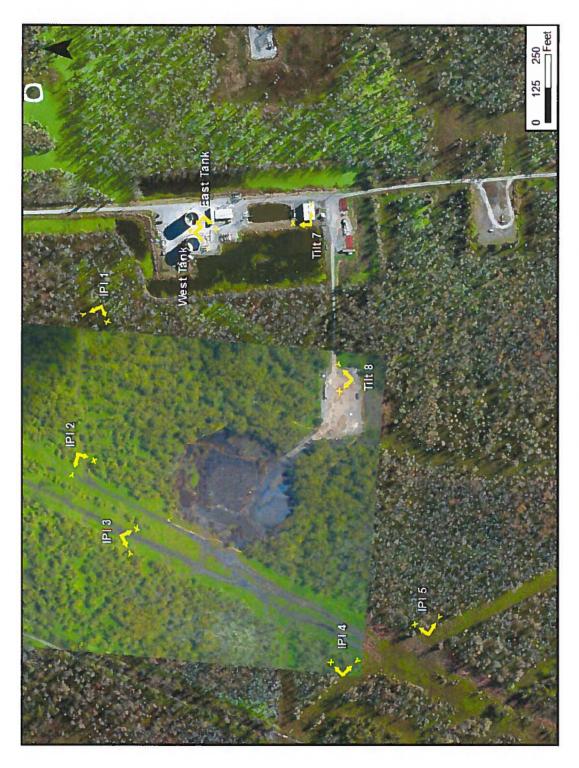
Figure 1. Inclinometer and Tiltmeter Locations.

Cornerpost bracing that was installed by airboat crews was inspected on the morning of Tuesday, October 2. Data indicates that the airboat visits to site IPI-4 caused noise in the data. The post that holds the datalogger housing at IPI-3 was left tilted approximately 30 degrees; on Wednesday morning this was corrected by lashing it upright to another post at the site. This also caused noise in the data. With the additional shoring, however, data noise has been reduced. At 14:45 on Thursday, October 4, IPI-4 recorded approximately 0.01 degrees tilt toward the sinkhole. IPI-5 is recording tilt toward the sinkhole following a linear trend at a rate of approximately 0.0013 degrees/day. Strain left in the system from corner-post construction may cause the posts to tilt over time as they reach equilibrium. Other IPI and tiltmeter data have reflected stable conditions over the past week.

Communication problems have been greatly reduced, but have not been completely solved. Settings in the Atlas server caused issues with communication; but these have been corrected. Antenna were reconfigured to improve communication with site Tilt 8 (Oxy-Geismar 3 pad);

however, the site has currently been offline for 2 days because of unknown causes. Texas Brine Company, LLC will be notified as soon as the communication problem is corrected.
