PHOTOGRAPHIC LOG

Client Name: Henning Management, L.L.C. v. Chevron U.S.A. Inc., et al.	Site Location: Hayes Oil & Gas Field, Calcasieu and Jefferson Davis Parishes, Louisiana	Project No.: 0526033
--	---	--------------------------------

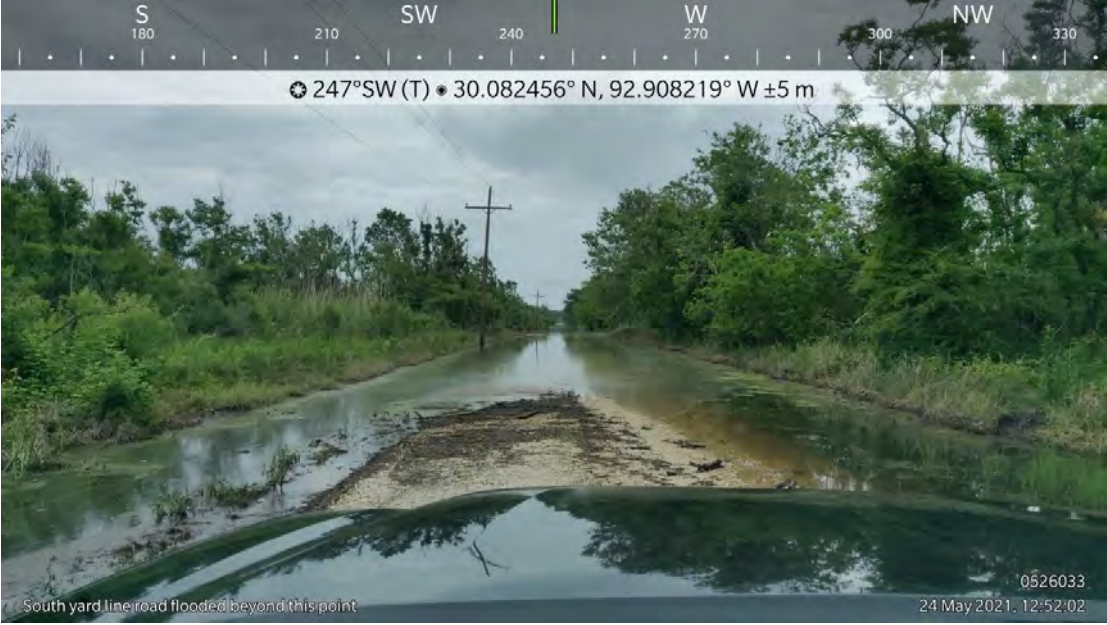
Photo No. 1	Date: 5/24/2021

Direction Photo Taken: West		
Description: File: 0526033-2021-05-24-12-52-02 South yard line road flooded beyond this point

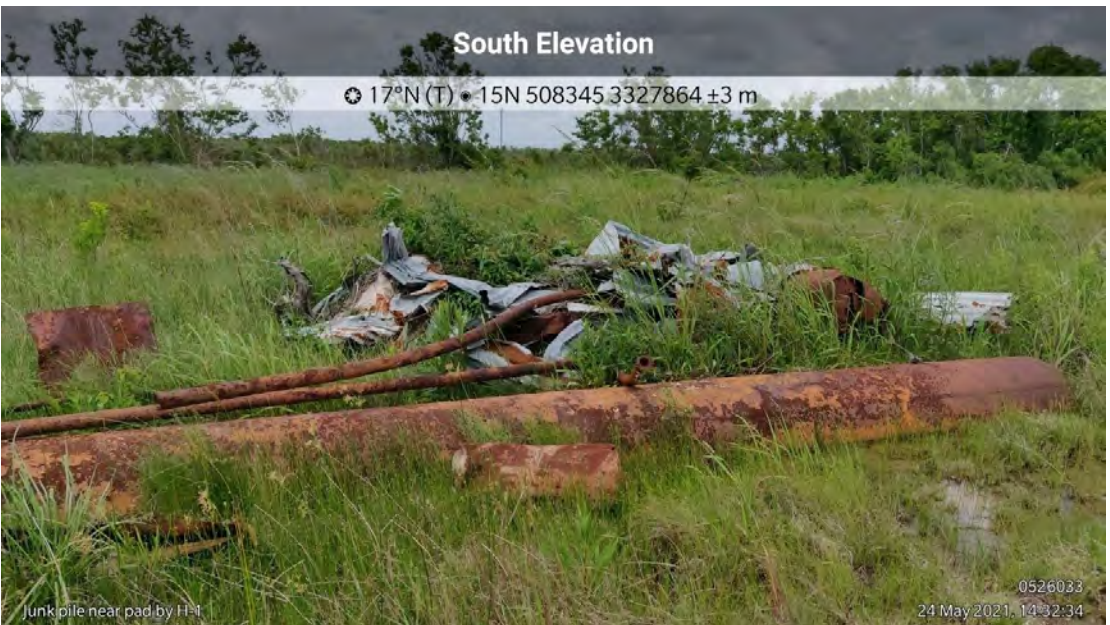
Photo No. 4	Date: 5/24/2021

Direction Photo Taken: North		
Description: File: 0526033-2021-05-24-14-32-34 Junk pile near pad by H-1

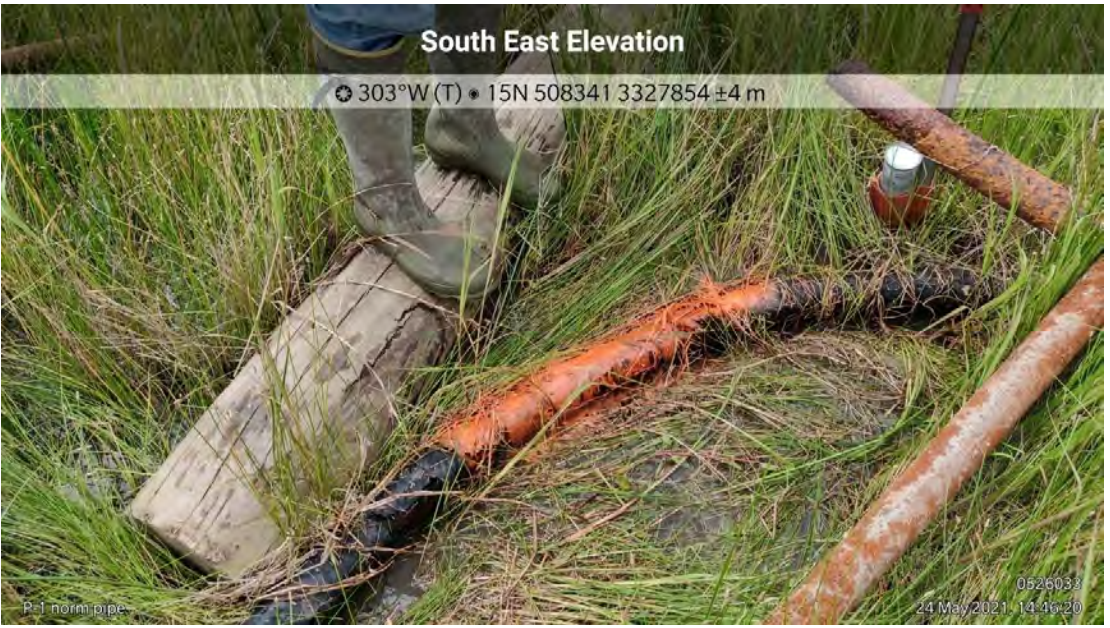
Photo No. 6	Date: 5/24/2021
Direction Photo Taken: West	
Description: File: 0526033-2021-05-24-14-46-20 P-1 Norm Pipe

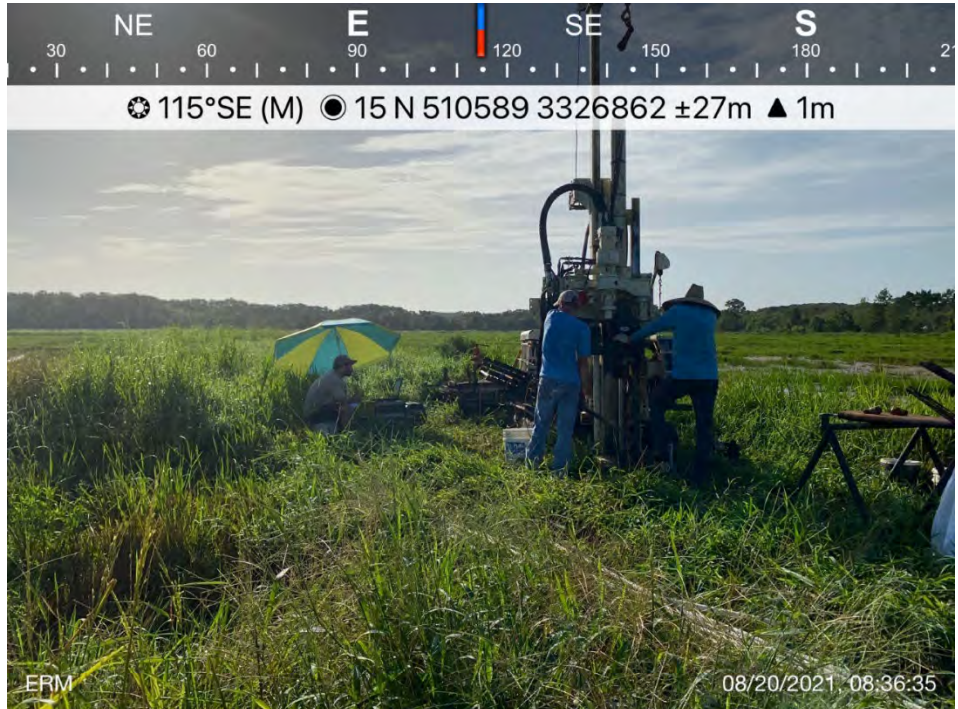
Photo No. 35	Date: 8/20/2021
Direction Photo Taken: E	
Description: IMG_0990 ICON conducting EC probe at H-34

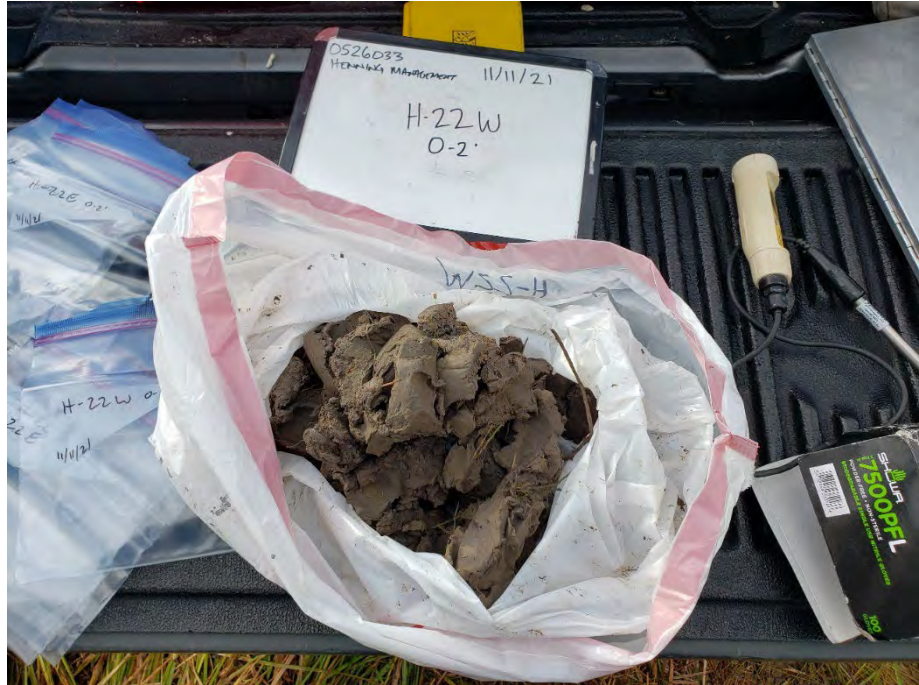
Photo No. 15	Date: 11/11/2021
Direction Photo Taken:	
Description: 20211111_085341 H-22W 0-2' soil cuttings -EC: 0.85 -Clay, dark brown (7.5 YR 3/2) -PID: 0.0 ppm

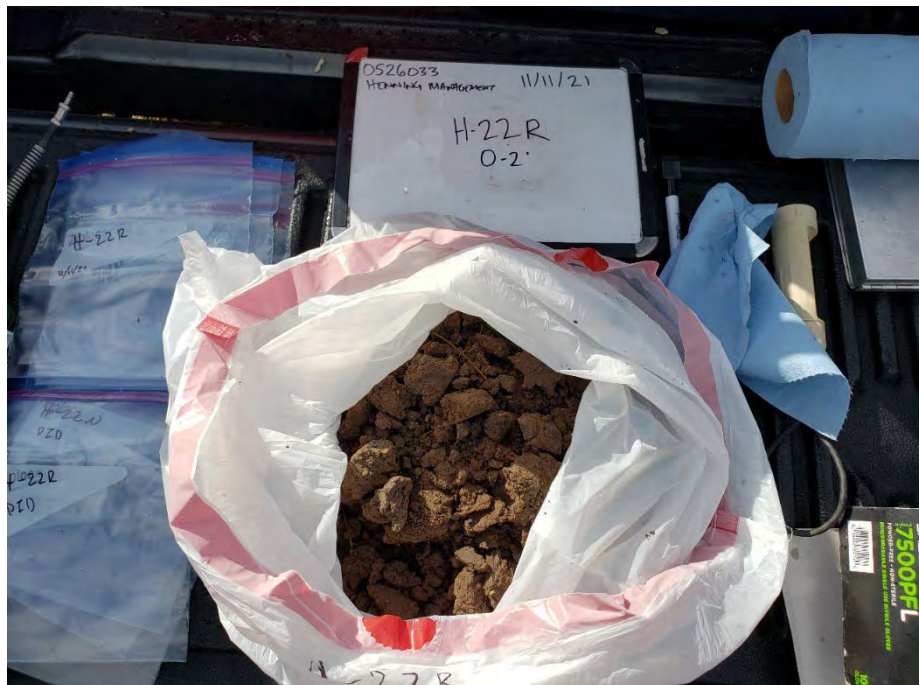
Photo No. 16	Date: 11/11/2021
Direction Photo Taken:	
Description: 20211111_090320 H-22R 0-2' soil cuttings -EC: 1.10 -Silt with clay, dark brown (10 YR 3/3) slightly moist, medium stiff, no odor -PID: 0.0 ppm

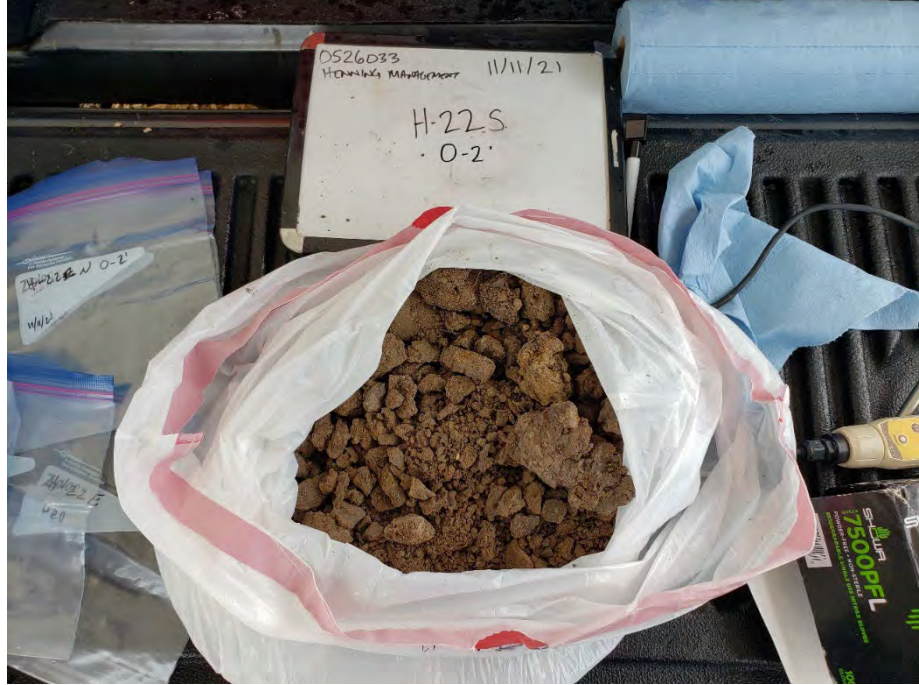
Photo No. 17	Date: 11/11/2021
Direction Photo Taken:	
Description: 20211111_091506 H-22S 0-2' soil cuttings -EC: 0.61 -Silt with clay, dark brown (10 YR 3/3), dry to slightly moist, medium stiff, no odor, minor rootlets -PID: 0.0 ppm

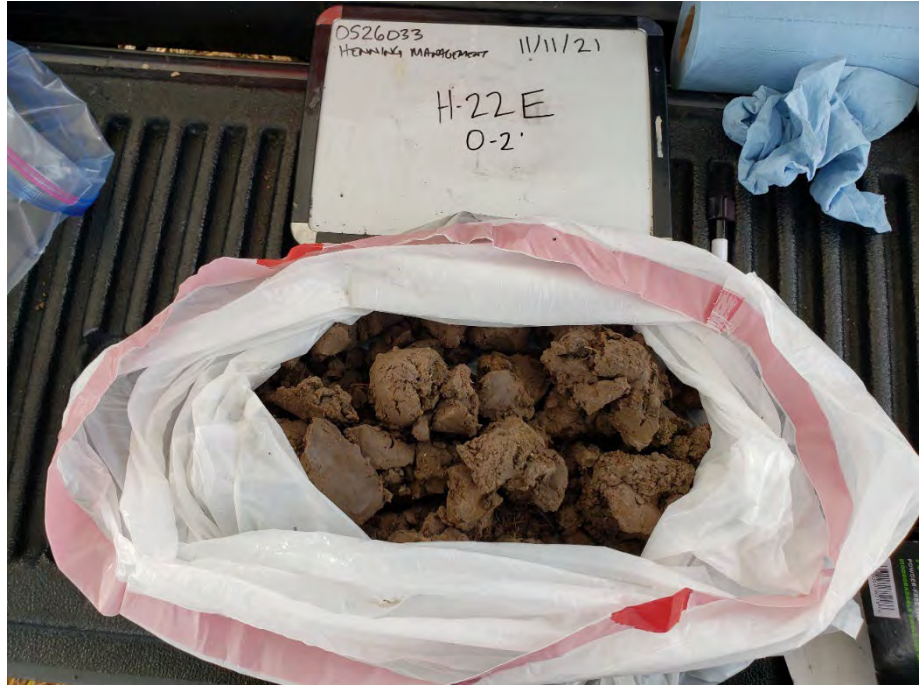
Photo No. 19	Date: 11/11/2021
Direction Photo Taken:	
Description: 20211111_093113 H-22E 0-2' soil cuttings -EC: 1.01 -Silty clay, dark brown (10 YR 3/3), moist, medium stiff, no odor -PID: 0.0 ppm

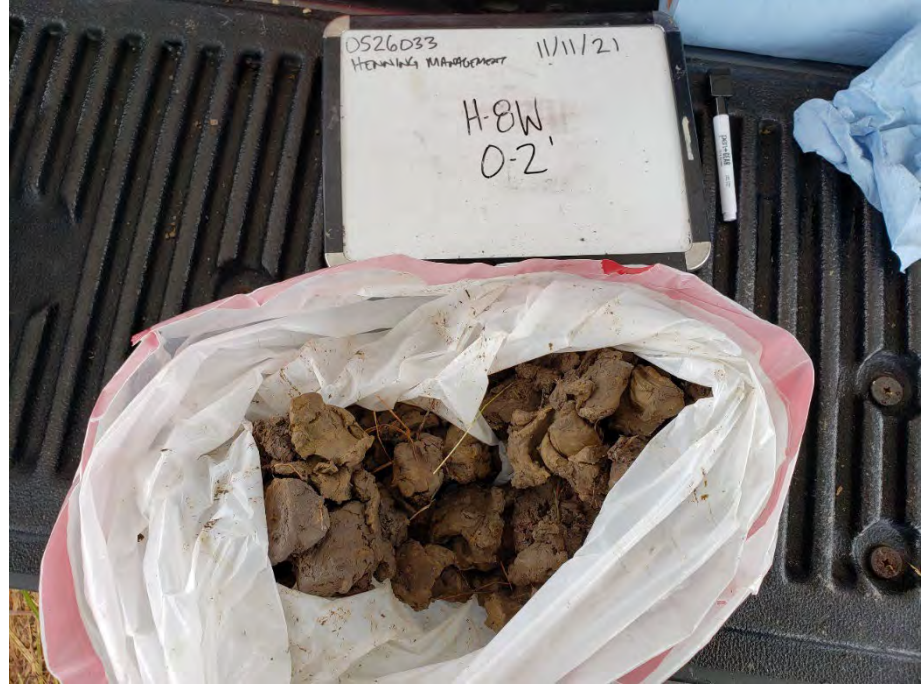
Photo No. 27	Date: 11/11/2021
Direction Photo Taken:	
Description: 20211111_113148 H-8W 0-2' soil cuttings -EC: 1.74 -Clay, dark yellowish brown (10 YR 4/4), moist, stiff, no odor -PID: 0.0 ppm

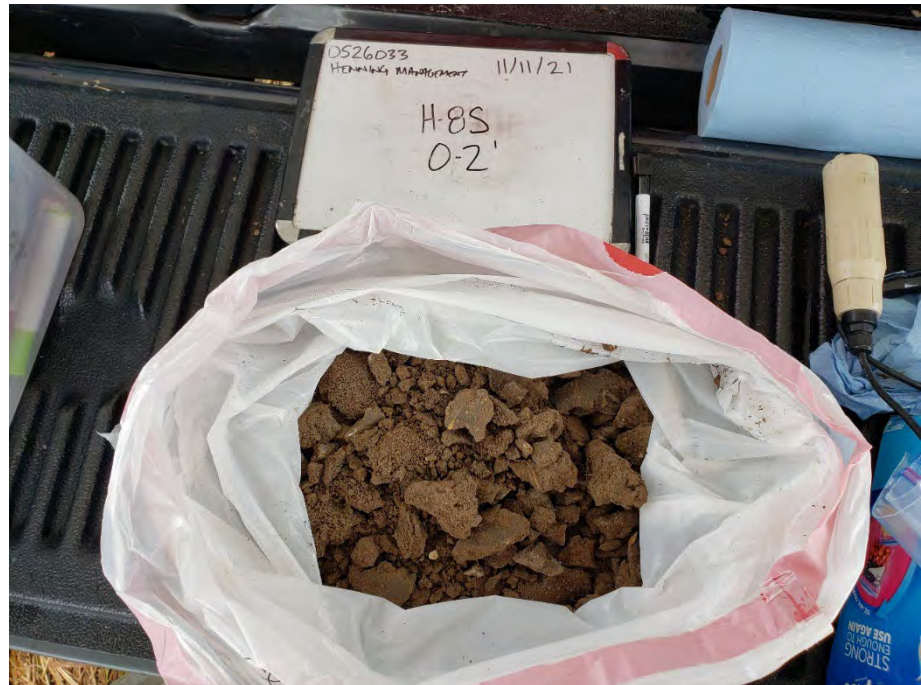
Photo No. 28	Date: 11/11/2021
Direction Photo Taken:	
Description: 20211111_113932 H-8S 0-2' soil cuttings -EC: 0.64 -Clayey silt, dark brown (10 YR 3/3), dry to slightly moist, stiff, no odor -PID:

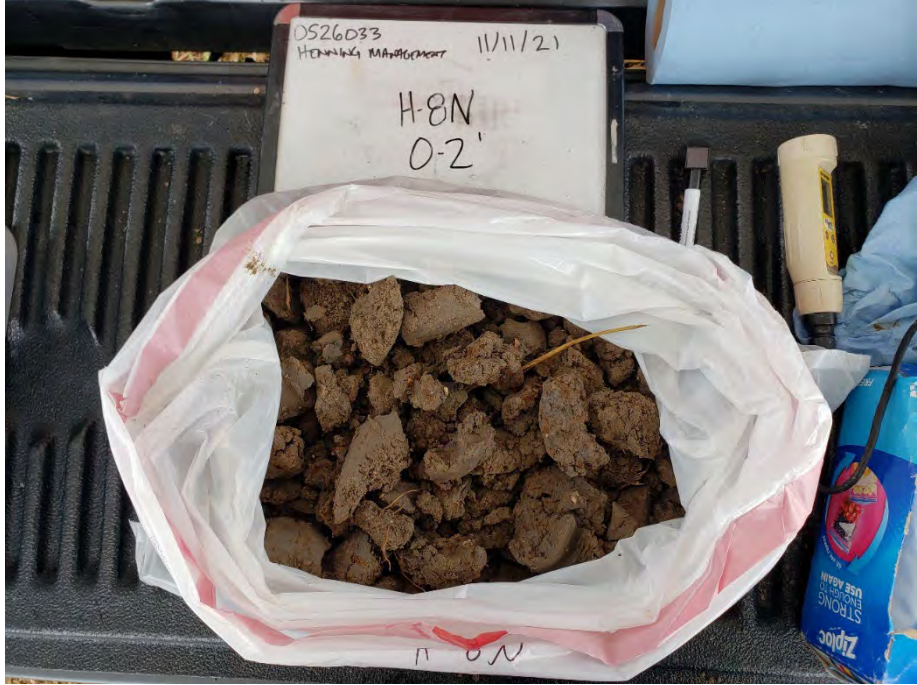
Photo No. 29	Date: 11/11/2021
Direction Photo Taken:	
Description: 20211111_114603 H-8N 0-2' soil cuttings -EC: 1.29 -Clay with silt, dark brown (10 YR 3/3), moist, stiff, no odor -PID: 0.0

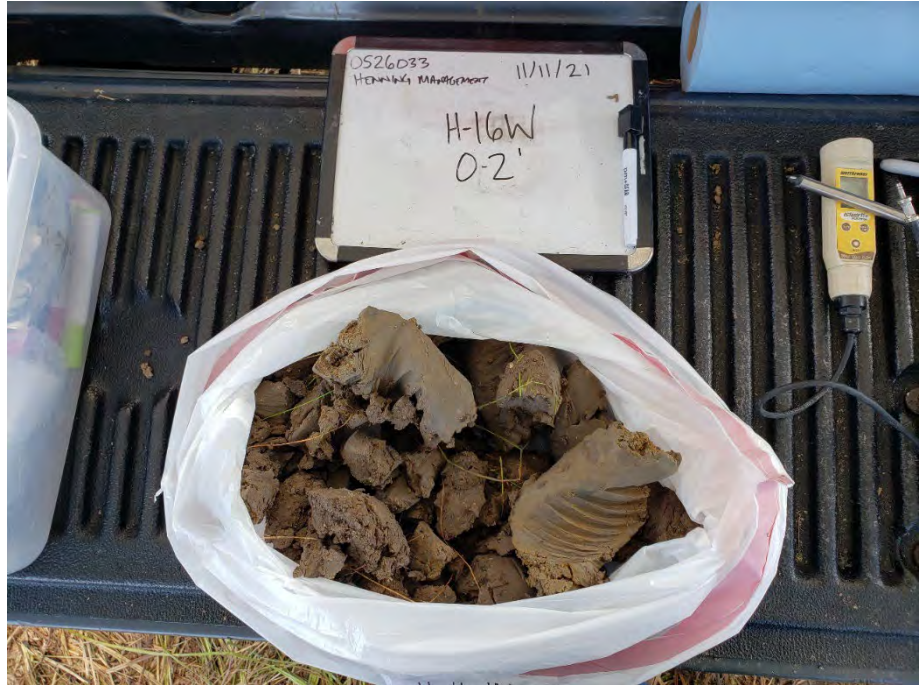
Photo No. 35	Date: 11/11/2021
Direction Photo Taken:	
Description: 20211111_132205 H-16W 0-2' soil cuttings -EC: 1.51 -Clay with minor silt content, dark brown (10 YR 3/3), moist, med. stiff, no odor -PID: 0.0 ppm

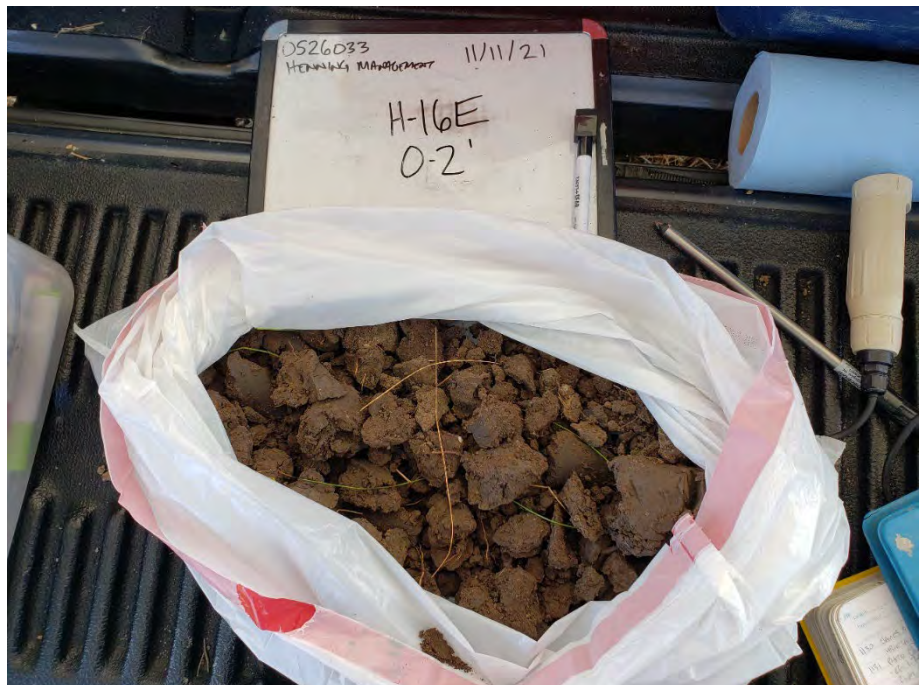
Photo No. 36	Date: 11/11/2021
Direction Photo Taken:	
Description: 20211111_133403 H-16E 0-2' soil cuttings -EC: 1.47 -Clayey silt, very dark brown (10 YR 2/2), moist, medium stiff, no odor -PID: 0.0 ppm

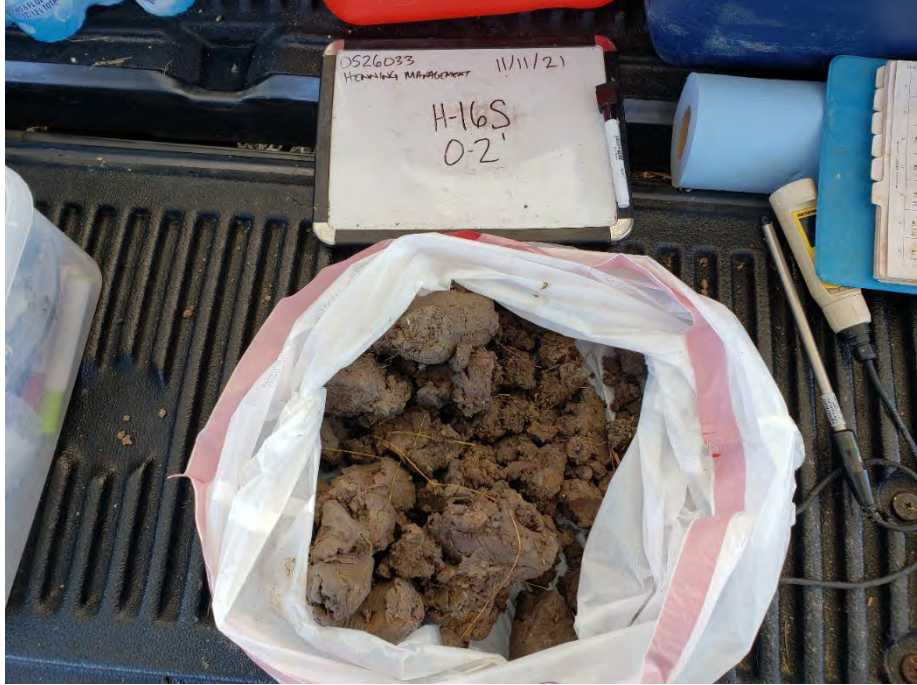
Photo No. 37	Date: 11/11/2021
Direction Photo Taken:	
Description: 20211111_134500 H-16S 0-2' soil cuttings -EC: 1.02 -Clay with silt, dark brown (10 YR 3/3), moist, medium stiff, no odor -PID: 0.0 ppm

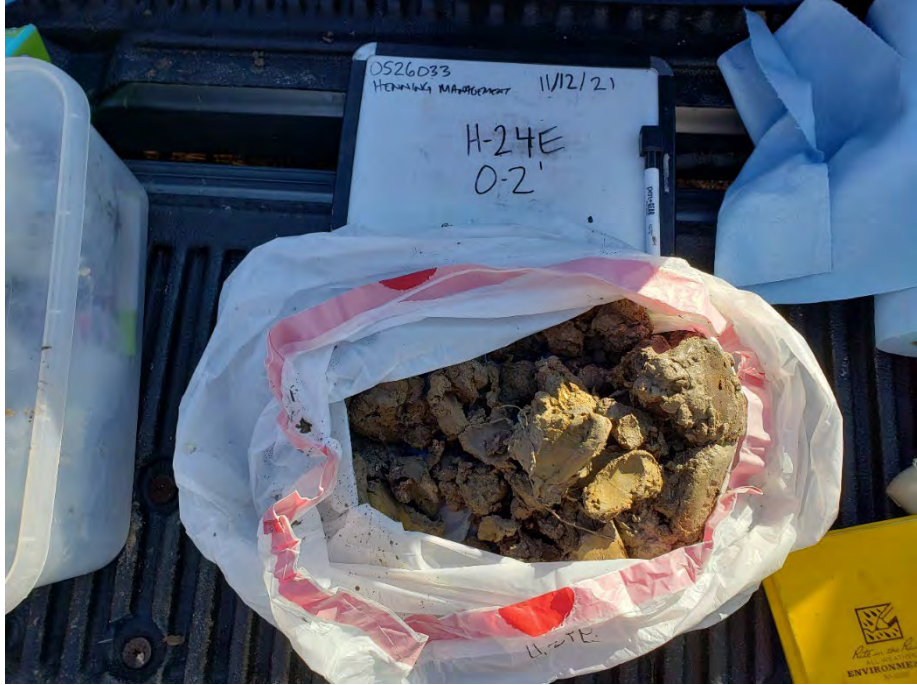
Photo No. 55	Date: 11/12/2021
Direction Photo Taken:	
Description: 20211112_084933 H-24E 0-2' soil cuttings -EC: 0.97 -Silty clay, yellowish brown (10 YR 5/4), moist, medium stiff, no odor, abundant sandy gravel (fill) in upper ~8", shells -PID: 0.5

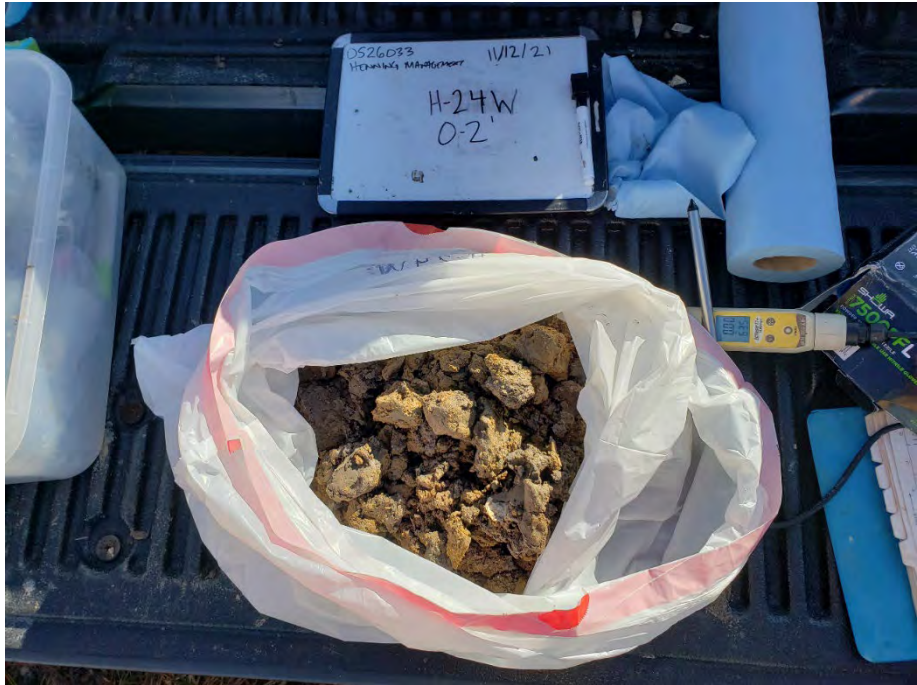
Photo No. 56	Date: 11/12/2021
Direction Photo Taken:	
Description: 20211112_085739 H-24W 0-2' soil cuttings -EC: 1.05 -Clayey silt, dark yellowish brown (10 YR 4/4), moist, medium stiff, no odor, abundant sand (fill) in upper ~8", shells -PID: 0.1

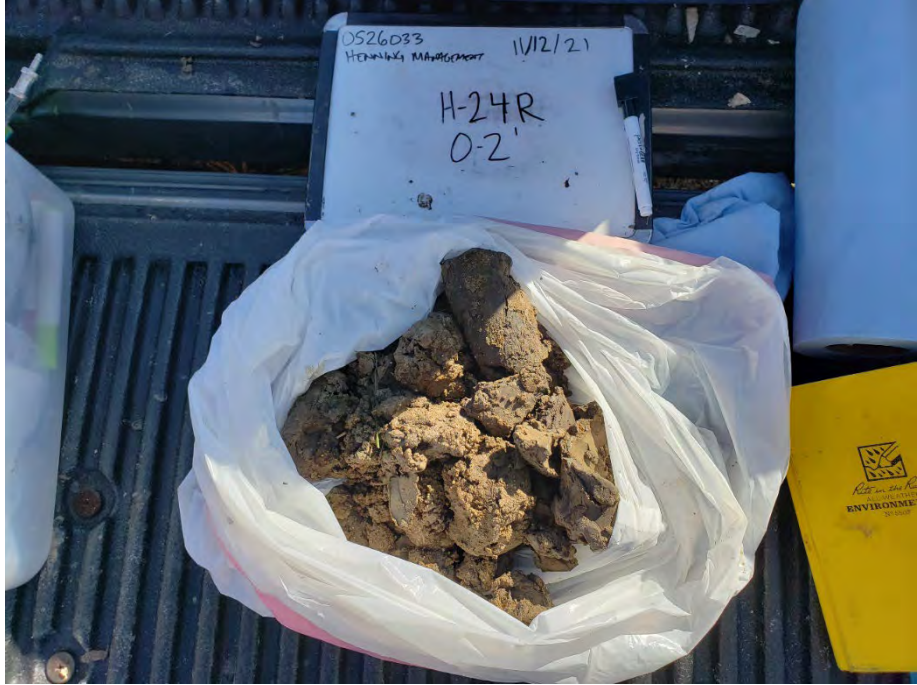
Photo No. 57	Date: 11/12/2021
Direction Photo Taken:	
Description: 20211112_090822 H-24R 0-2' soil cuttings -EC: 1.45 -Silty clay, very dark gray (10 YR 3/1) moist, medium stiff, no odor, minor shells, abundant sand w/ some gravel (fill) in upper ~8" -PID: 0.1

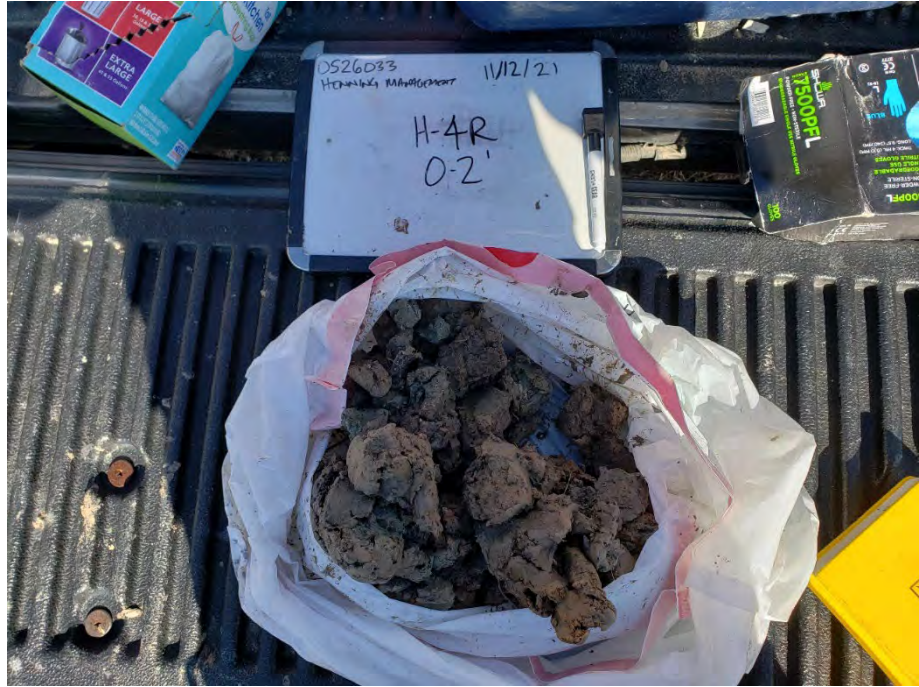
Photo No. 65	Date: 11/12/2021
Direction Photo Taken:	
Description: 20211112_102417 H-4R 0-2' soil cuttings -EC: 0.75 -Silty clay, very dark gray (10 YR 3/1), moist, medium stiff, no odor -PID: 5.6 ppm

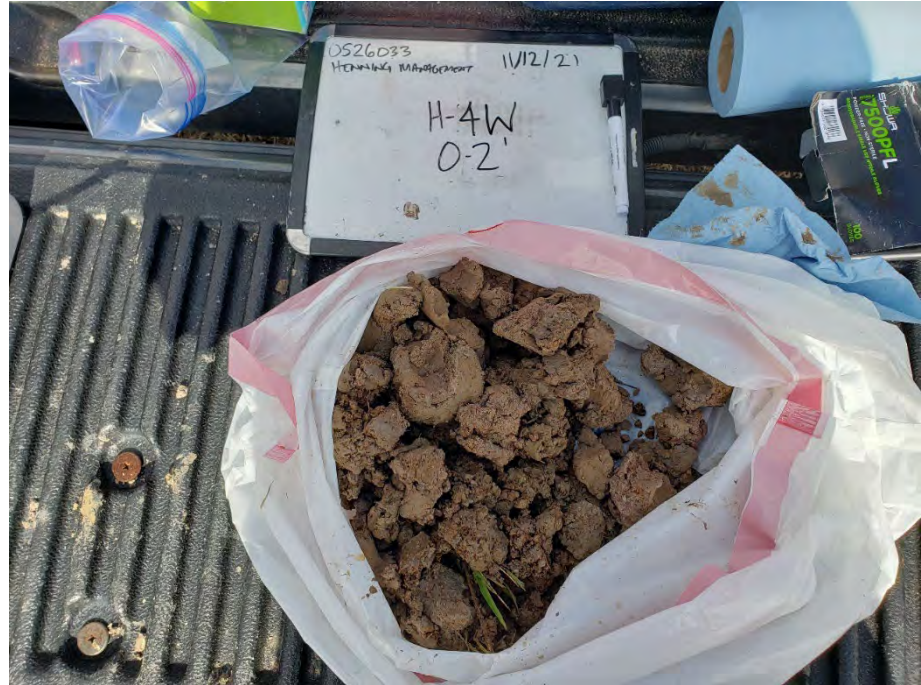
Photo No. 69	Date: 11/12/2021
Direction Photo Taken:	
Description: 20211112_111512 H-4W 0-2' soil cuttings -EC: 0.36 -Clayey silt, dark brown (10 YR 3/3), moist, medium soft, no odor, minor rootlets -PID: 5.1 ppm

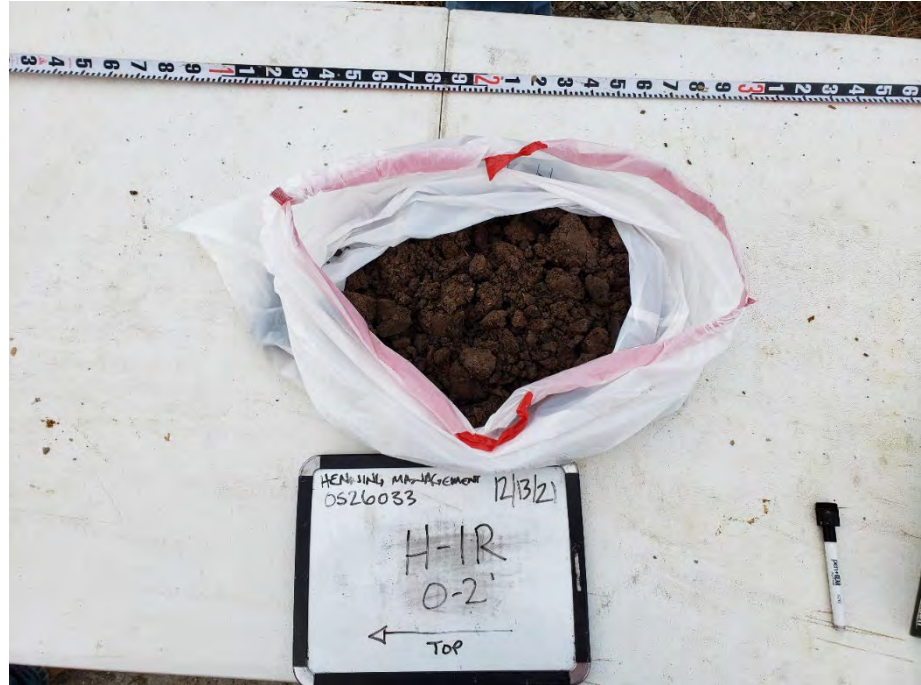
Photo No. 87	Date: 12/13/2021
Direction Photo Taken:	
Description: 20211213_161523 H-1R soil cutting 0-2' H-1R: 0-2': Silty clay, dark reddish brown (5 YR 3/2), moist, medium stiff, no odor, minor shells & rootlets EC: 2.16 PID: 0.1

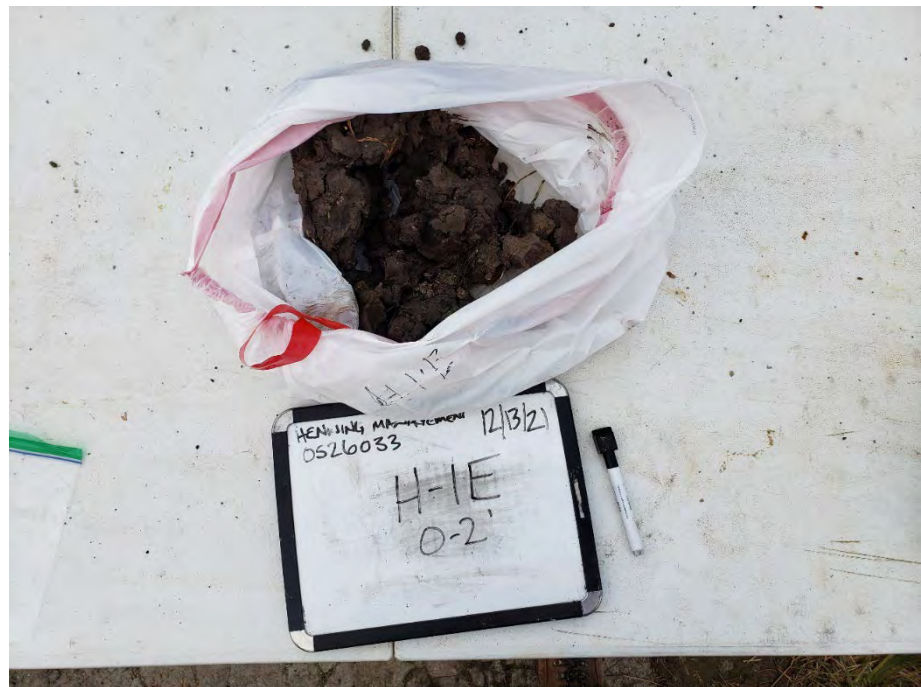
Photo No. 88	Date: 12/13/2021
Direction Photo Taken:	
Description: 20211213_162355 H-1E 0-2' soil cuttings H-1E: 0-2': clay, very dark brown (7.5 YR 2.5/2), moist, med. soft, no odor, high plasticity, rootlets EC: 0.63 PID: 0.0

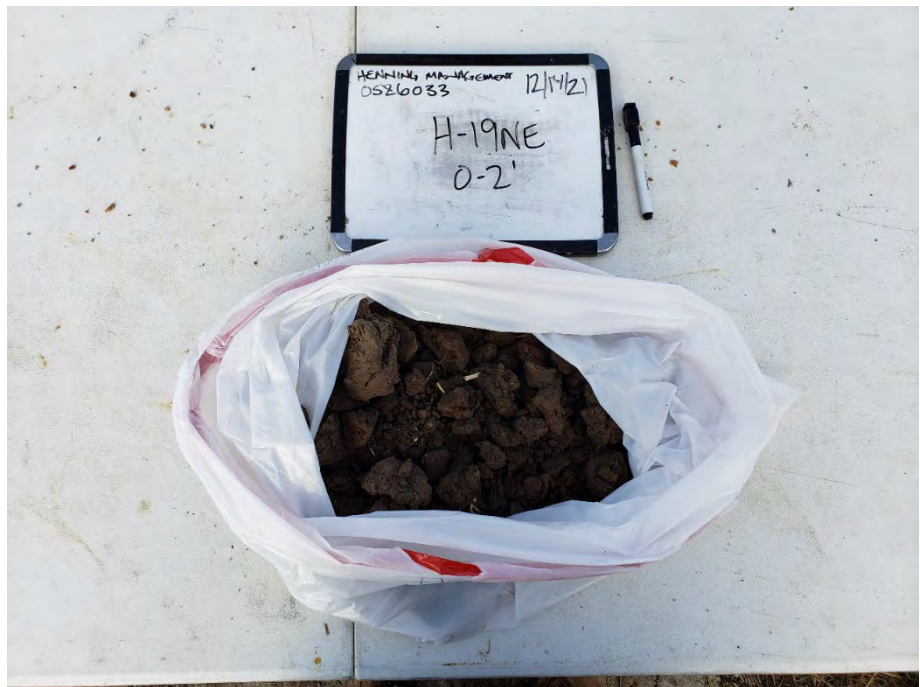
Photo No. 110	Date: 12/14/2021
Direction Photo Taken:	
Description: 20211214_135429 H-19NE 0-2' soil cuttings H-19NE 0-2': Silty clay, very dark brown (10 YR 2/2), slightly moist, med stiff, no odor, minor rootlets EC: 2.64 PID: 0.0

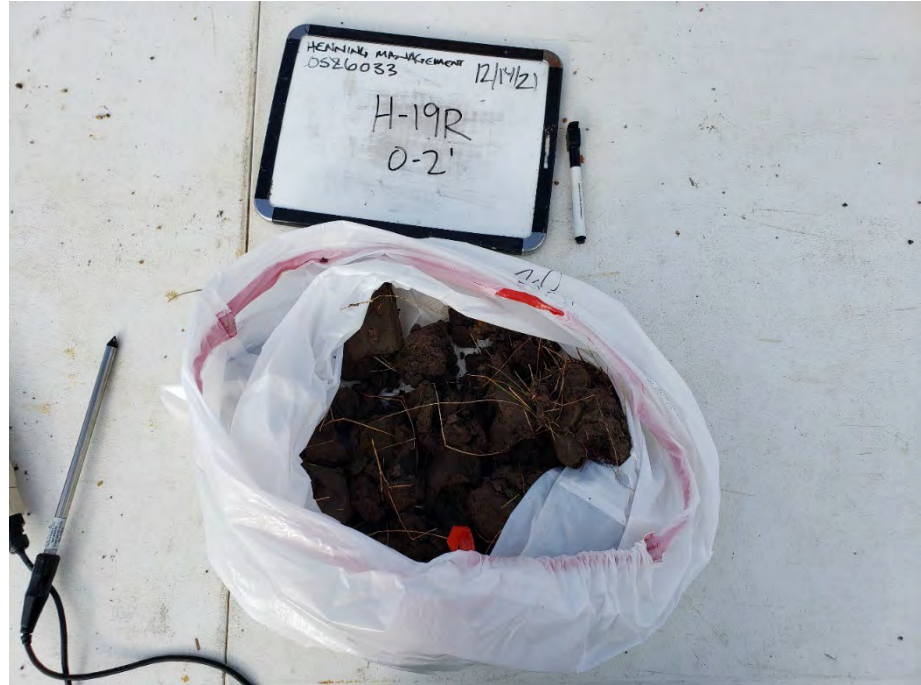
Photo No. 111	Date: 12/14/2021
Direction Photo Taken:	
Description: 20211214_135950 H-19R 0-2' soil cutting H-19R 0-2': Silty clay, very dark brown (10 YR 2/2, moist, stiff, no odor, rootlets EC: 0.9 PID: 0.0

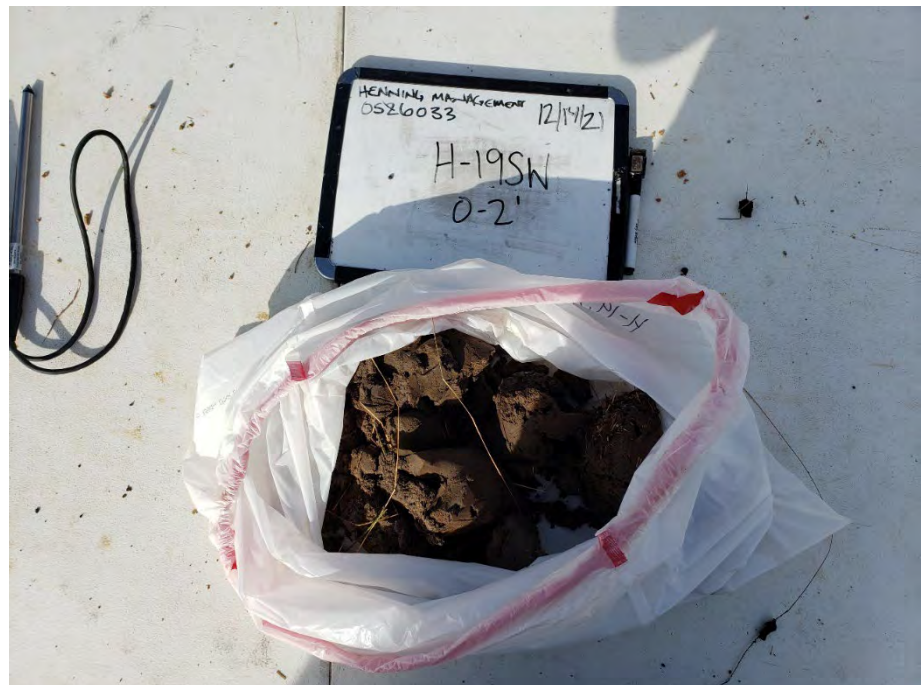
Photo No. 112	Date: 12/14/2021
Direction Photo Taken:	
Description: 20211214_140507 H-19SW 0-2' soil cuttings H-19SW 0-2': Silty clay, very dark brown (10 YR 2/2), moist, med stiff, no odor, rootlets EC: 1.22 PID: 0.0

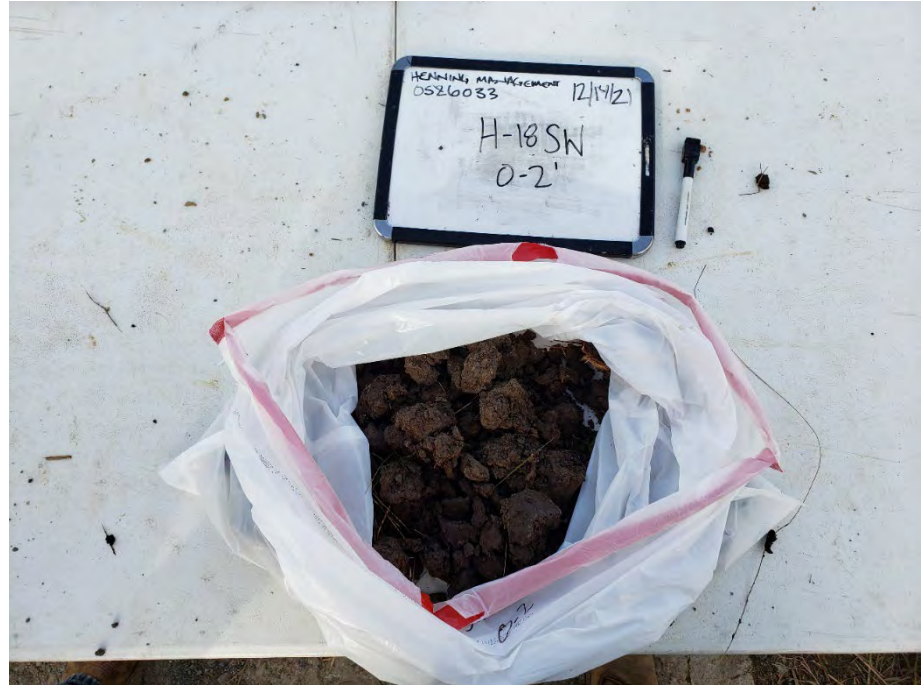
Photo No. 113	Date: 12/14/2021
Direction Photo Taken:	
Description: 20211214_141014 H-18SW 0-2' soil cuttings H-18SW 0-2': Silty clay, very dark brown (10 YR 2/2), moist, med soft, no odor, rootlets EC: 1.11 PID: 0.0
