**Documentation of Peak Restoration Activities
Attachment D**

*Vermilion Parish School Board v.
Louisiana Land, et al*

*2014 Supplemental Data/Expert Report
Michael E. Pisani, P.E.
David G. Angle, P.G.*

Attachment D-2
Documentation of Restoration Work

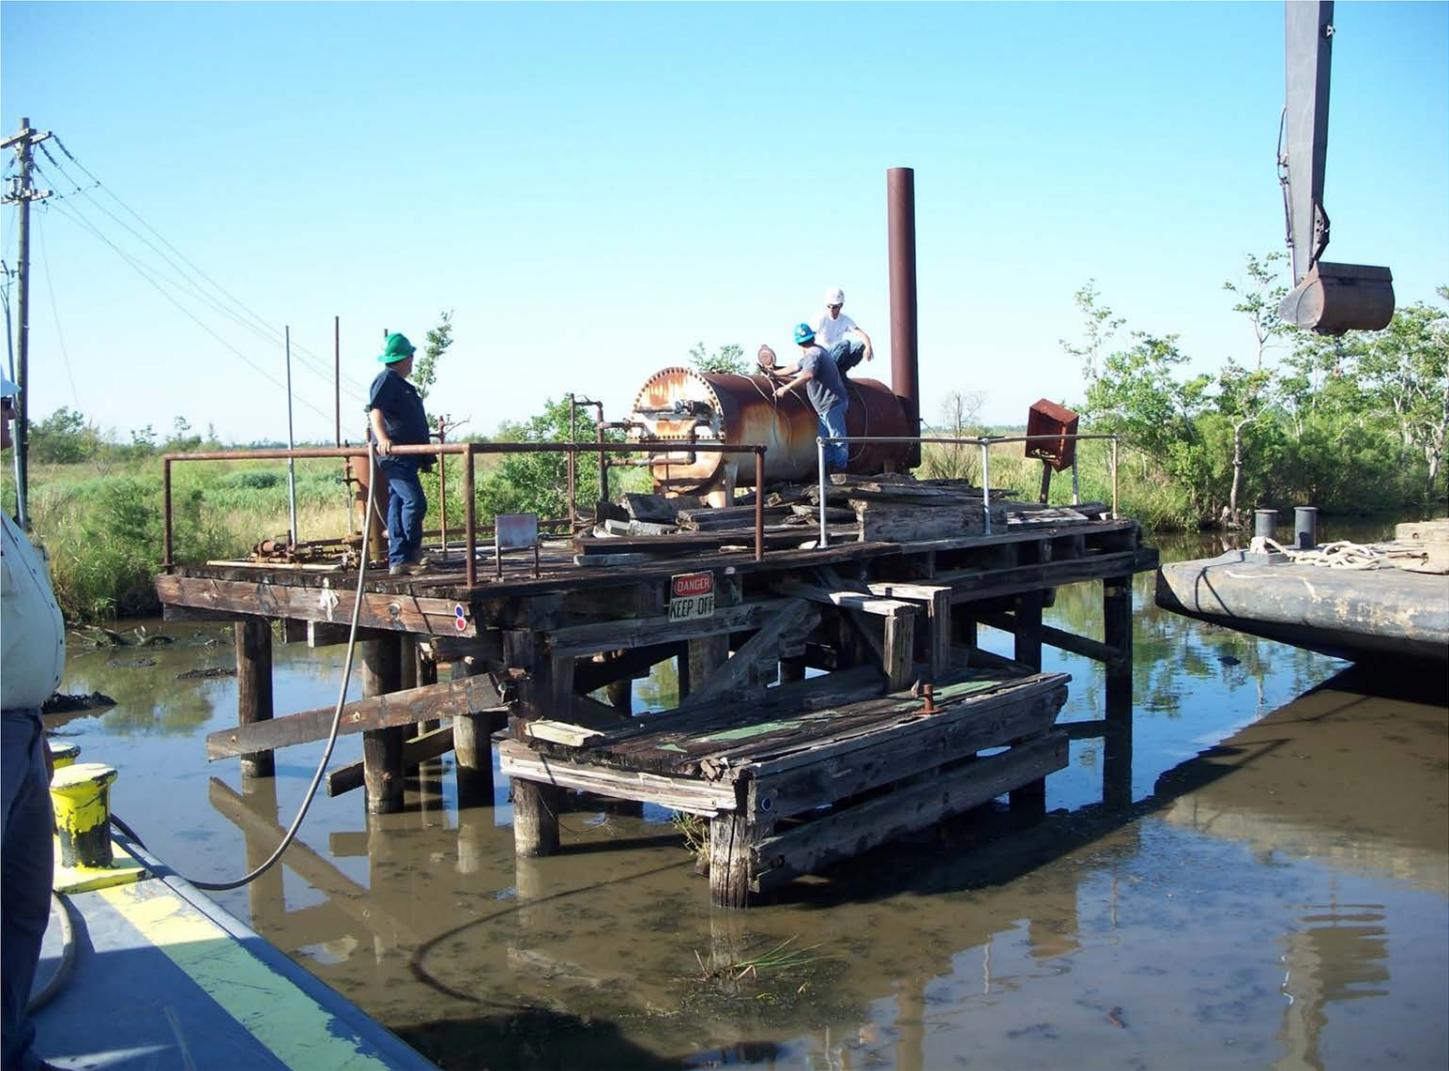
Tab- 1
Tank with
Platform:
Set up for
removal

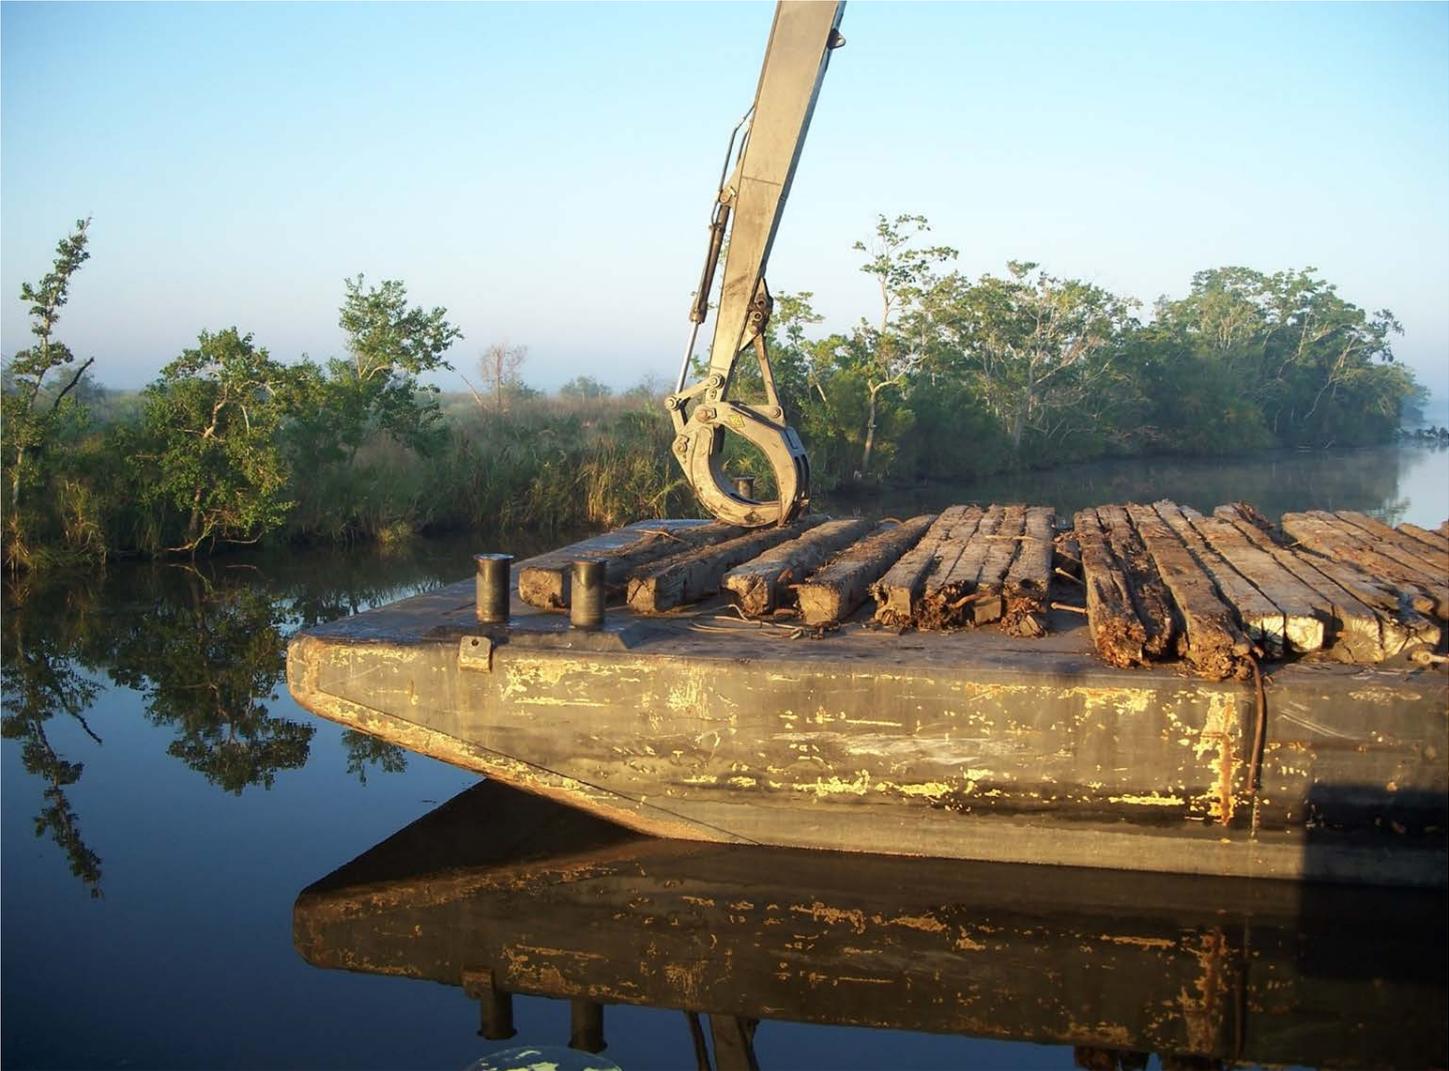
Tab- 1
Tank with
Platform:
Stockpile
of
removed
platform

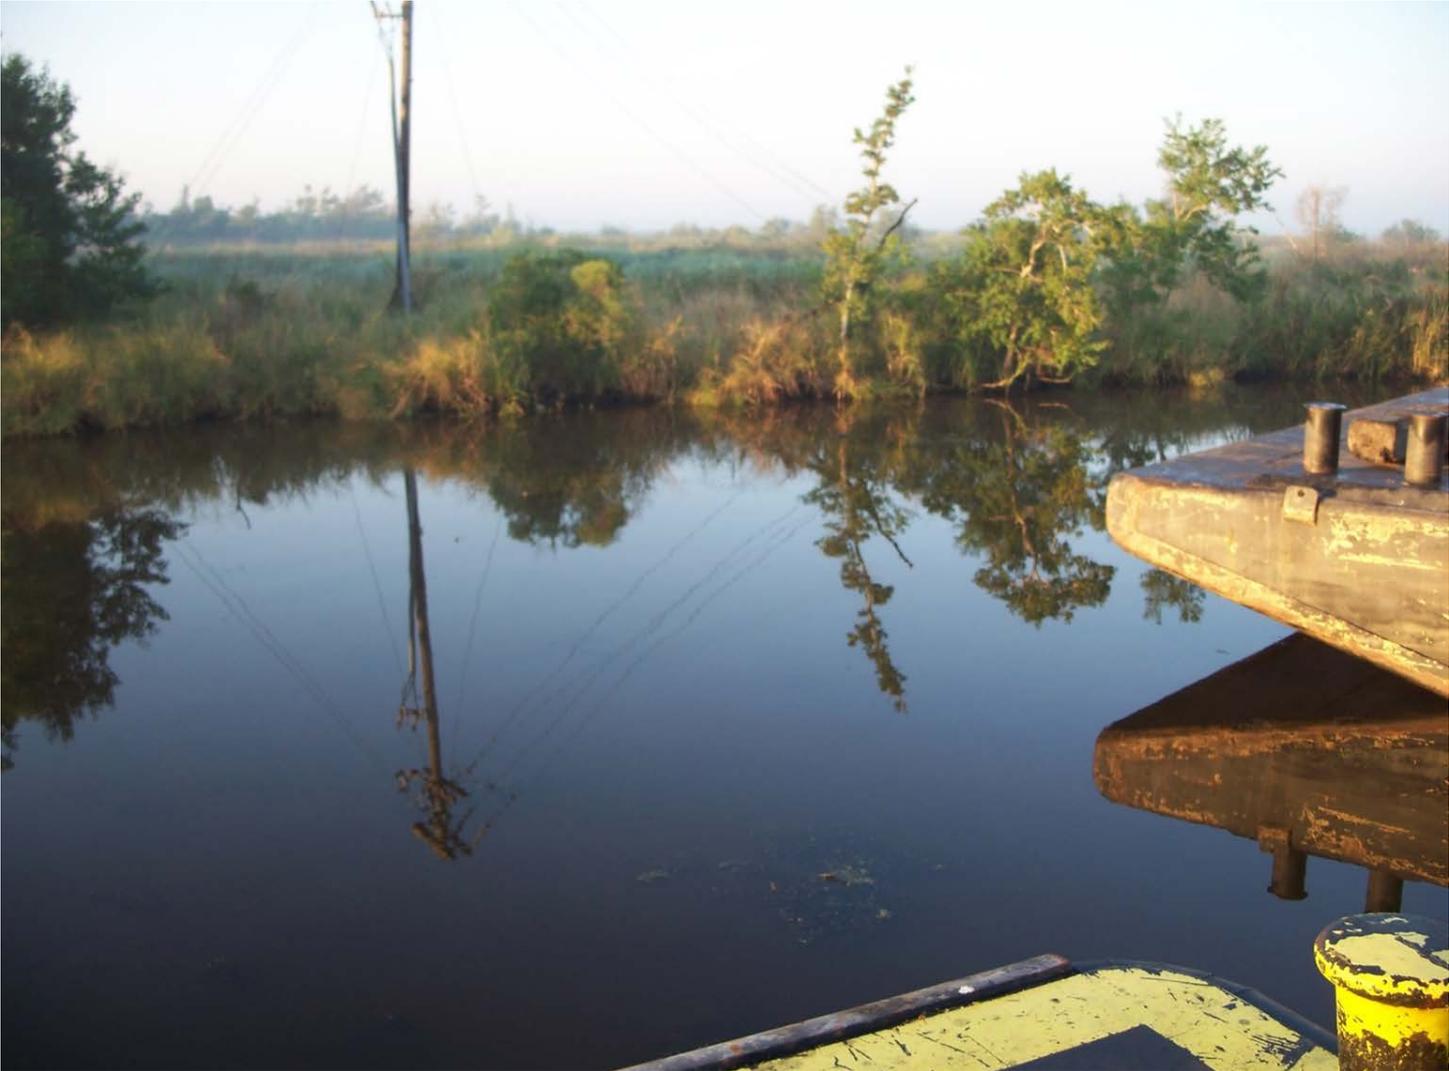
Tab- 1
Tank with
Platform:
Location
after
restoratio
n work

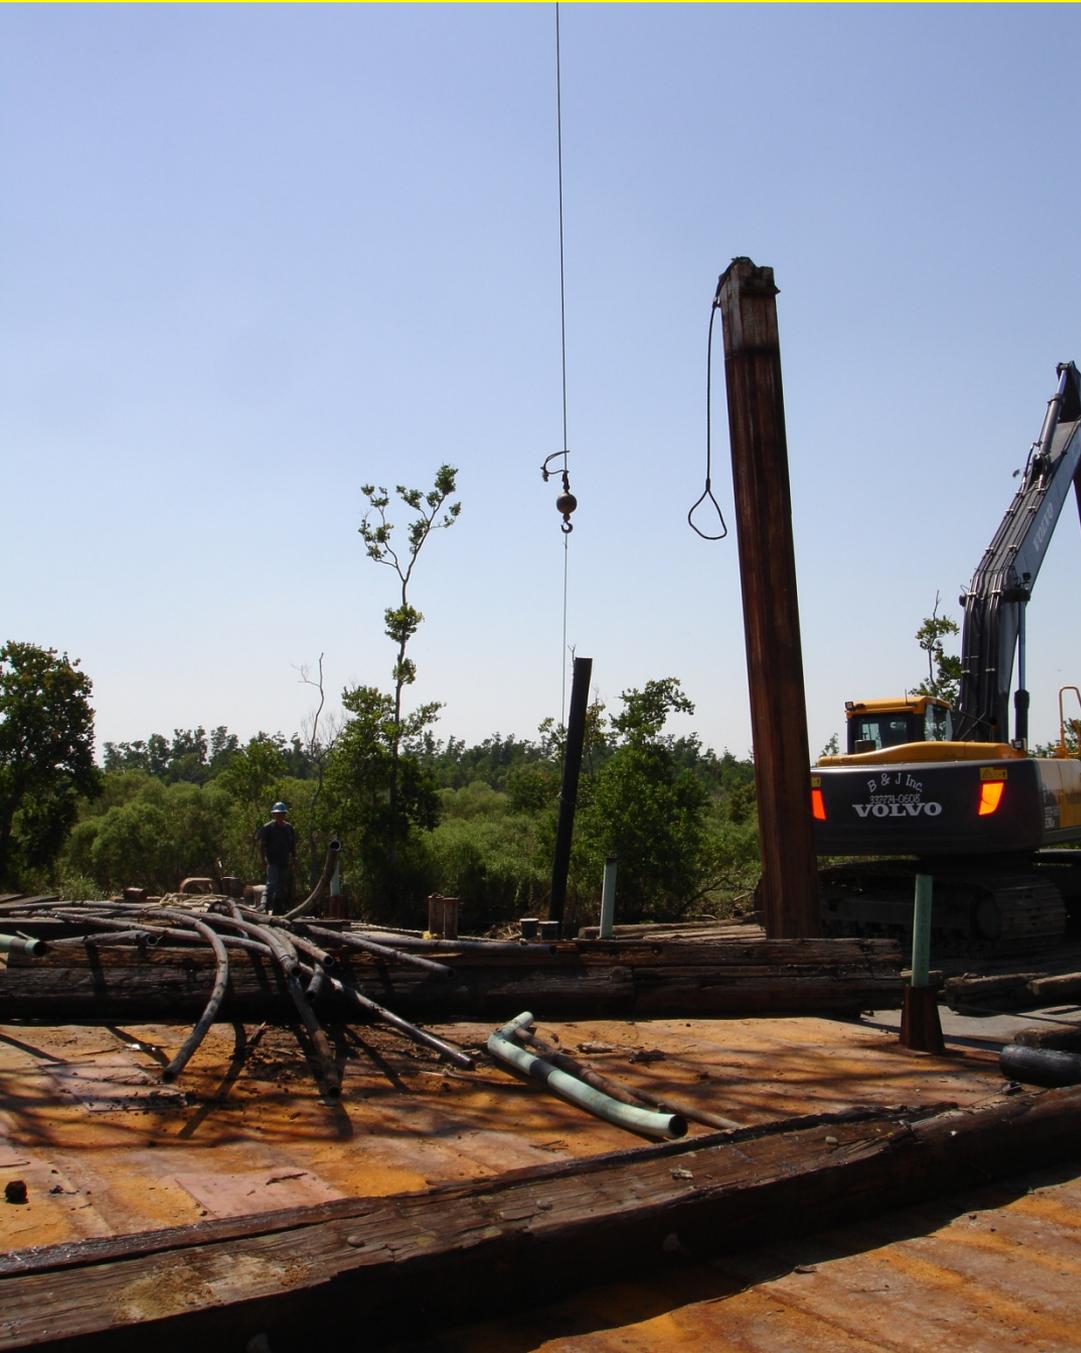
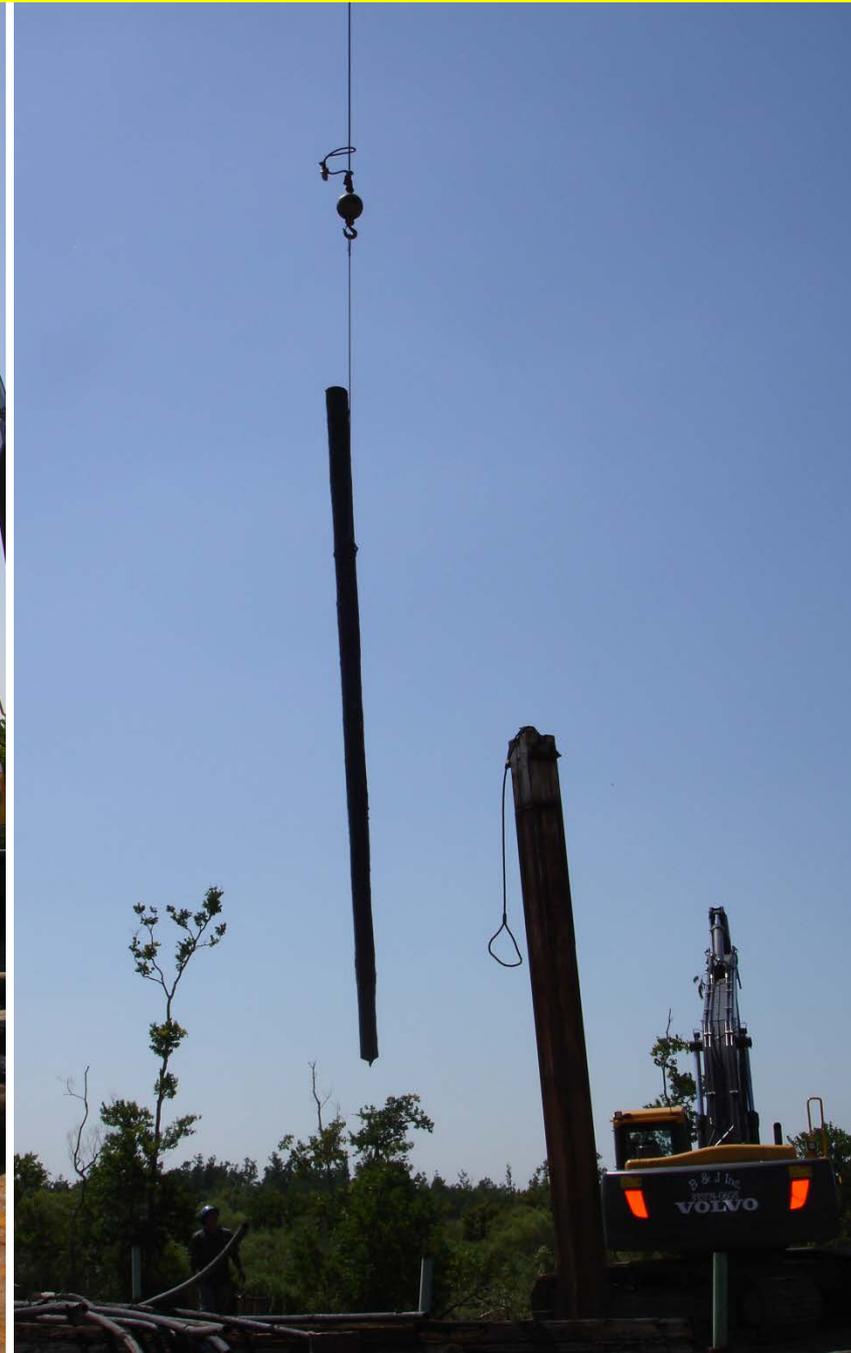
Stockpile of piers and tanks/oilfield equipment at Tank Battery "B"

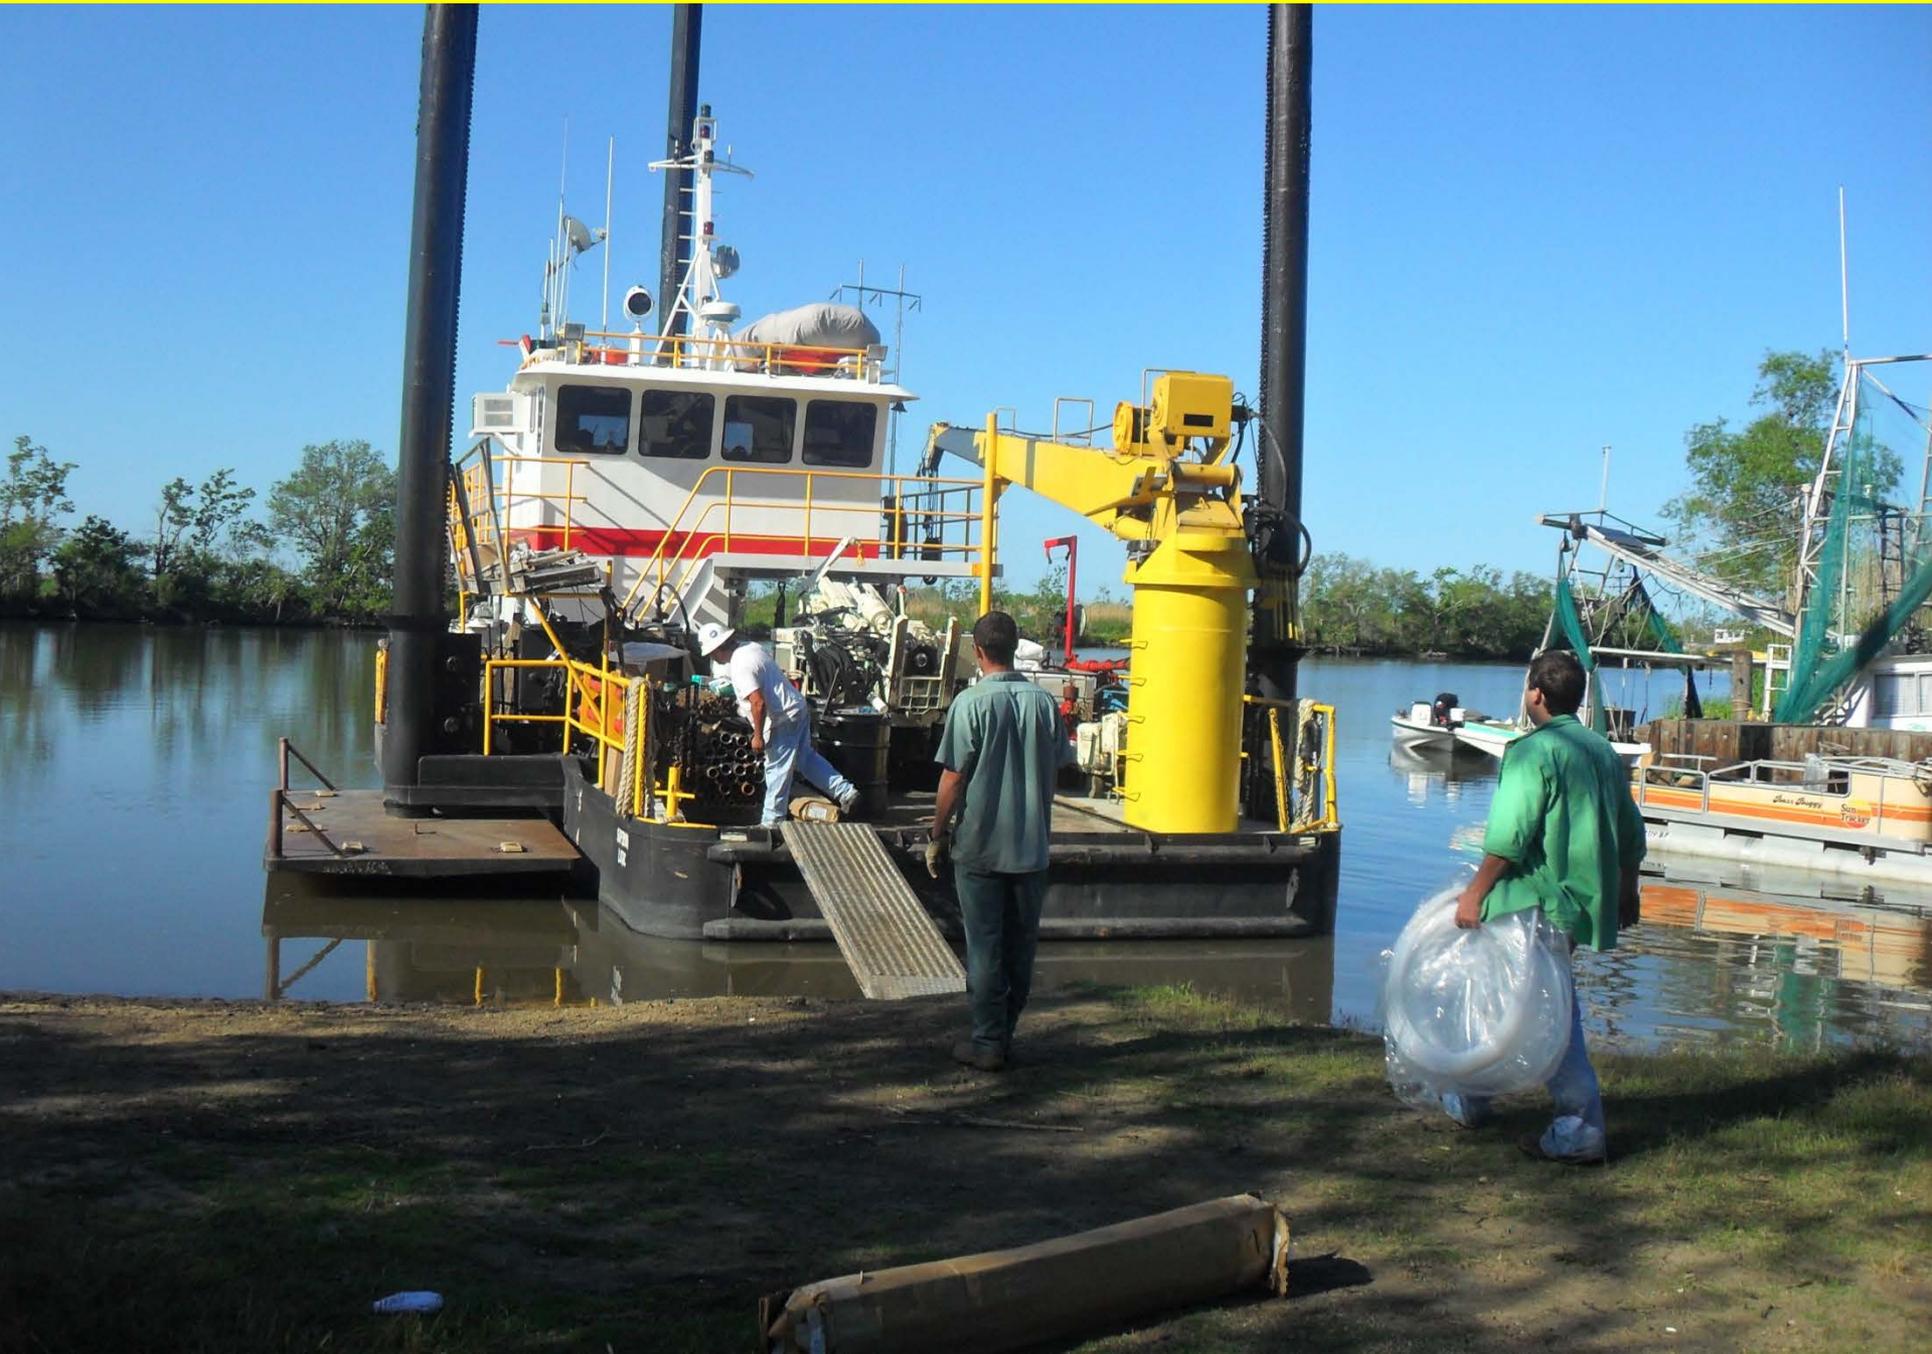
Geoprobe Sampling Rig on Lift Boat

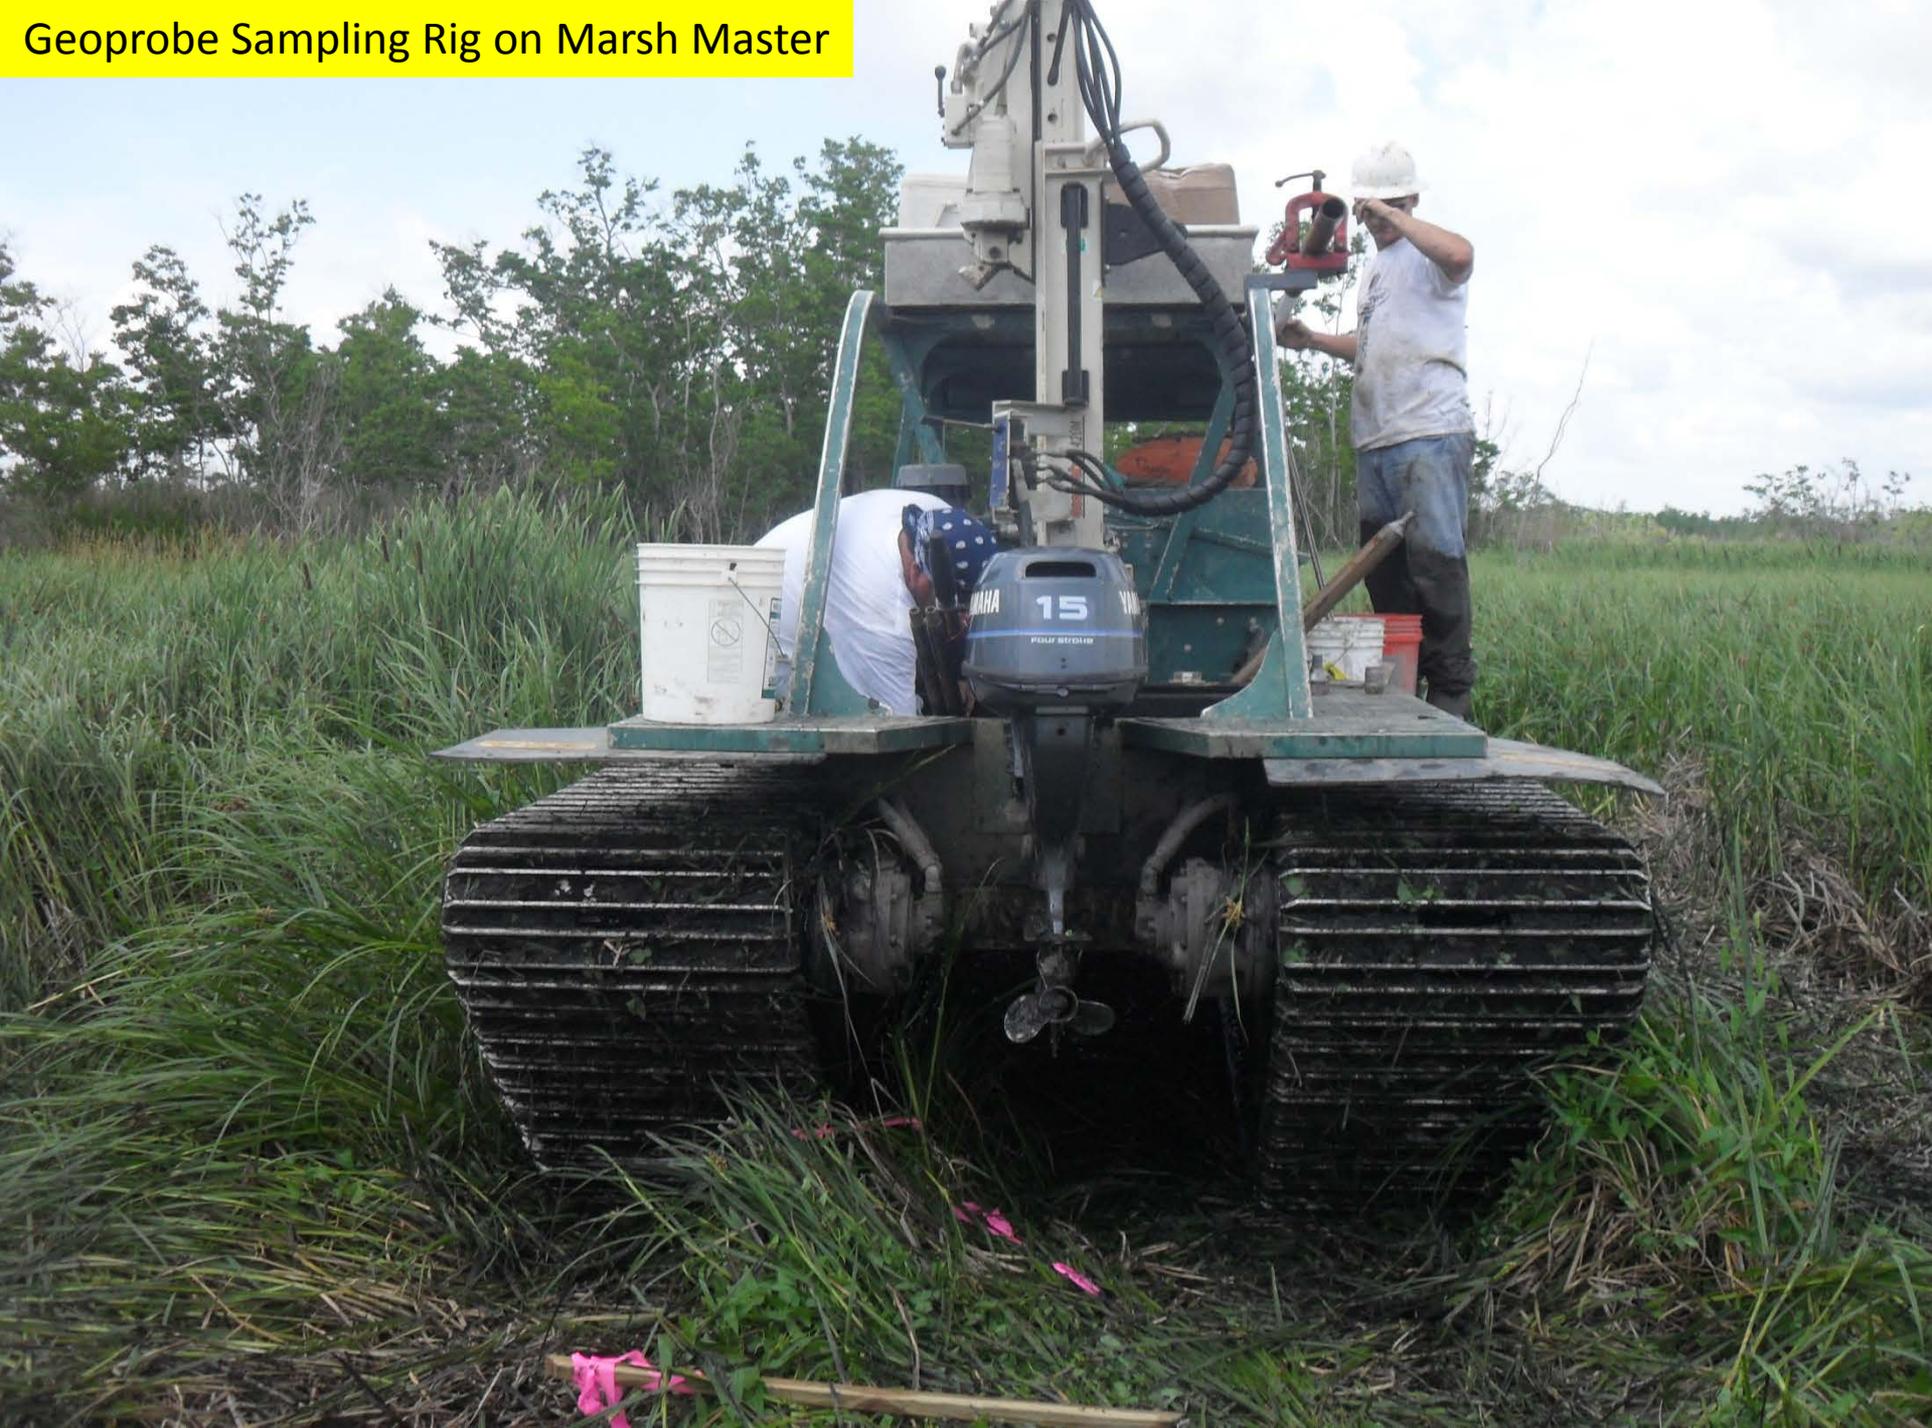
Geoprobe Sampling Rig on Marsh Master
